ATSB TRANSPORT SAFETY REPORT
Marine Occurrence Investigation No. 269
MO-2009-009
Final

Independent investigation into the steering gear compartment fire
on board the Marshall Islands registered anchor handling tug

Petra Frontier

28 September 2009

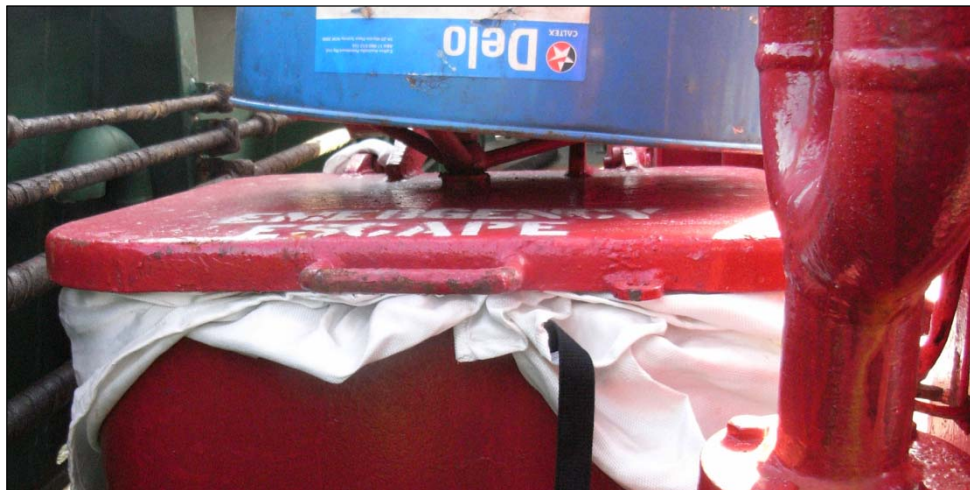
Figure 4: Closed hatch with drum on top

At 0619, the chief mate, via hand-held radio, directed the second mate to concentrate all his efforts on closing the steering gear compartment vents. The second mate tried several times to close the port side emergency hatch but it would not latch. One of the crew got a cut down 205 litre drum, placed it on top of the hatch and put a few large shackles inside it, to weigh it down. However, smoke continued to escape from the hatch. The drum was removed, the hatch opened and oil spill absorbent mats were placed around the rim of the hatch. The hatch was then closed, the drum replaced and filled with water to weigh it down (Figure 4).

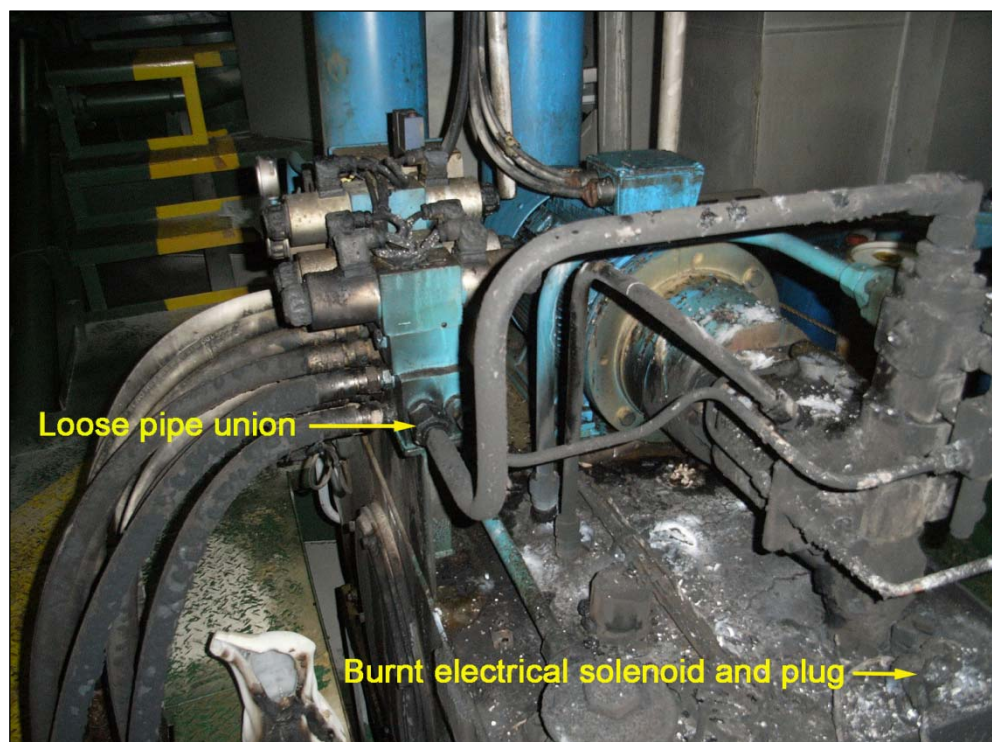
Figure 5: Towing pin hydraulic pump discharge pipe

At about 0600 on 28 September, when the breathing apparatus (BA) equipped IRs entered the steering gear compartment in an attempt to extinguish the fire, they saw oil spraying from a hydraulic pipe union on the towing pin hydraulic unit. The pipe union was later identified as the one connecting the hydraulic pump discharge pipe to the control valve block (Figure 5) and an inspection carried out by the ATSB investigators found that the union was little more than finger tight.

The leak probably started as a drip and then grew into a spray as the pipe union loosened. The first engineer did not notice anything unusual when he inspected the steering gear compartment at about midnight. Therefore, it is likely that the oil did not start spraying until sometime after that.

At the time of the incident, the ship was less than a year old and there were no records of any maintenance being carried out on the hydraulic unit pipe work. Therefore, the hydraulic unit pipe work was probably in its original condition. Since the unit was normally run only for short periods of time, it is possible that it had never before run for such a long period of time. As a result, it is likely that the pipe union, which was probably not sufficiently tight in the first place, had not had a prior opportunity to work loose.

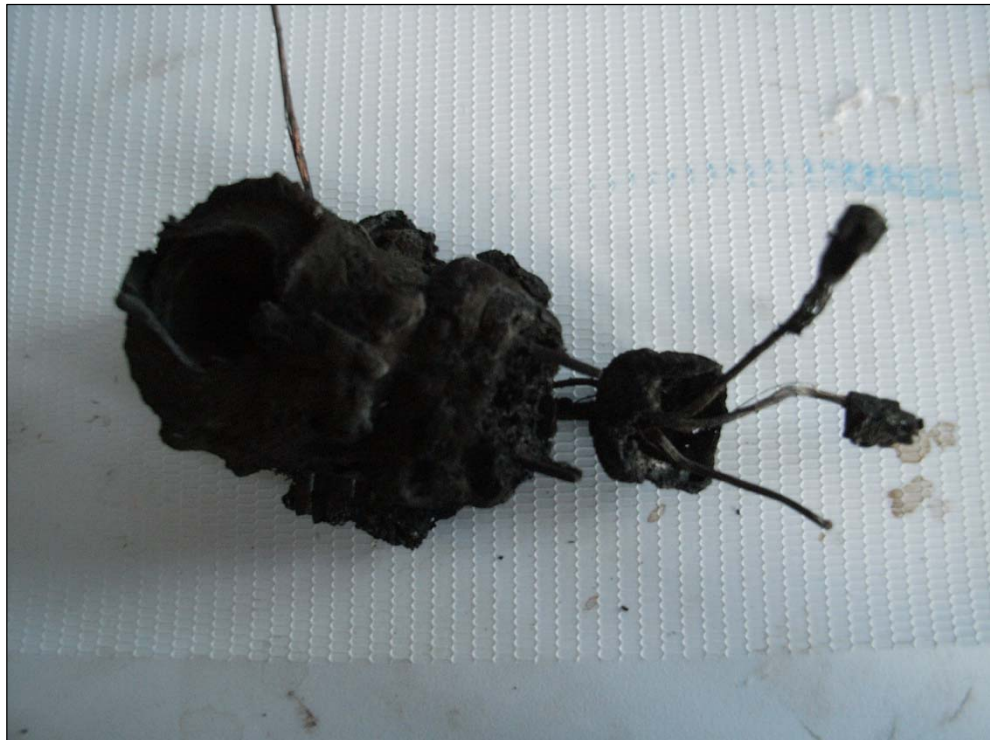
Figure 6: Remains of the electrical solenoid and connecting plug

- The leaking oil probably penetrated the connecting plug of an electrical solenoid located at the starboard end of the hydraulic unit, causing it to short circuit. The short circuit either created enough heat, or a spark, that was sufficient to ignite the oil soaked rags.

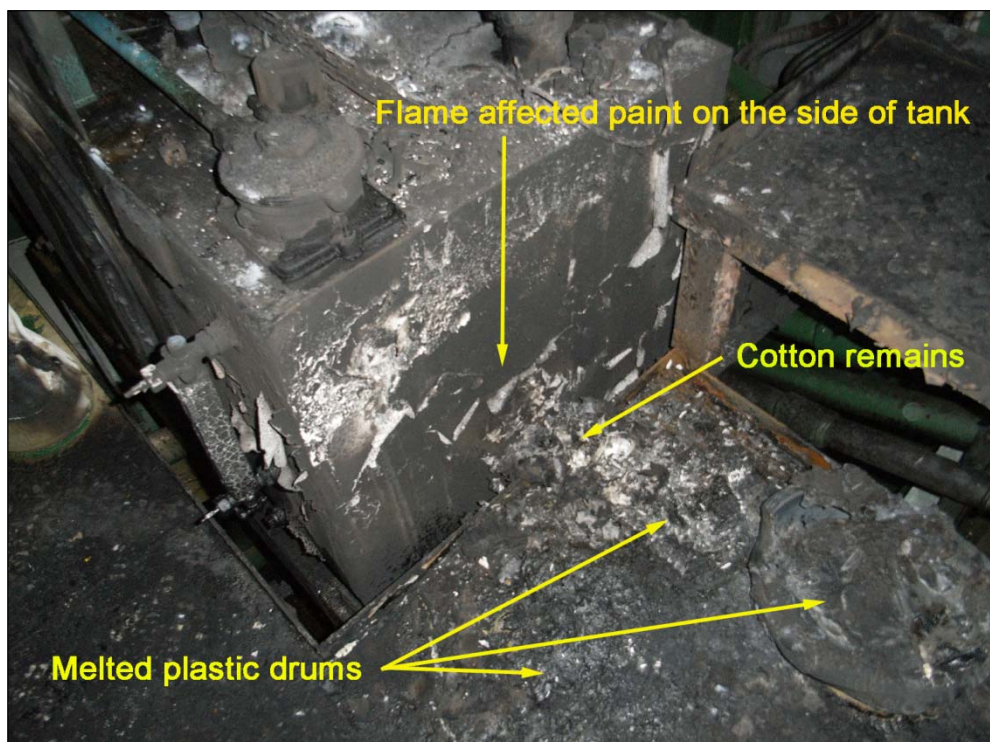
Figure 7: Burnt remains of rags at the side of the hydraulic oil tank

The hot leaking oil sprayed around the area, saturating the starboard side of the hydraulic unit, the electrical fittings located there and some used cotton rags (rags) that had been left on top of the drums near the end of the hydraulic unit tank. The drums were about the same height as the hydraulic oil tank and the rags were near the tank's starboard end and perhaps even on top of it.

When the BA-equipped IRs saw the smouldering rags, they put them on the deck and stomped on them. However, the evidence indicates that not all of the rags were removed and that some rags had fallen between the drums and the hydraulic unit tank (Figure 7). The supply of air to these rags probably increased when the rags around them were removed and the smouldering developed into a flame. The fire then grew in size, consuming the available hot hydraulic oil. It was probably at this time that the crew noted the smoke change colour from white to black and the heat in the compartment start to increase.

Not only were the chemicals stored in *Petra Frontier*'s steering compartment, but used oily rags had been placed on top of them. Used oily rags are a safety hazard and have been linked to the source of many machinery space fires, including this one. Therefore, they should never be left lying around machinery spaces. Used rags should always be placed in appropriate garbage containers that are regularly emptied, thus eliminating a possible source of fuel from machinery spaces.
