ATSB TRANSPORT SAFETY REPORT Aviation Occurrence Investigation AO-2009-068 Final

Operational event 132 km west of Horn Island Aerodrome Queensland 9 November 2009 VH-EMZ Bell Helicopter 412

Operational event 132 km west of Horn Island Aerodrome, Queensland 9 November 2009 VH-EMZ Bell Helicopter Company 412

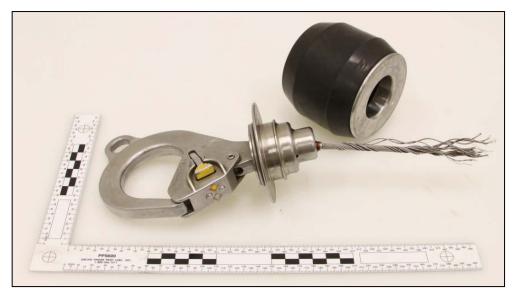
Figure 9: Winch cable hook and bump stop

An examination of the helicopter's rescue winch identified that the cable separated about 14 cm from the hook (Figures 9 and 10). There was also evidence of white paint on the bump stop striker plate (Figure 11), which was consistent with contact between the winch cable and the ship's white-coloured foremast structure.

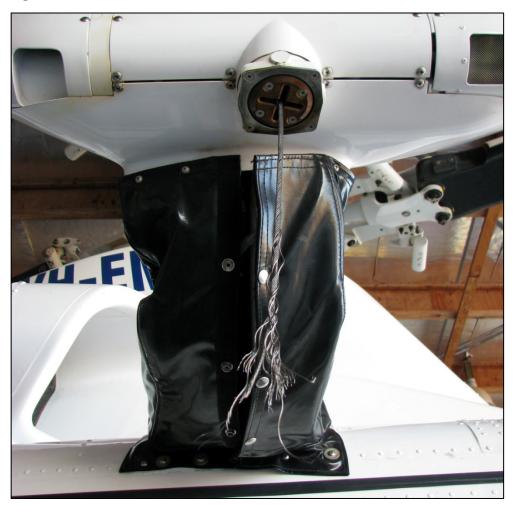
Figure 10: Winch cable

Examination of the winch cable via visual and scanning electron microscopy techniques identified that about 17% of the cable had been severed through abrasive contact with the foremast structure (Figure 16). The separation of the remainder of the cable was consistent with the effects of a combination of shear and tensile overstress. There was no evidence of fatigue failure within any of the cable strands.

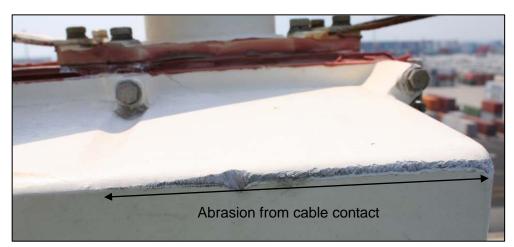
Figure 17: Contact marks on the radar scanner

An examination of the foremast structure following the ship's arrival in Brisbane identified marks that were consistent with contact between the winch cable and the radar scanner and the associated platform railing (Figures 17 to 20).
