ATSB TRANSPORT SAFETY REPORT
Marine Occurrence Investigation No. 263
MO-2009-002
Final

Independent investigation into the loss of containers
from the Hong Kong registered container ship

Pacific Adventurer

off Cape Moreton, Queensland

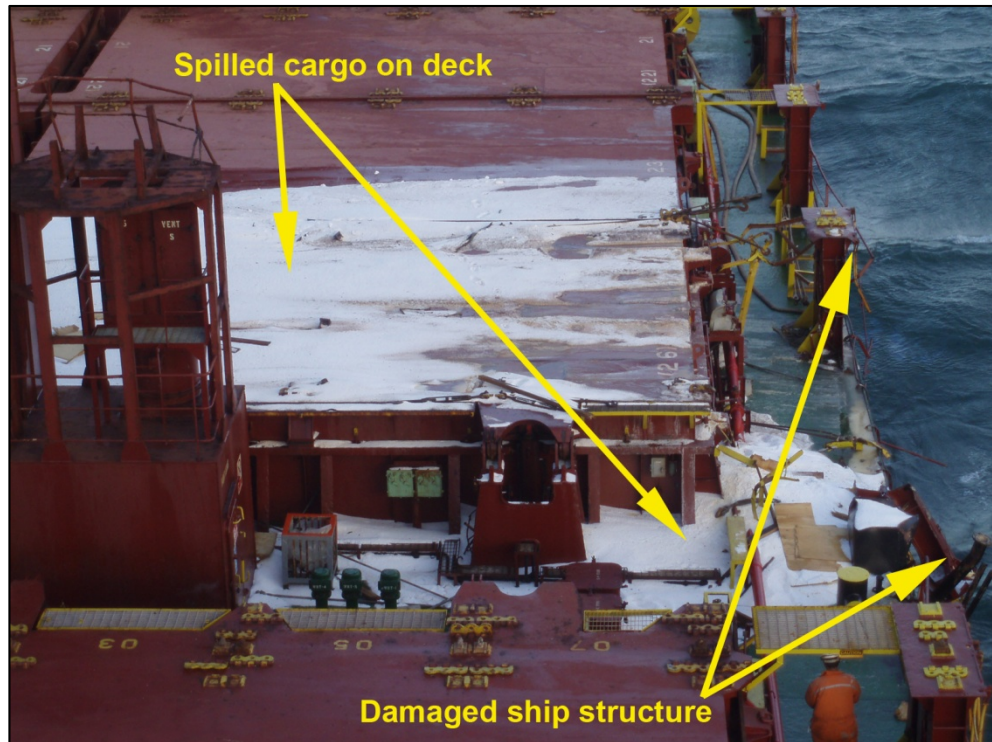
Following the internal inspection of the holds, conditions had moderated sufficiently to allow the chief mate and chief engineer access to the port side of the ship's main deck, just forward of the accommodation. From there, they were able to confirm the loss of the containers from Bay 25 and that the ship's structure in the vicinity of Bay 25 had been damaged as a result of the incident (Figure 11).

Figure 11: Bay 25 starboard following the loss of the containers

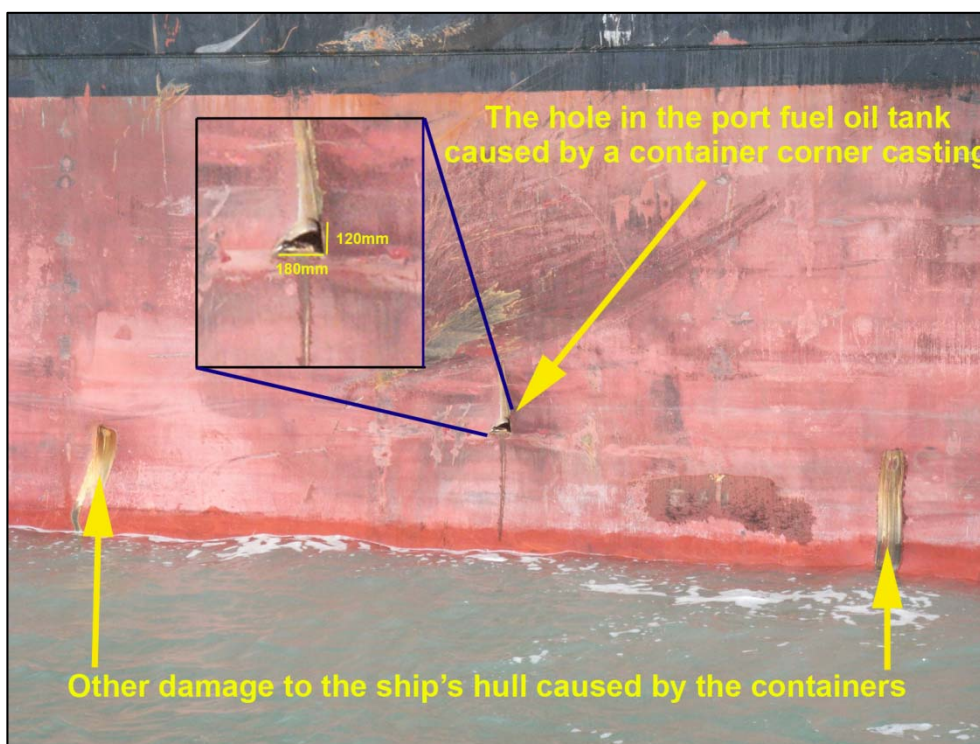
At 0552, just after sunrise, during the on-deck inspection, the chief engineer looked over the port side of the ship while it was rolling to port. As the ship rolled back to starboard, the chief engineer saw what looked like fuel oil spouting from the side of the ship. On closer inspection, he was able to see that the ship had been holed and that fuel oil was leaking into the sea from number one port fuel oil tank.

Figure 12: The hole in the port side of the ship (enlarged inset showing the hole and its approximate dimensions)

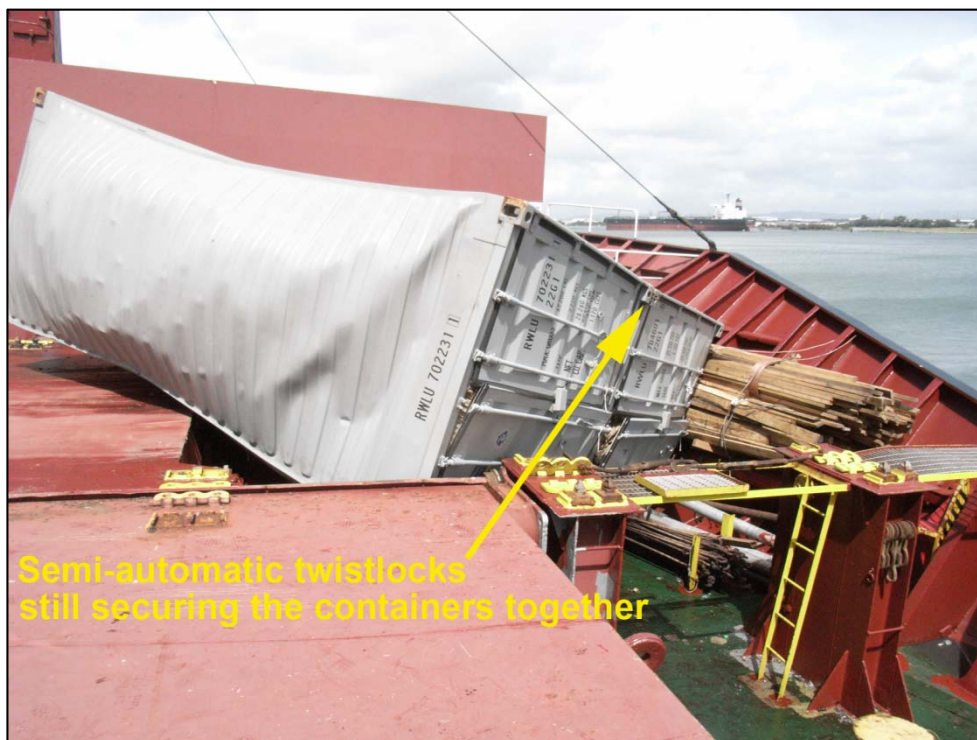
Figure 13: Damaged containers containing orange juice (note: semi-automatic twistlocks still in place between the two containers)

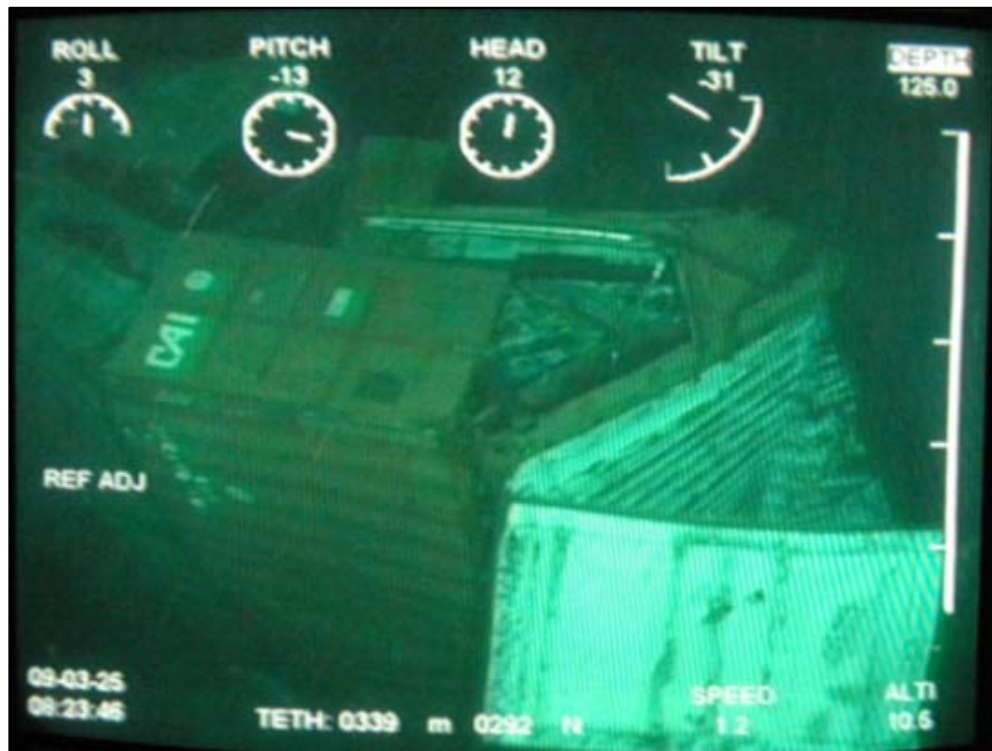
Figure 15: Containers on the seabed off Cape Moreton, still partially secured by semi-automatic twistlocks

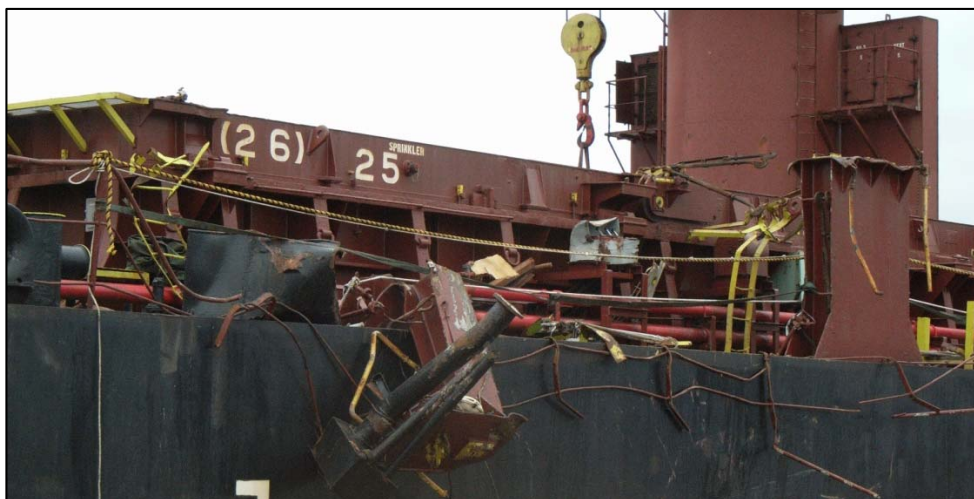
Figure 18: Damage to the ship's starboard side

Extensive damage was caused to the ship's side and hand railings, outboard container pedestals and general structure as the containers fell over the side (Figure 18). Damage to the hatch cover and loose lashing equipment, as a result of the forces on the containers and lashings, included bent lashing rods (both older and newer), turnbuckles with sections sheared off, lashing eyes on the hatch cover torn out, dovetail twistlocks (both older and newer) with sheared centre shafts and sections of the deck twistlock sliding plates sheared off (Figure 19).

This damage indicates that the forces generated by the ship's movement in the prevailing conditions were greater than the breaking loads of the fixed and loose lashing equipment that was in poor condition (discussed later in this report). Additionally, several container corner fittings were found on the deck, indicating that the containers were subjected to separation forces in addition to the other forces.

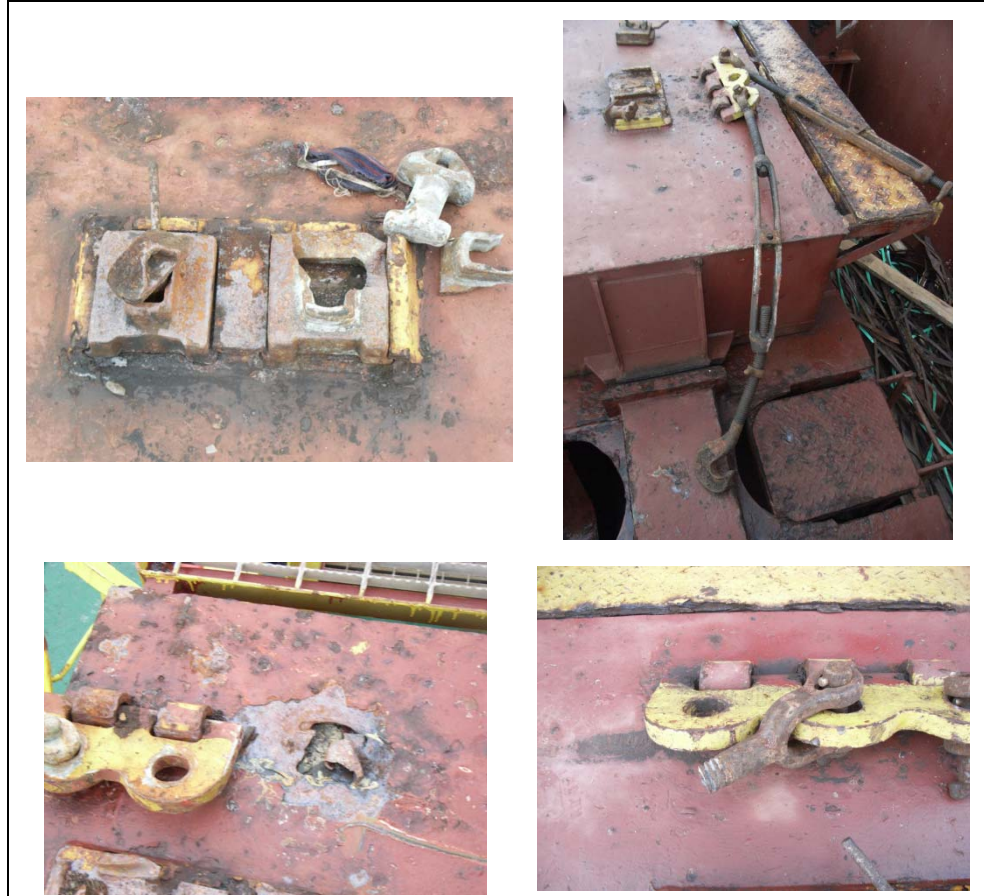
Figure 19: Damage to the ship's lashing gear

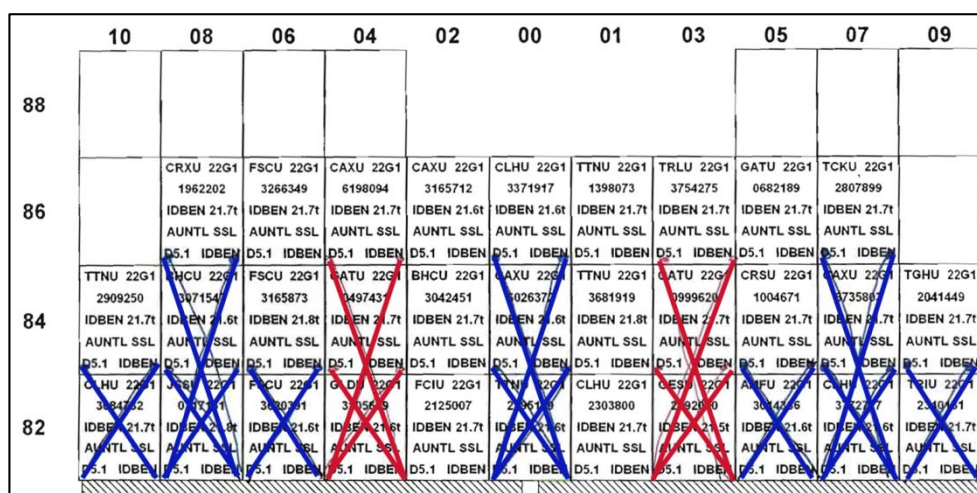
The ship's procedures stated that containers must be secured in accordance with the approved CSM or stability/loading program carried on board. However, when the chief mate drew up the lashing plan to give to the stevedores, and for the additional lashings which were added, he modified it such that rows 00, 03, 04, 07, 08, 09 and 10 were fully lashed; rows 05 and 06 were partly lashed; and rows 01 and 02 were not lashed at all (Figure 21), except with twistlocks.

Figure 21: Chief mate's lashing plan where blue indicates lashings applied in Newcastle and red indicates the additional lashings applied by the ship's crew before it sailed (ATSB emphasis of chief mate's annotations)

The chief mate probably amended the ship's loading program's lashing plan because he believed, like others in his position on container ships, that applying lashings, as he indicated in Figure 21, would be sufficient as the outboard and inner most containers were lashed to the maximum extent possible and that other lashings

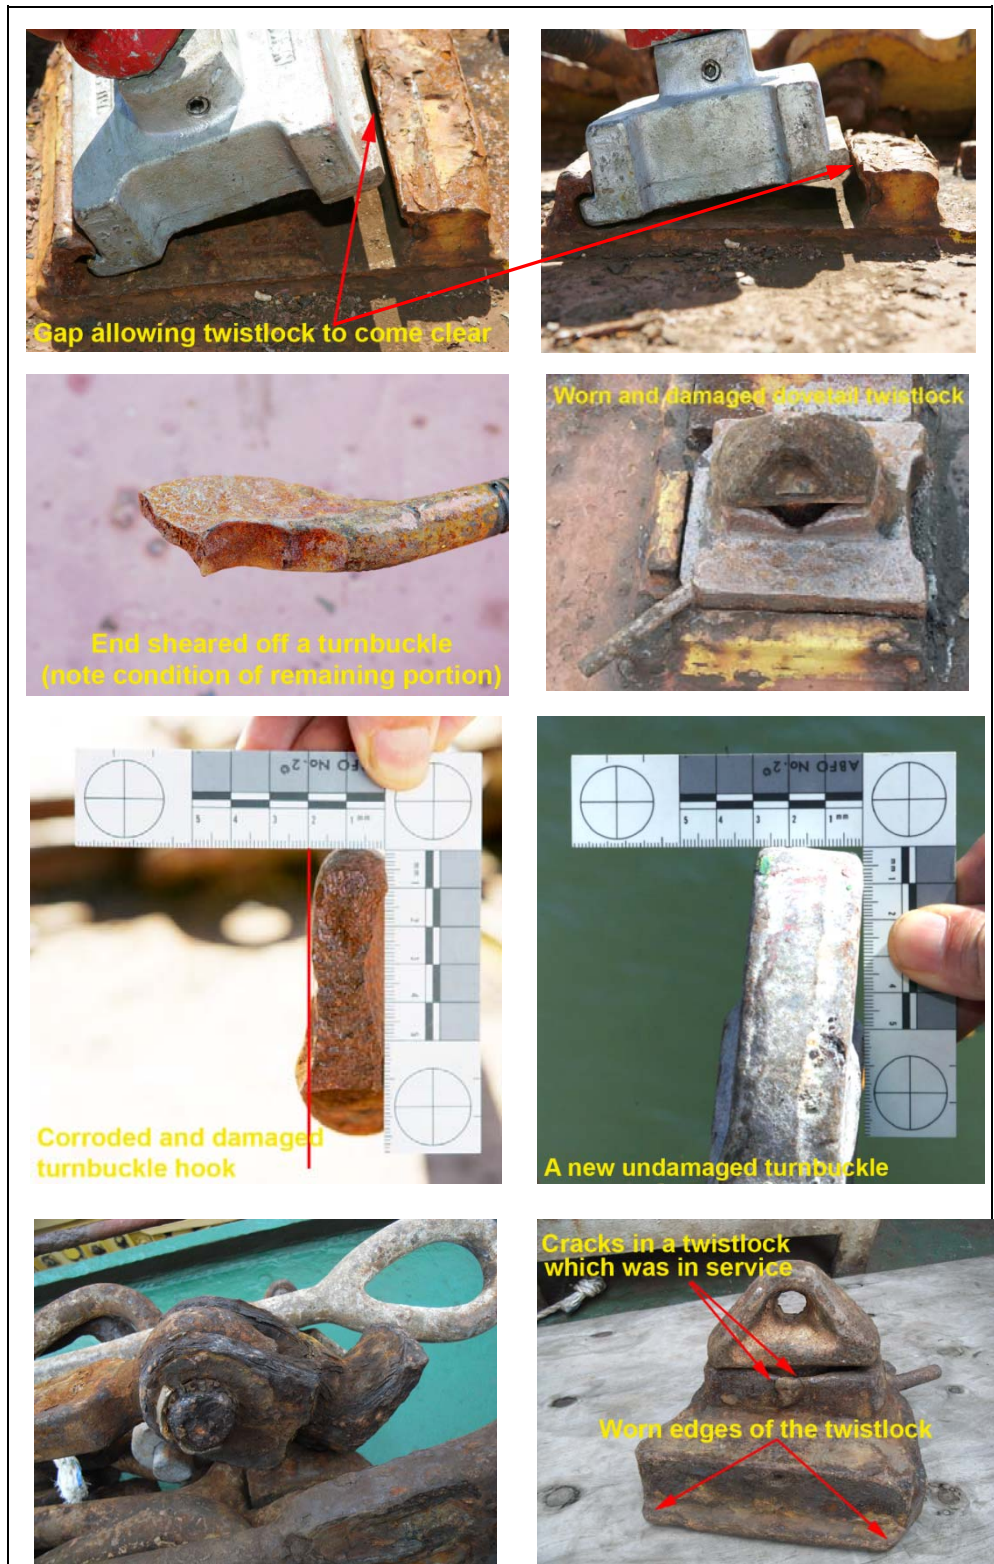
Much of the ship's fixed and loose lashing equipment was in a poor condition. While this had been recognised by senior officers on board, and shore management, the progressive replacement of the equipment had not progressed to the Bay 25 area. In addition, because not all the stacks of containers in Bay 25 were lashed, there was different flexibility in adjacent stacks. It is likely that the unlashed stacks of containers imposed excessive forces on neighbouring lashed container stacks which caused the lashings and the containers to fail when subjected to the significant forces resulting from the ship's excessive roll motions.

Figure 22: A sample of the condition of lashing equipment

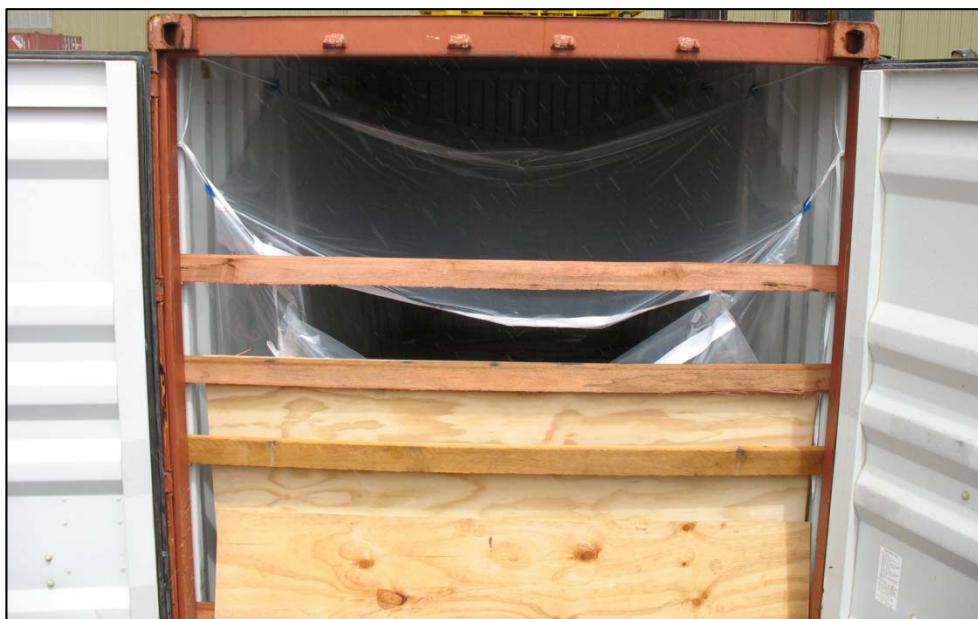
Figure 23: The packaging of the ammonium nitrate prills in a container similar to those lost from *Pacific Adventurer*

While ammonium nitrate prills could be shipped in bulk, in this way, there was a potential problem with the strength of the wooden bulkhead. The wooden bulkhead did not comply with the end wall strength provisions of section 6.9.3.1.2 of the IMDG Code. In addition, the use of wood did not comply with section 4.3.2.3 of the

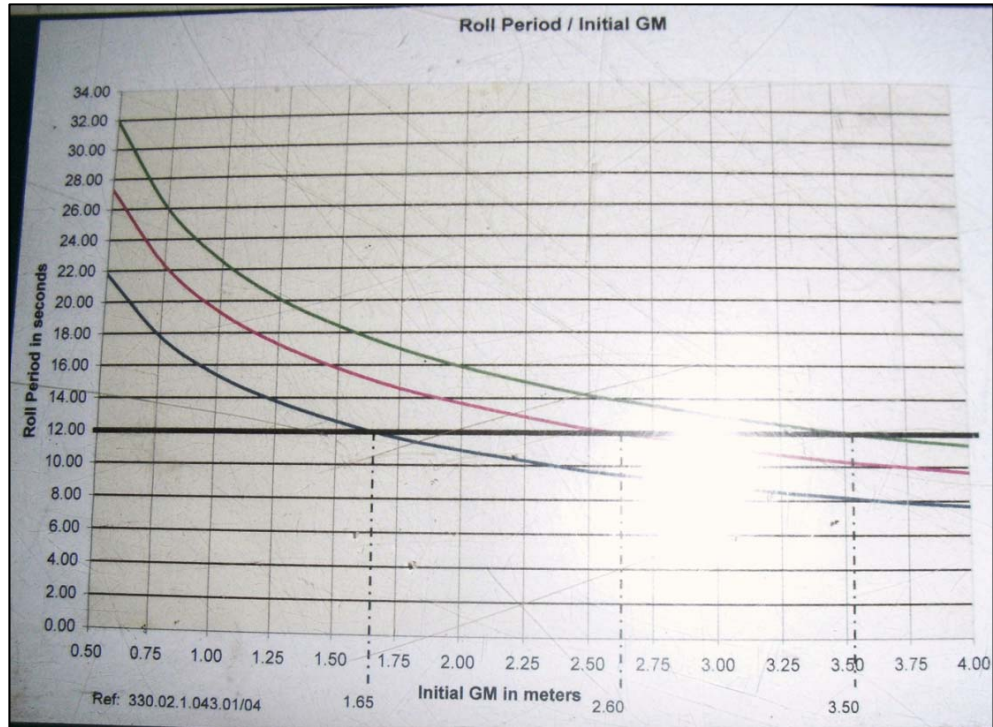
Figure A2: *Pacific Adventurer's* roll period (in red) graphed against its GM

Therefore, the fact that roll motions, and the resultant roll angles during the passage were so severe, and encountered for prolonged periods of time, suggests that the ship's natural roll period must have been close or equal to the wave encounter period that was in the vicinity of 9 or 10 seconds.
