ATSB TRANSPORT SAFETY BULLETIN

Aviation Level 5 Investigations

AB-2010-103

# Level 5 Factual Investigations: 1 October 2010 to 31 December 2010

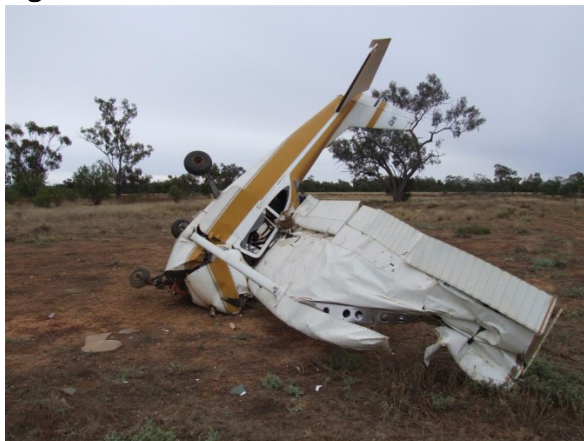
Figure 1: Cessna 172 VH-RZV

A police officer who attended the scene observed that a large tree in the vicinity of the accident site had several freshly broken branches about 10 m above the ground. Severed branches and part of the aircraft's right wing tip were found between the tree and the aircraft.

The damage to RZV was consistent with the right wing colliding with a tree branch followed by the aircraft impacting the ground inverted, with a steep nose-down attitude (Figure 1).

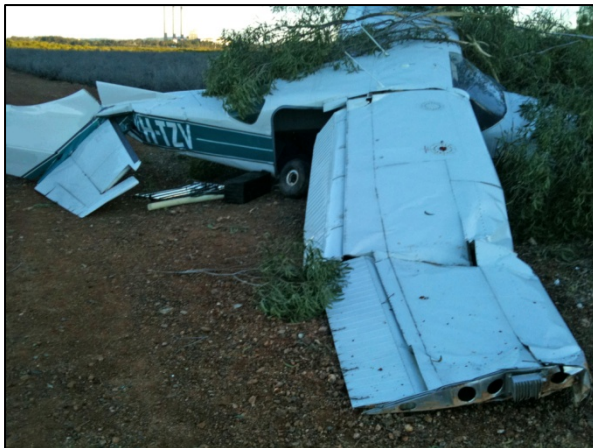
**Figure 1: Aircraft accident site**

The aircraft landed heavily on the gravel road and sustained serious damage (Figure 1). Two of the occupants sustained serious injuries, while another two sustained minor injuries.

The fuselage of the aircraft sustained significant damage as a result of the landing. The right wing had partly detached from the main fuselage structure and the right wing fuel tank was compromised.

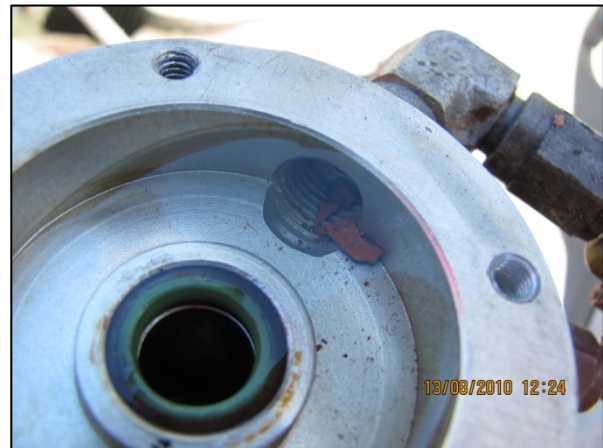
**Figure 2: Fuel manifold valve with debris**

An inspection of the fuel system found a small amount of orange coloured debris in the fuel manifold valve, before the fuel filter screen (Figure 2).

The Australian Transport Safety Bureau (ATSB) obtained a sample of the debris for identification and found that the debris appeared to be an agglomeration of fine particulate matter. The composition of the debris was primarily iron and oxygen with traces of cadmium, manganese and zinc. The investigation could not determine the exact origin of the debris.

It was unlikely that the small quantity of debris found in the fuel system lead to the total power loss of the engine.

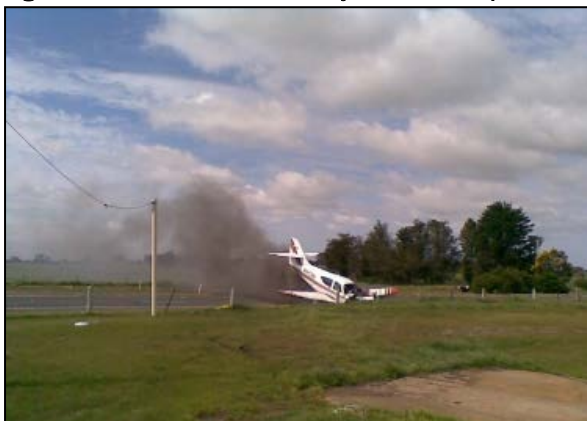
**Figure 1: VH-CSH immediately after the impact**

With assistance, the pilot and passenger exited the aircraft through the windscreen. The pilot sustained serious injuries, including a fractured ankle, while the passenger sustained minor injuries. After the occupants egressed, the aircraft caught alight, resulting in serious damage<sup>2</sup>.

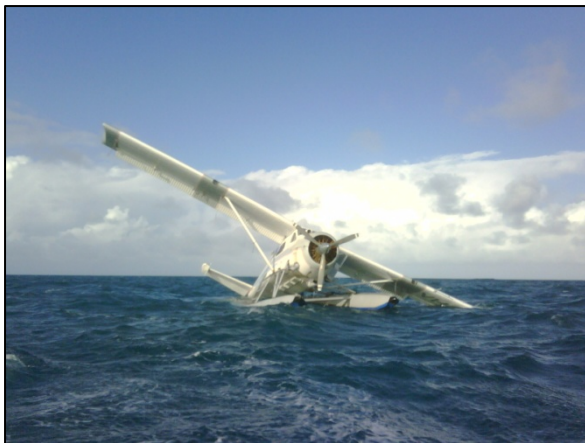
**Figure 1: VH-PCF**

The aircraft sustained serious damage to the left float, left and right wing tip and left elevator.

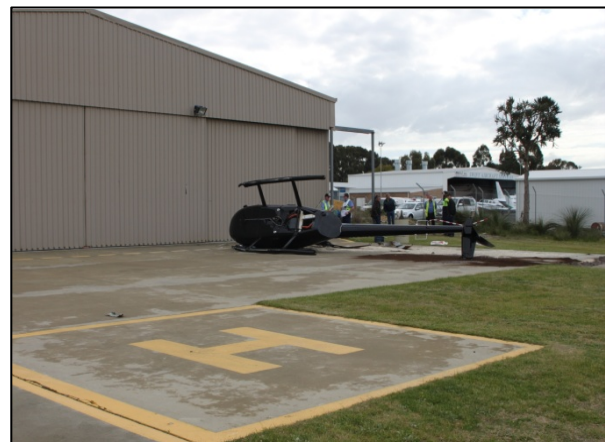
**Figure 1: VH-ZVF at the accident site**

A Jandakot tower controller reported that at 0714 they observed the helicopter rise above the hangar, tilt towards it and then descend out of their view. About a second later, they heard a loud bang. The helicopter sustained serious damage in the impact (Figure 1). The pilot sustained minor injuries while the passenger was uninjured.

The helicopter came to rest on its right side and fuel leaked from the fuel vent lines, about 70 litres was recovered by emergency services. As a result of the main rotor blades impacting the apron, fragments of blade were deposited over a large area. The furthest of these fragments was found 352 m from the accident site within an area of parked aircraft. Main rotor blade fragments also penetrated the hangar doors adjacent to the accident site.

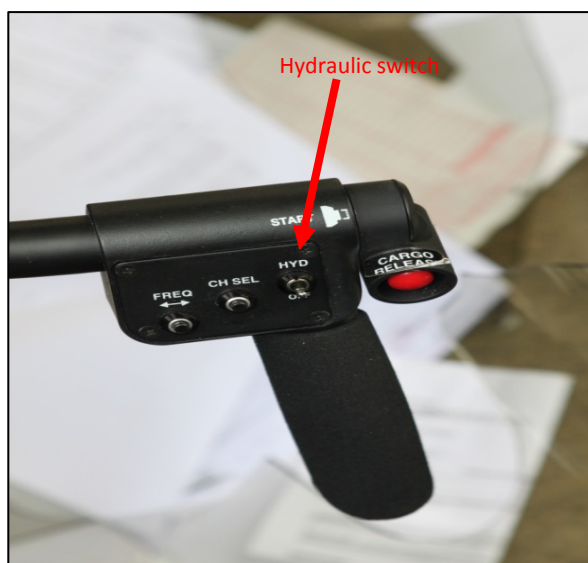
Figure 2: VH-ZVF Cyclic mounted hydraulic switch

The pilot had been taught a supplementary method of checking the hydraulic system that, in addition to the preceding check, involved the momentary deactivation of the hydraulic circuit breaker. Once the circuit breaker was re-set, the cyclic hydraulic switch must be returned to ON. It was after this supplementary procedure that the pilot believes he may have inadvertently forgot to switch the hydraulics switch back to ON.
