# Collision with terrain, VH-DQP

## Flinders Island, Tasmania

### 15 October 2010

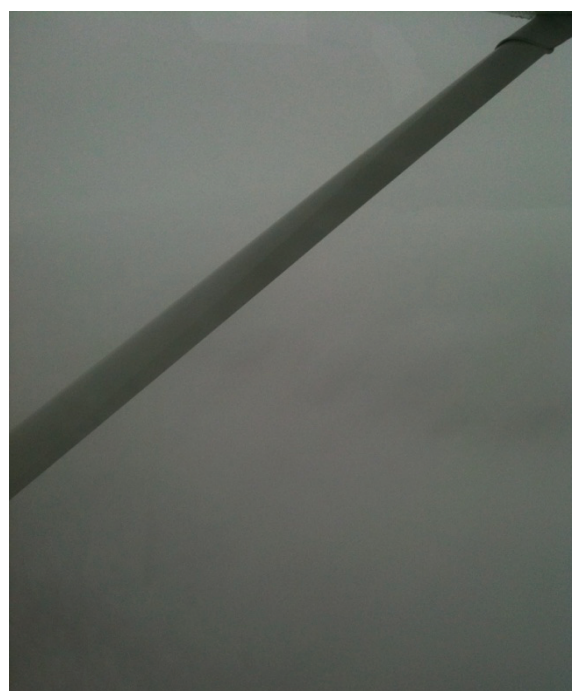
**Figure 3: Indication of the conditions affecting the flight at 1705**

During the climb, the weather conditions deteriorated to below those necessary for flight under the VFR. The pilot, who was not qualified to fly in instrument meteorological conditions (IMC),<sup>2</sup> reported that he was nevertheless concerned about adhering to an unwritten operator rule that he should not fly below 1,000 ft. He continued to climb into IMC instead of remaining visual below the cloud and lost all visual reference with the ground and horizon (Figure 3).

The pilot reported that he continued to fly in IMC for several minutes in the hope that he would climb above the cloud. When this did not happen, he decided to turn the aircraft back towards Lady Barron Aerodrome, initiating a gentle turn to the right. Despite not being instrument-rated, he succeeded in maintaining controlled flight with reference to the aircraft's flight instruments.

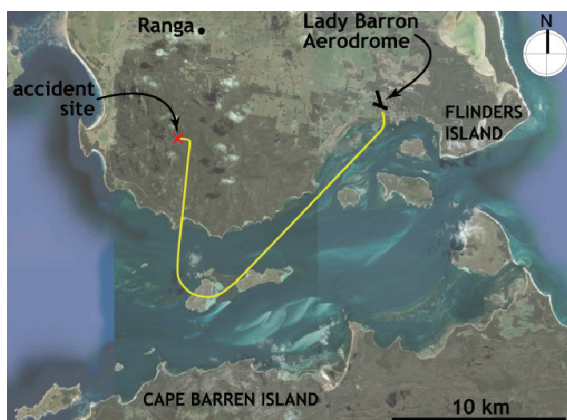
Figure 4: Estimated aircraft track

Although intending to turn through 180°, the pilot inadvertently steered a northerly course towards the high ground in the Strzelecki National Park. The passenger in the right pilot seat noted from the aircraft's Global Positioning System display that it was tracking north towards the settlement of Ranga (Figure 4), but did not realise the pilot was unaware of this.

Visual reference to the ground was regained by the passengers when the aircraft crossed the coast of Flinders Island. The pilot reported that the workload was so high that his attention was wholly directed at the task of maintaining control of the aircraft and he continued to fly in a northerly direction. When the pilot finally became visual, he could see terrain directly before him and turned left. Moments later, he realized the aircraft was in a valley in which he could neither turn round nor out-climb the terrain. After 10 or 15 seconds, the pilot decided to conduct a forced landing into the tree tops, and slowed the aircraft to the stall speed to land at the slowest speed possible. The stall warning horn sounded, and the aircraft struck the trees and then the ground.

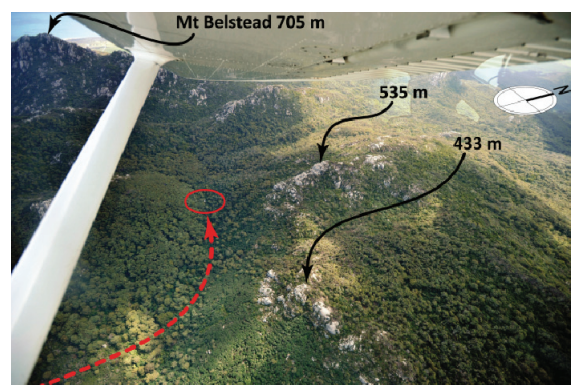
**Figure 7: Accident site and approximate final track (indicated in red)**

The aircraft impacted trees at about 1,150 ft (350 m) AMSL in the Strzelecki National Park, of which the highest point is 2,555 ft (779 m) AMSL.

The area was wooded with steep terrain (Figure 7).

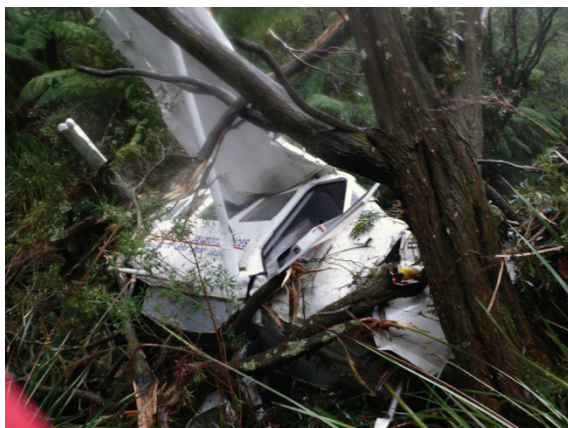
**Figure 8: Aircraft wreckage**

The aircraft was seriously damaged<sup>3</sup> by impact forces. One passenger sustained minor injuries and the pilot and other passengers were uninjured

The aircraft impacted trees at or just below its aerodynamic stall speed of about 64 knots<sup>9</sup> and the aircraft's movement was slowed by the vegetation as it fell to the ground (Figure 8).

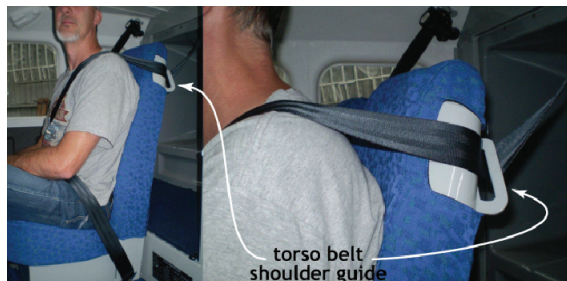
**Figure 9: Passenger restraint harness assembly**

The GA-8 Airvan passenger seats were developed in conjunction with the Civil Aero Medical Institute in the US. The seats include a frangible base box, which crushes progressively to reduce vertical impact loads that may cause spinal injury, and a torso belt shoulder guide (Figure 9).

The shoulder guide is designed to positively retain the occupant and to reduce torso belt loads on the occupant during impact by transferring loads into the seat structure itself.

The design of the aircraft's seats, and the provision to passengers in the GA-8 Airvan of three-point automotive-type restraint harnesses with inertia reel should straps contributed to the passengers' survival, almost without injury.
