# Collision with terrain, VH-LKI

## Moree Airport, New South Wales

### 30 March 2011

#### Abstract

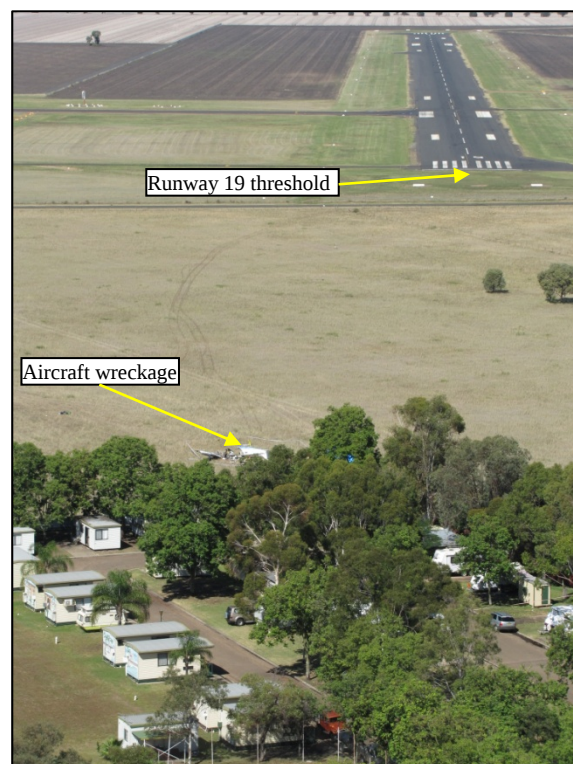
**Figure 1: Relative position of the accident site to runway 19**

The wreckage was located in a level, grassed paddock about 550 m from the runway 19 threshold and about 40 m to the left of the extended runway centreline.
