ATSB TRANSPORT SAFETY REPORT
Aviation Occurrence Investigation
AO-2010-033
Final

Wirestrike
37 km SSW Latrobe Valley Airport, VIC
20 May 2010
VH-OSU, Bell Helicopter 206L
LongRanger III

Wirestrike
37 km SSW of Latrobe Valley Airport,
Victoria
20 May 2010
VH-OSU
Bell Helicopter Company 206L LongRanger
III

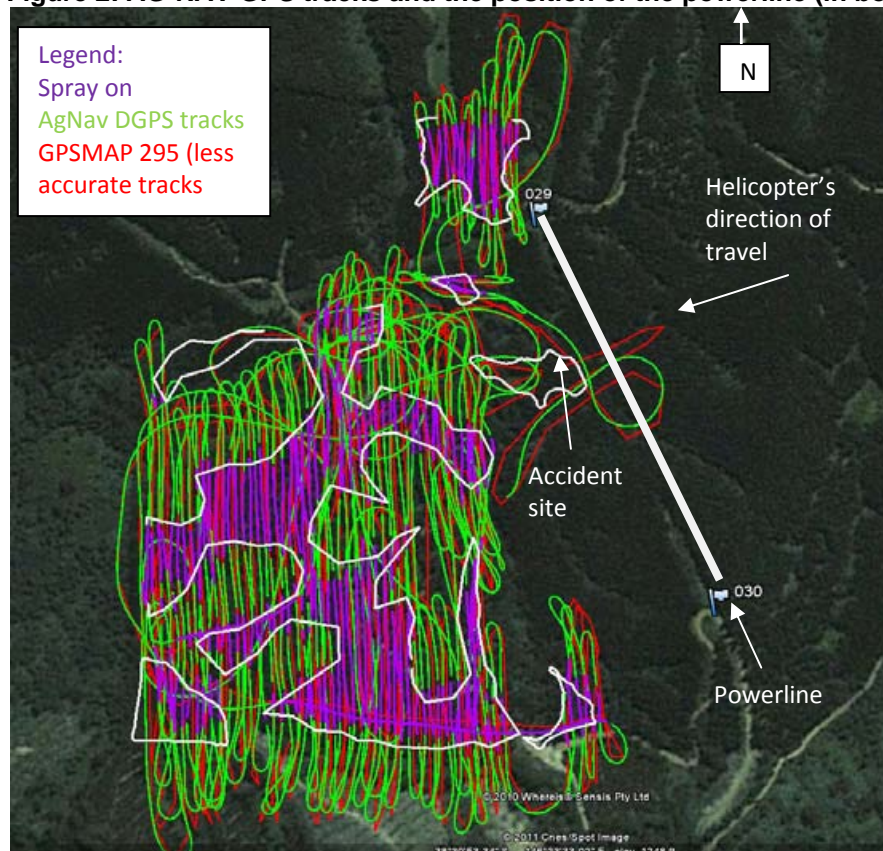
Figure 2: AG-NAV GPS tracks and the position of the powerline (in bold white)

The pilot overflew the powerline three times while preparing to spray the final area of the coupe (Figures 2 and 3). Moreover, recorded information showed that the pilot last flew in the vicinity of the powerline within 1 minute of the wirestrike.

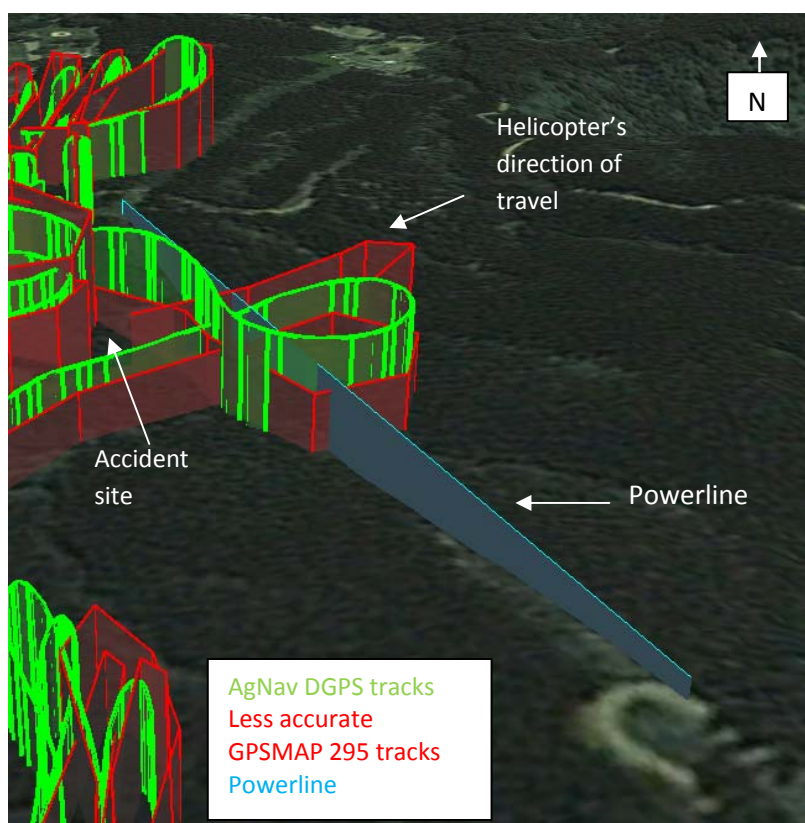
Figure 3: Vertical profile of the helicopter's track, indicating that the helicopter crossed the powerline at least twice just before the wirestrike

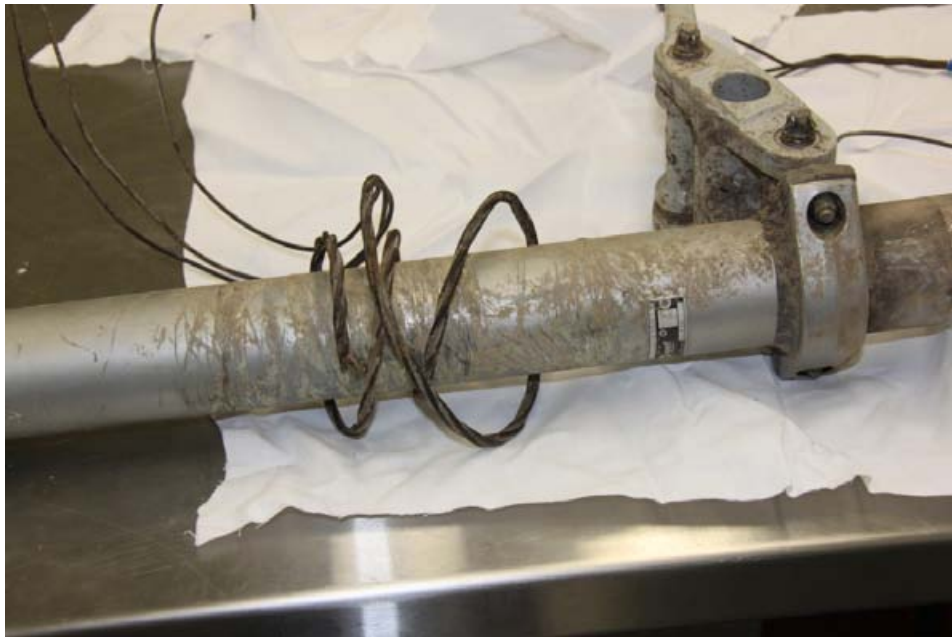
Transfer markings were evident on the conductor in the area adjacent to the break in the wire (see *Wreckage and impact information* section). Those markings corresponded with score marks on the helicopter's main rotor mast and pitch links (Figure 6).

Figure 6: Powerline wrapped around the helicopter's main rotor mast⁸

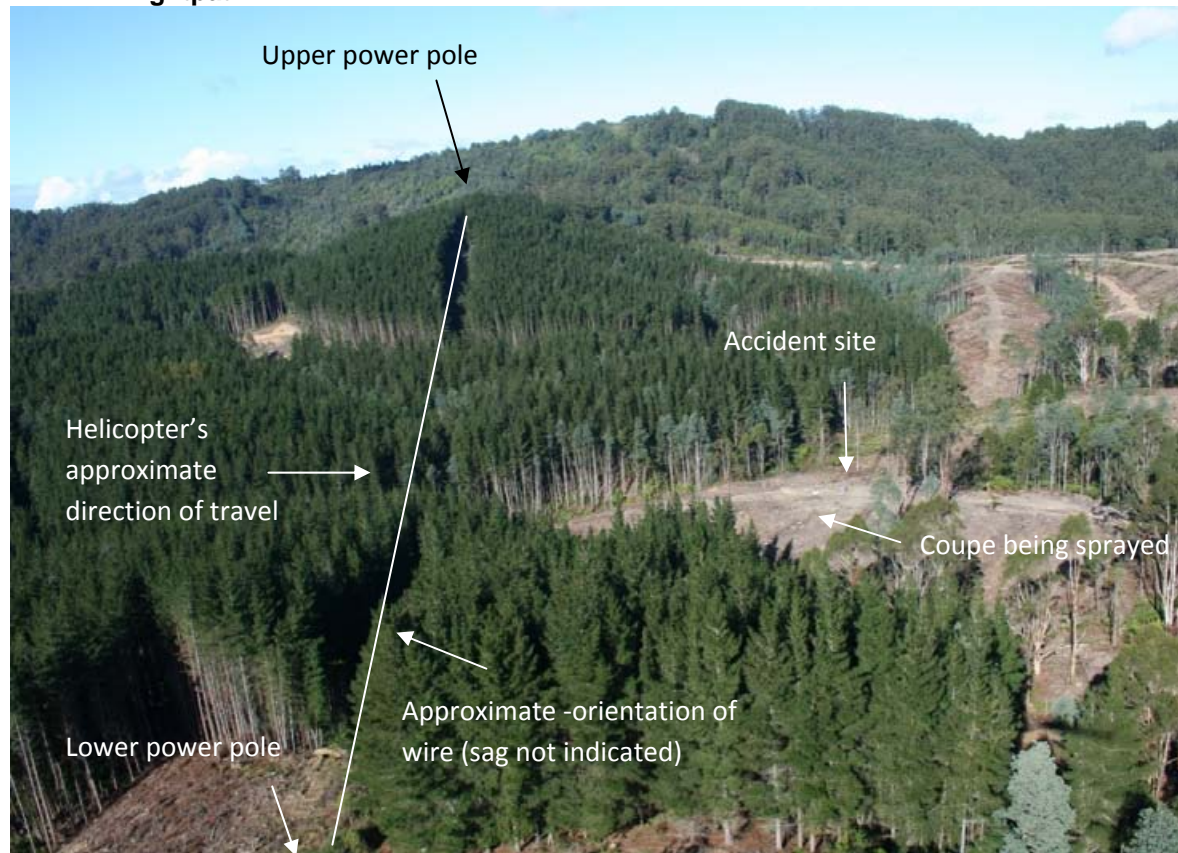
Figure 7: Aerial view of powerline, accident site and helicopter's approximate flightpath

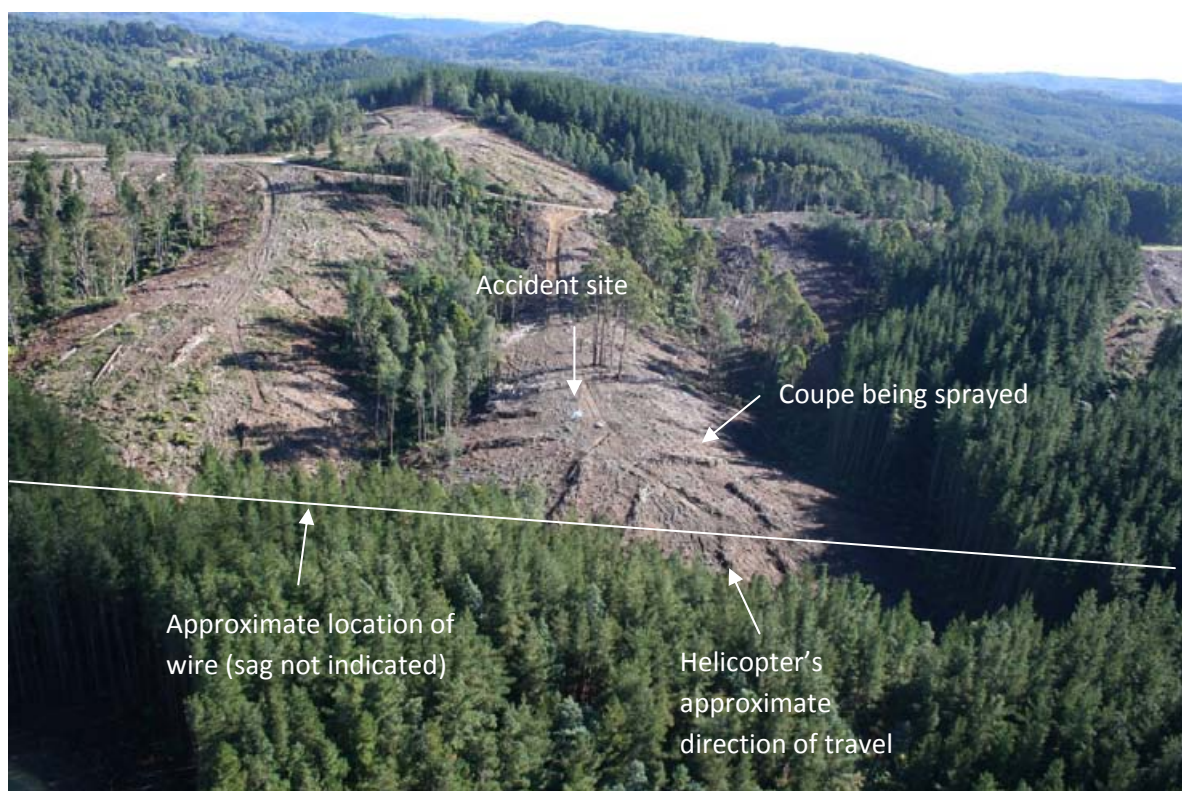
There was little evidence of good visual cues being available to alert the pilot to the relative position of the wire. The investigation determined that, when viewed from the direction of travel, the upper power pole was totally obscured by large trees. The lower pole was also partly camouflaged by a cluster of large trees. Furthermore, the elevation of the terrain to the west (approach path direction) of the accident site was higher than the wire (Figure 8). That increased the risk of the wire blending into the background terrain.

Figure 8: Western perspective of the accident site

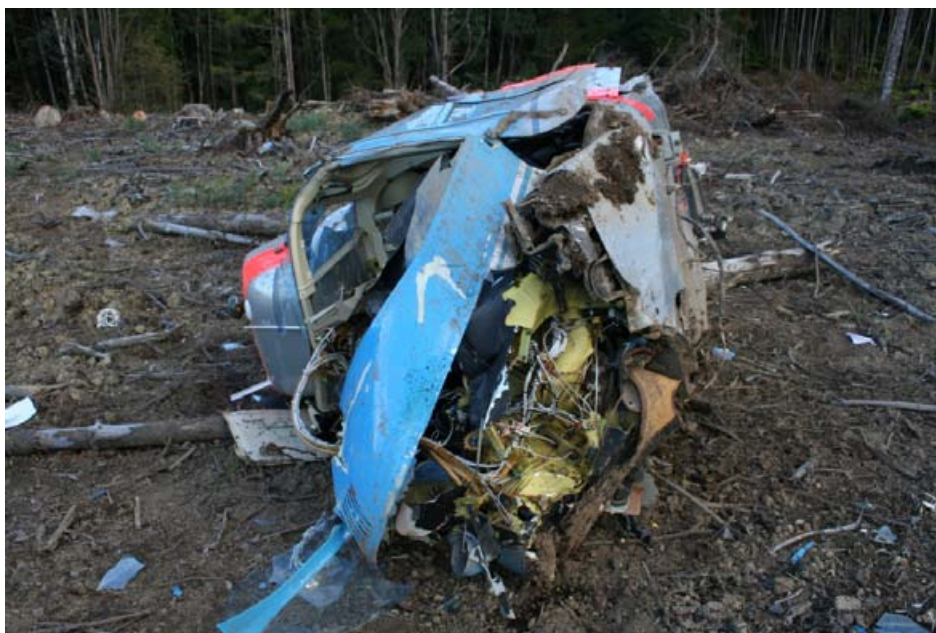
Impact damage to the helicopter was extensive (Figure 9). The helicopter came to rest on its right side, which exhibited significant deformation. There was severe disruption to the cockpit, and the instrument pedestal had been dislodged from the floor. As a result of the wirestrike and subsequent ground impact forces, the main rotor blades, mast, skid-landing gear, spray tank and tail boom had separated from the helicopter's fuselage but remained in close proximity to the main wreckage (Figure 10).

Figure 9: Overview of the main helicopter wreckage

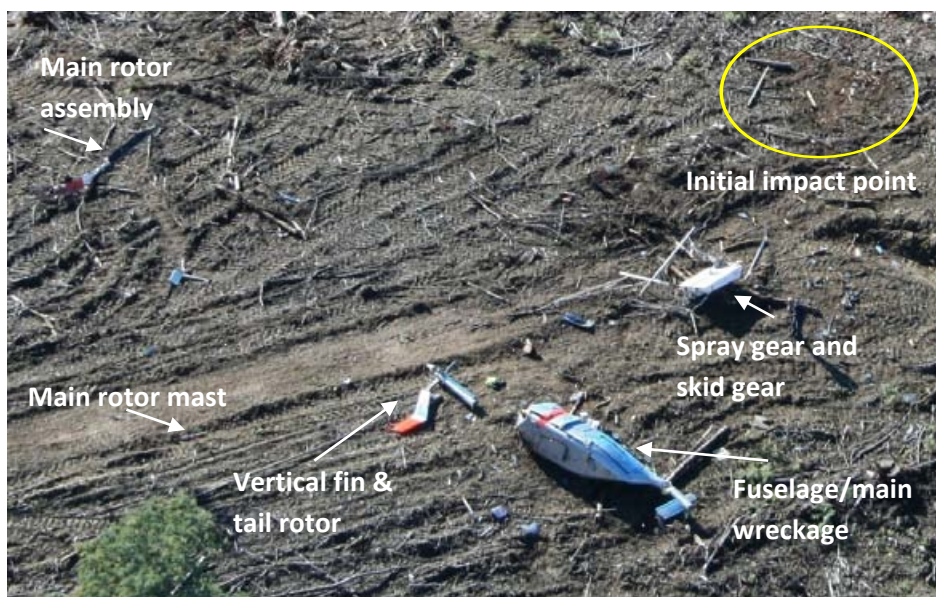
Figure 10: Aerial perspective of the accident site, showing the initial impact point (circled) and main wreckage

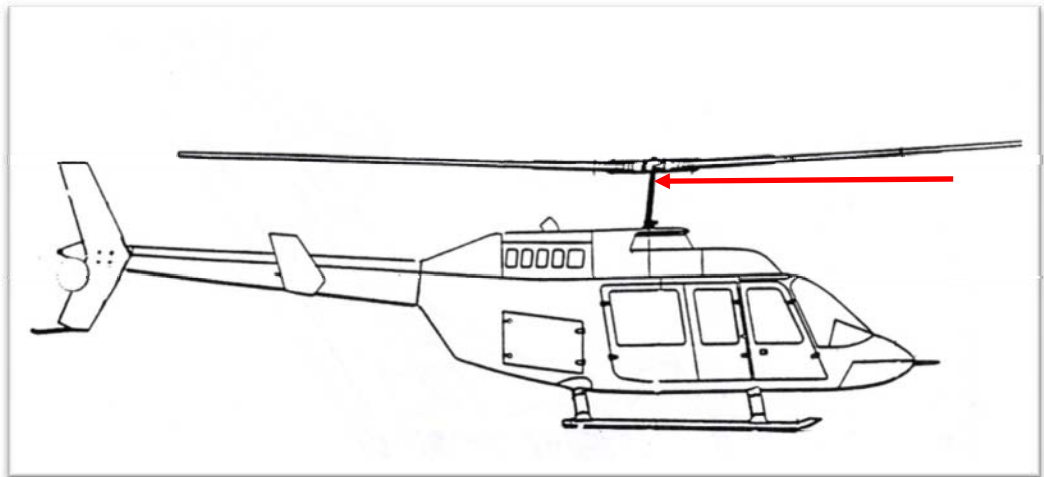
Examination of the wreckage indicated that the powerline passed between the top of the fuselage and main rotor disc and impacted the mast and flight control pitch change links (Figures 11 and 12). Examination of the mast revealed rotational scoring that commenced about 6 cm above the top surface of the swashplate drive collar (idler link to mast attachment point) and continued up the mast for about 19 cm (Figure 13).

Figure 11: Approximate point of impact of wire with mast and pitch links.

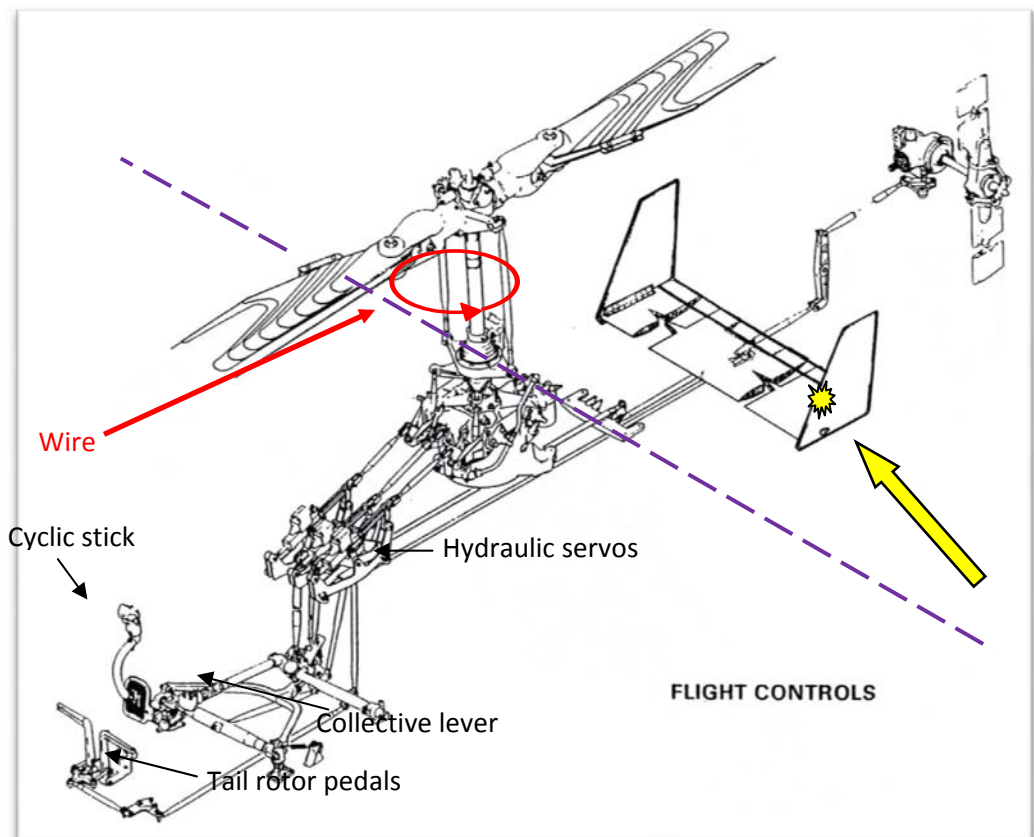
Figure 12: Approximate area of wire contact on mast and pitch change links and direction of main rotor rotation (red circle).

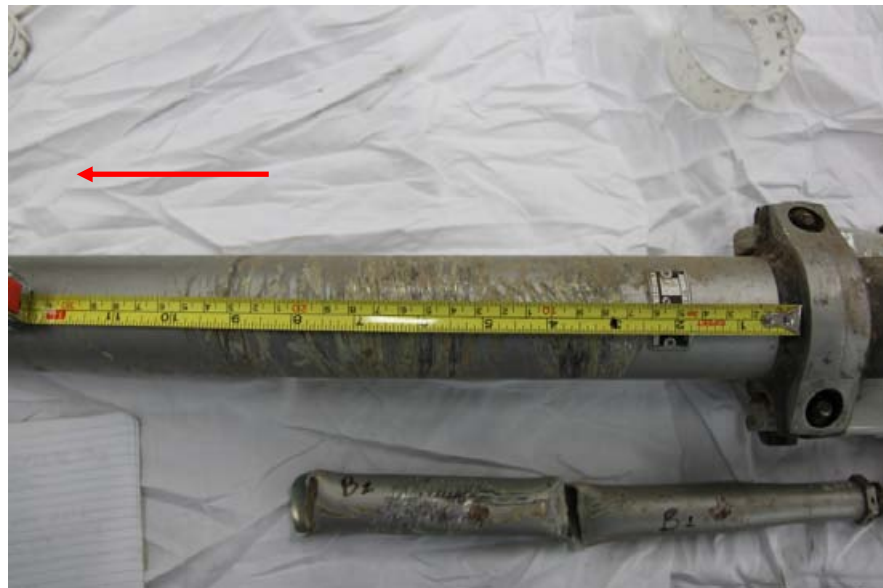
Figure 13: Main rotor mast showing the position of the scoring damage in relation to swashplate drive collar (the red arrow indicates the upper end of the shaft)

The main rotor mast showed evidence of a significant mast bump that bent and failed the mast at a position 31 cm below the swashplate drive collar. It was not possible to determine if the mast failed shortly before the helicopter impacted the ground or during that sequence.

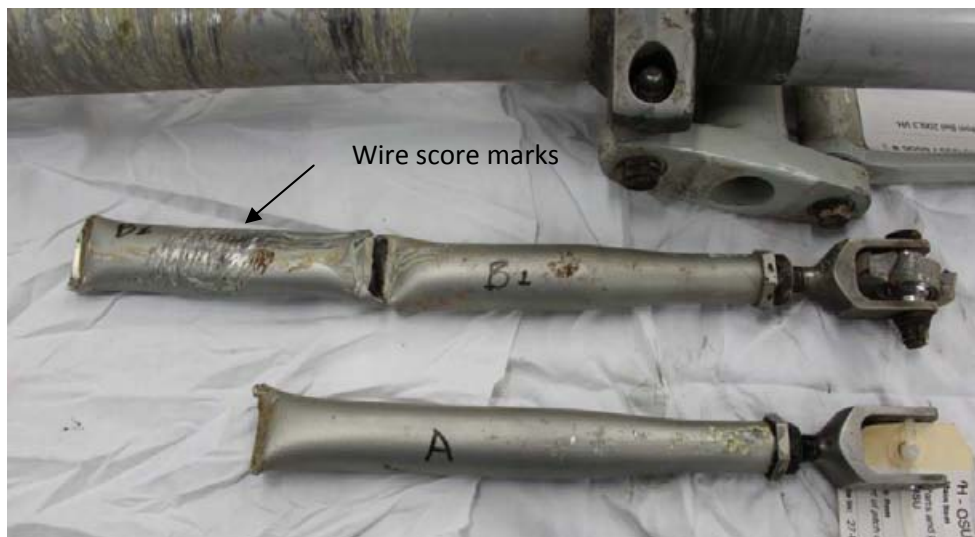
Following contact with the helicopter, the wire wrapped around the mast and pitch links (PCLs), bending the PCLs in toward or against the mast ('hourglassing') and fracturing both links as the helicopter moved forward.¹⁸ The fractured sections of the PCLs showed evidence of multiple wire score marks (Figure 14). One of the PCLs showed evidence of indentation from the PCL having been pulled against the rotating main rotor mast prior to failure. All PCL fracture surfaces were of the bending overstress type.

Figure 14: Severed pitch links showing significant wire scoring

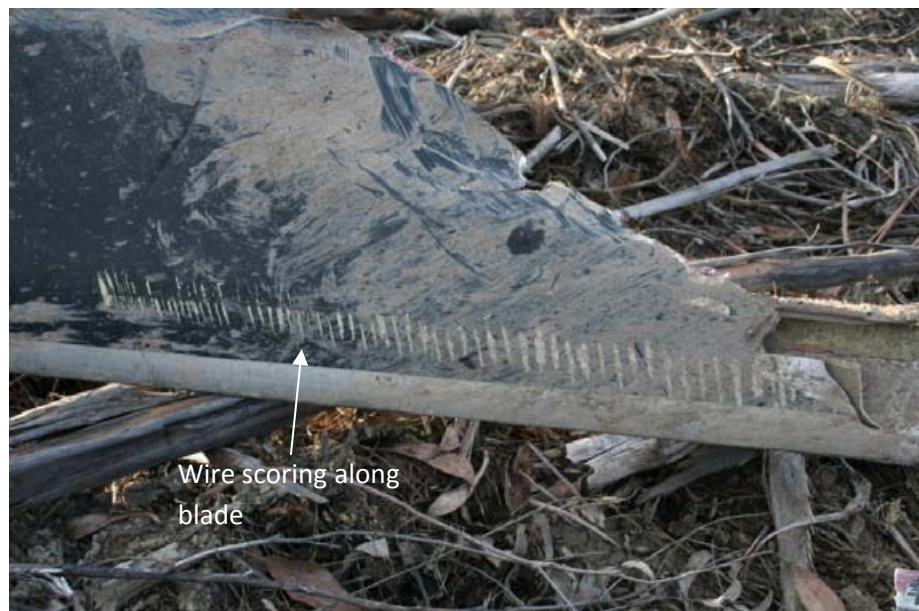
The black paint finish on the underside of both main rotor blades showed evidence of scoring. That scoring exhibited a 'regular pattern' and appeared to have been the result of contact with the wire (Figure 15).

Figure 15: Wire scoring damage to the underside of one of the main rotor blades
