ATSB TRANSPORT SAFETY REPORT

External Investigation – AE-2010-024

Flight Data Recovery

CT-4 Airtrainer, NZ1990

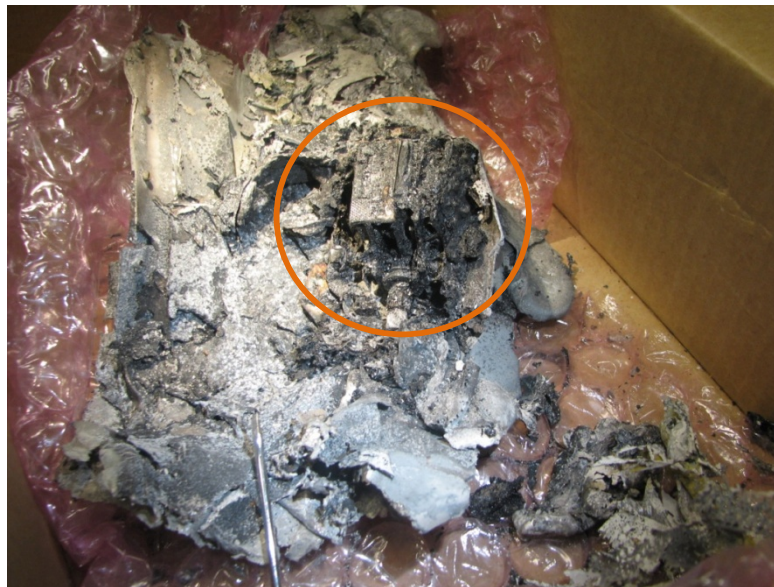
Figure 3: Contents of the box from the RNZAF. (GAU1000 is circled)

On 31 March 2010, the recorder was unpacked (Figure 3) and disassembled in the ATSB's Canberra technical facilities. The initial approach to recovering data from the unit focussed on the removable SD/MMC card.

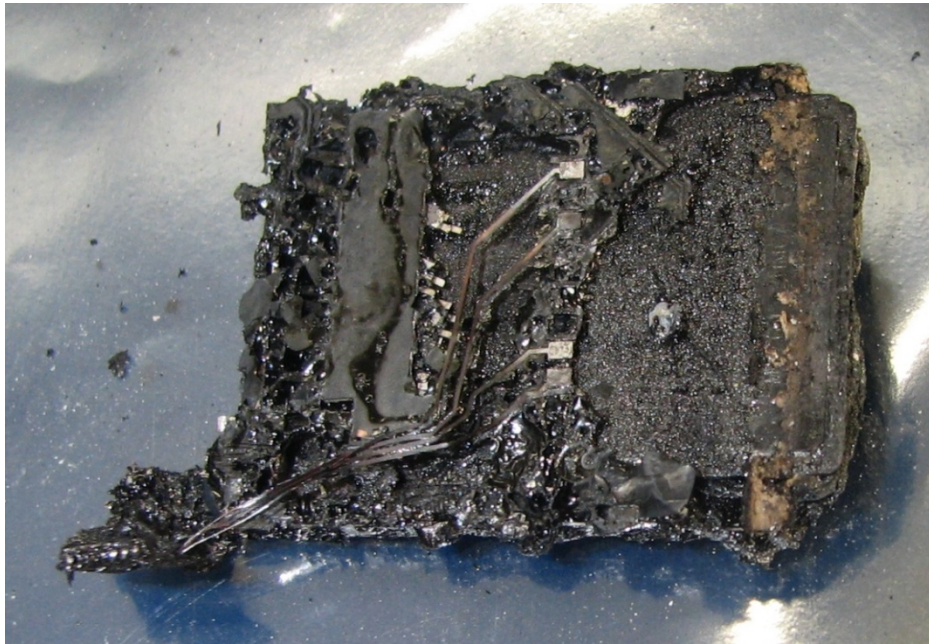
Figure 4: SD/MMC card removed from the recorder

The SD/MMC card and socket were removed from the recorder (Figure 4). Removal of the card from its socket was obstructed by thermally-induced deformation of the surrounding material (Figure 5).

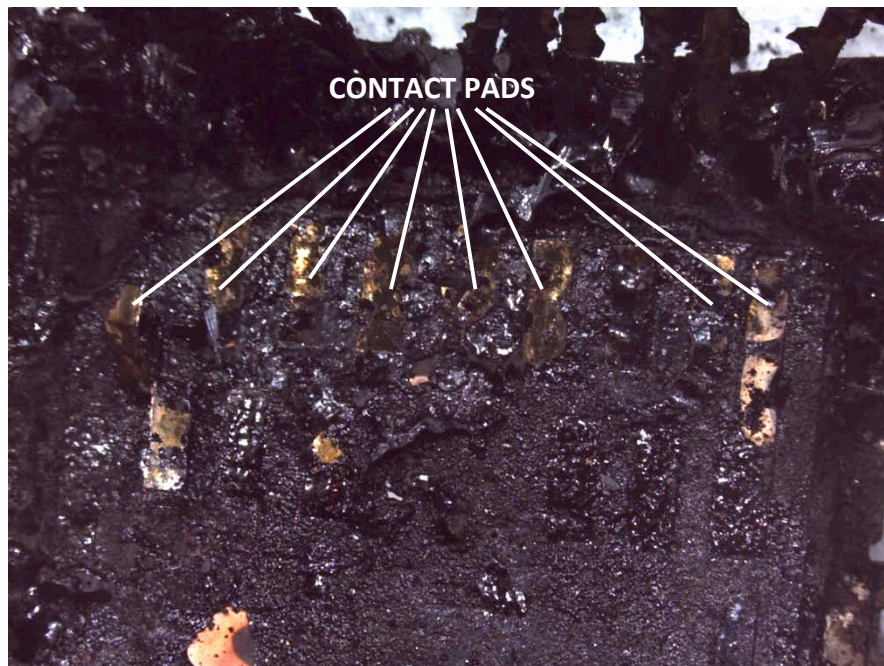
Figure 6: SD/MMC card with contact pads visible

The charred material was carefully removed from the front face of the card exposing the pin contacts (Figure 6).

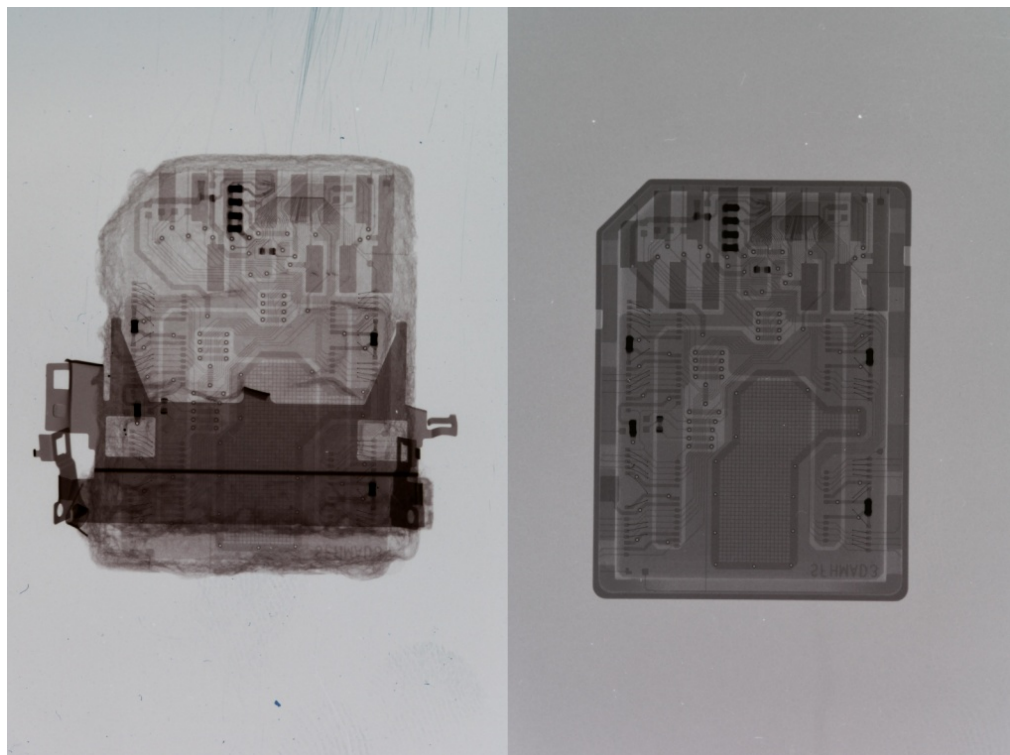
Figure 9: X-ray comparison of undamaged card (right) and accident card (left)

Comparison of the x-ray images revealed no substantial damage to the circuit tracks. However, these images gave no indication of the condition of other key components within the card or the integrity of any stored data.

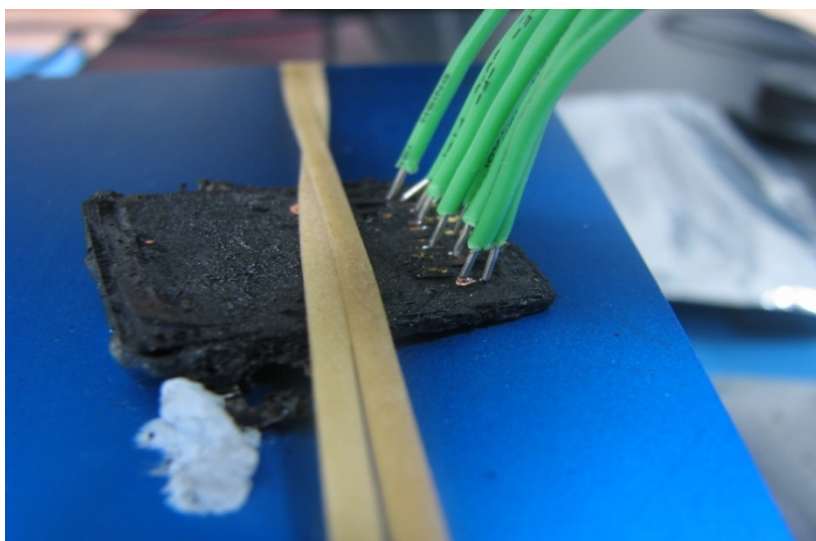
Figure 10: Accident MMC in contact with fly-leads from the card reader

Numerous attempts were made to access the data on the accident card using the card reader setup (Figure 10). The card was not recognised by the computer in use and no data was recovered.

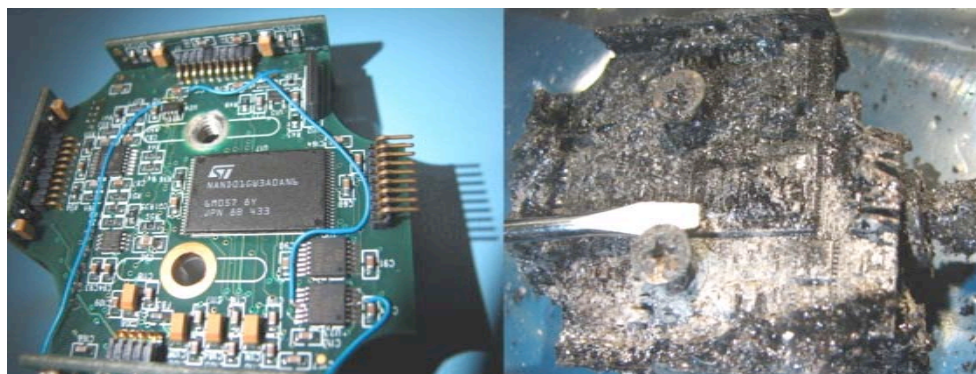
Figure 13: Left - NAND flash on undamaged GAU1000 recorder, Right - NAND flash as seen on accident board indicated by screw driver tip.

The NAND flash device was identified on the circuit board during the disassembly (Figure 13). Typically, the removal of a flash device from a circuit board would be performed using a rework or hot-air station. For the accident board, heat exposure had caused the device pins to separate and lift away from the circuit board. The device was held in situ by solidified charred plastic. Once this material was removed, the device was easily lifted away from the board (Figure 14). The pins of the flash memory device were found to be in good condition.
