ATSB TRANSPORT SAFETY REPORT
Rail Occurrence Investigation
RO-2010-001
Final

Derailment of freight train 2224

Exeter, NSW

24 January 2010

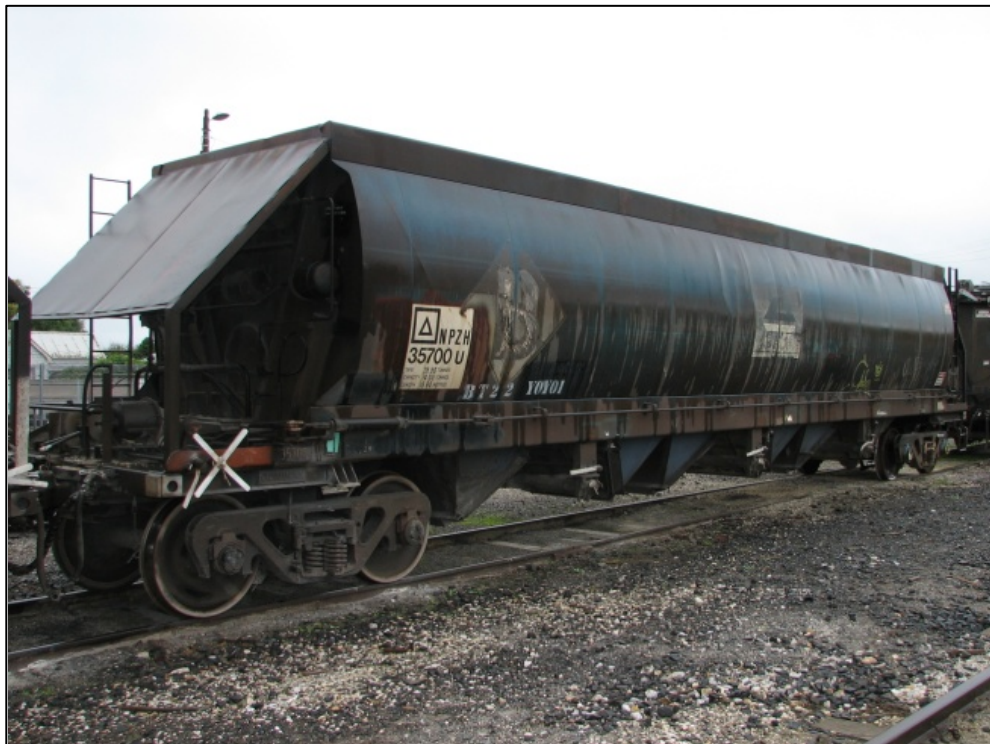
Figure 2: Wagon NPZH 35700U, in storage at Moss Vale yard

Wagon NPZH 35700U (Figure 2) was built in 1977 by A. Goninan & Co. as a coal hopper coded as CHS class then later changed to NHGF and more recently in 1998 to NPZH.

The wagon weighed 27 t tare and up to 100 t gross, was 16.9 m in length and rated as a class ‘F’ vehicle up to a maximum speed of 80 km/h empty, or 65 km/h loaded, for the section of track on which it was operated. The wagon was fitted with three piece National Super C1 bogies rated at 70 t per bogie. The wagon was originally fitted with axle boxes, but these were replaced with 11 x 6 inch ‘E’ class tapered roller package bearings circa 1986.

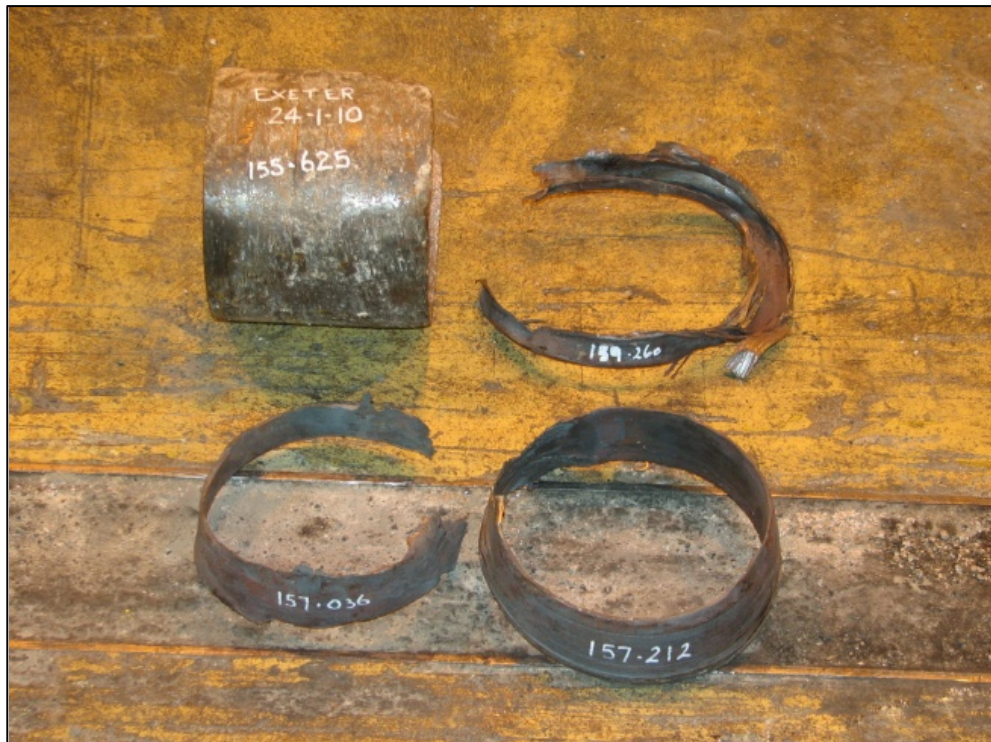
Figure 4: Remains of R3 bearing

It was clear from on-site evidence that the derailment was caused by a ‘screwed journal’ as a result of the R3 wheel bearing failing on wagon NPZH 35700U. As the bearing failed, it generated and transmitted sufficient heat to the axle journal to make it ‘plastic’ and allow the end carrying the failed roller bearing assembly to ‘screw off’.

The failed package bearing R3 was manufactured in 1986 by Svenska Kullagerfabriken (SKF). The bearing was requalified⁹ and installed into the wagon on 23 April 2008 and had travelled 98,028 km from the time of requalification until it failed in service. The bearing had been destroyed so that no evidence was found that could be used to determine the likely cause of the failure (Figure 4). However, the L3 bearing from the same wheel-set was examined closely to identify any faults or defects that may have suggested any factors that could have contributed to the failure of the R3 bearing.

The failed bearing assembly was so damaged that an examination of its components provided no evidence to determine the likely cause of the failure. Consequently, the investigation looked at the common failure modes for railway bearings to provide stronger support for any possible conclusions.

The failed bearing was extensively damaged such that much of the direct evidence was destroyed and examination of the rolling surfaces provided no useful information. The adjacent bearing showed no signs of indentations on the rollers or races.

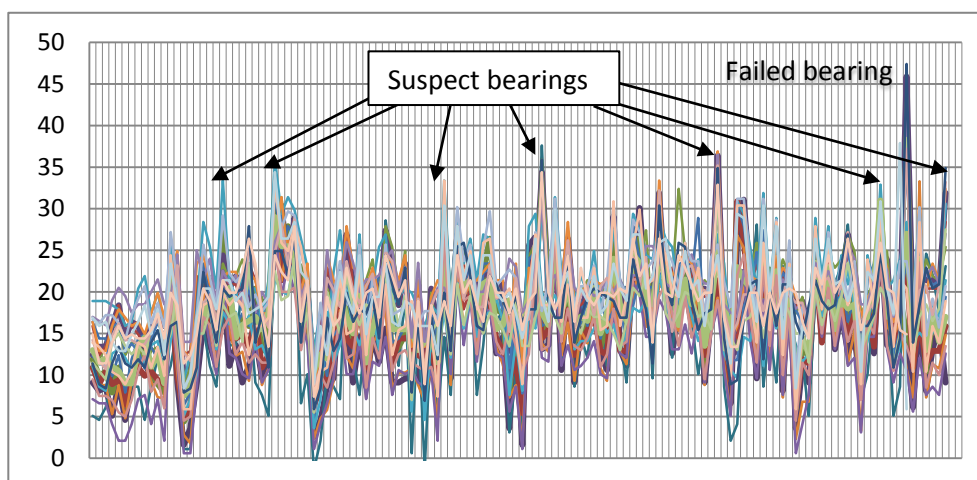
Figure 5: Graph of bearing running temperatures above ambient air temperature

Data was extracted from the HBD at Exeter and the previous 12 journeys of rake BT22 were compared and examined¹³. The data between 19 January 2010 and 24 January 2010 was examined showing clear repeatable patterns in elevated bearing operating temperatures above ambient air temperature¹⁴, Figure 5. The highest recorded running temperature was the failed R3 bearing on wagon NPZH 35700U at 61.5 °C (47.4 °C above ambient) on 24 January 2010 at 0834, the morning journey, but was not high enough to trigger a warning alarm set at 90¹⁵ °C. The data showed that this bearing was running significantly hotter than the opposite bearing and the average for the rest of the train. Seven other bearings were identified as running hotter than the opposite bearing and the train average, although not all bearings have an escalating temperature signature.

As a consequence of the temperature analysis and RailBAM results, all seven of the hottest bearings identified were removed from service, only two of which were inspected further by Pacific National. One bearing examined had a large spall (48x34 mm) and heat scoring, the other failed a rumble test¹⁷ and was almost seized.
