ATSB TRANSPORT SAFETY REPORT
Aviation Occurrence Investigation – AO-2008-003
Final

Electrical system event
25 km NNW of Bangkok International
Airport, Thailand
7 January 2008
VH-OJM
Boeing 747-438

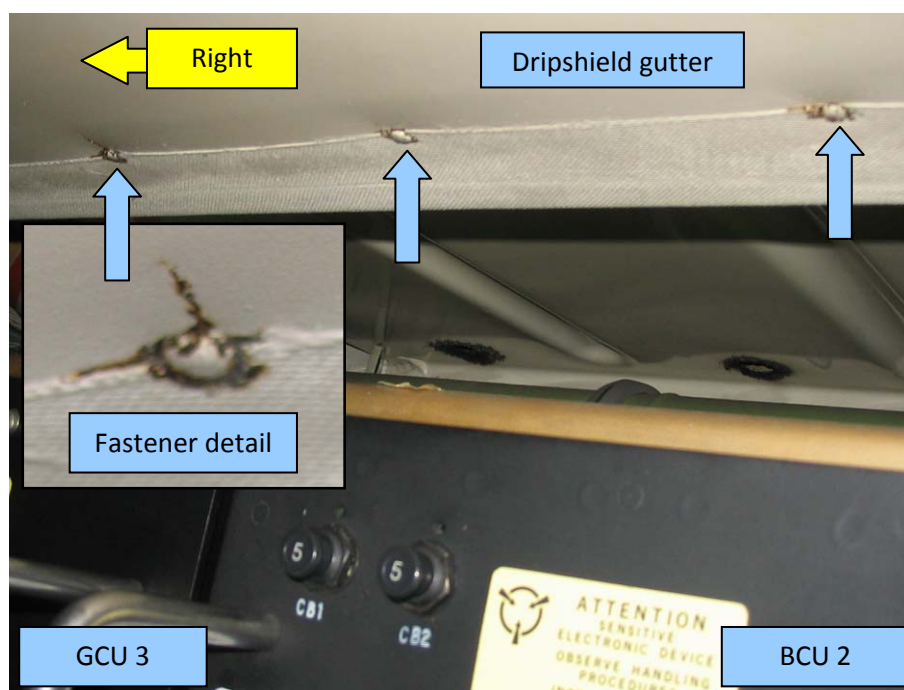
Inspections of the aircraft's main equipment centre (MEC) found cracks around a number of fasteners in a polycarbonate dripshield above the E1/E2 equipment racks⁹ (Figure 2 and Figure 3). Water was observed on and around the No 3 generator control unit (GCU).¹⁰

Figure 3: Dripshield fasteners, viewed from below

- No 2 and No 3 GCUs and both BCUs were replaced
- a temporary repair of the dripshield was carried out
- the batteries were recharged
- the electrical power system was tested
- an inspection and temporary rectification of potential water leak sources was carried out
- various systems were inspected for liquid ingress and/or tested for correct operation.

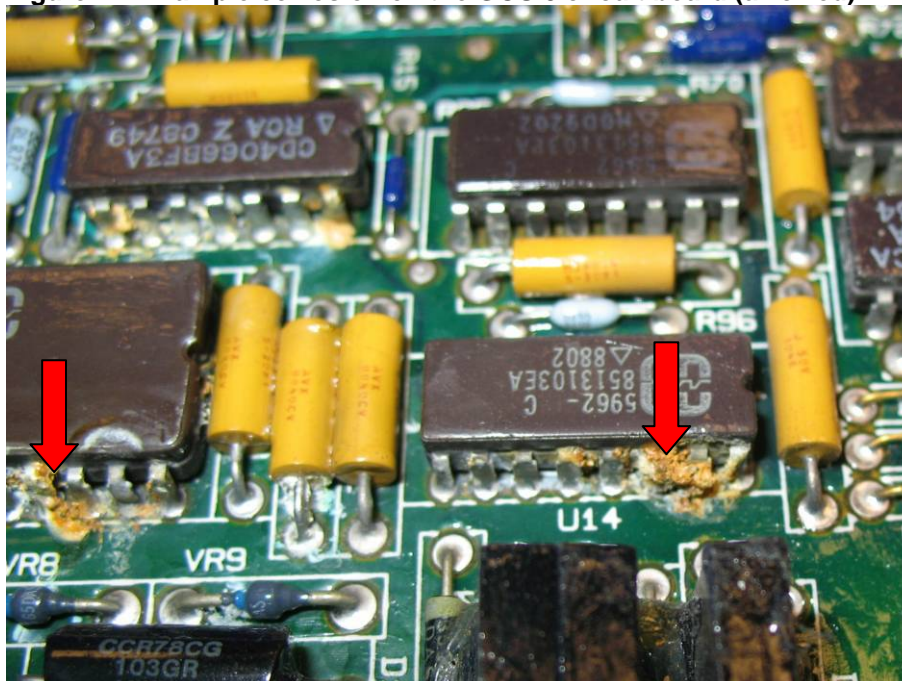
The aircraft's four GCUs and two BCUs were removed for testing following the incident flight. Water was reported to be present in GCU 3, which controlled the AC bus 3 circuit breakers. No water was reported to be present in any other electrical equipment. Examination and testing revealed that GCUs 1, 2, and 3 exhibited internal corrosion that was consistent with long-term liquid ingress, particularly in respect of a circuit board that was located directly under the edge of an equipment rack brace.

The A08 circuit board was located directly underneath the rear edge of an equipment rack brace when the units were installed on the aircraft.

Figure 17: Example corrosion on the GCU 3 circuit board (arrowed)

The test report stated that many of the units exhibited dust on the circuit boards, and that any moisture present could cause the dust to be slightly conductive. The report also recorded that some boards had areas that did not have conformal coating.

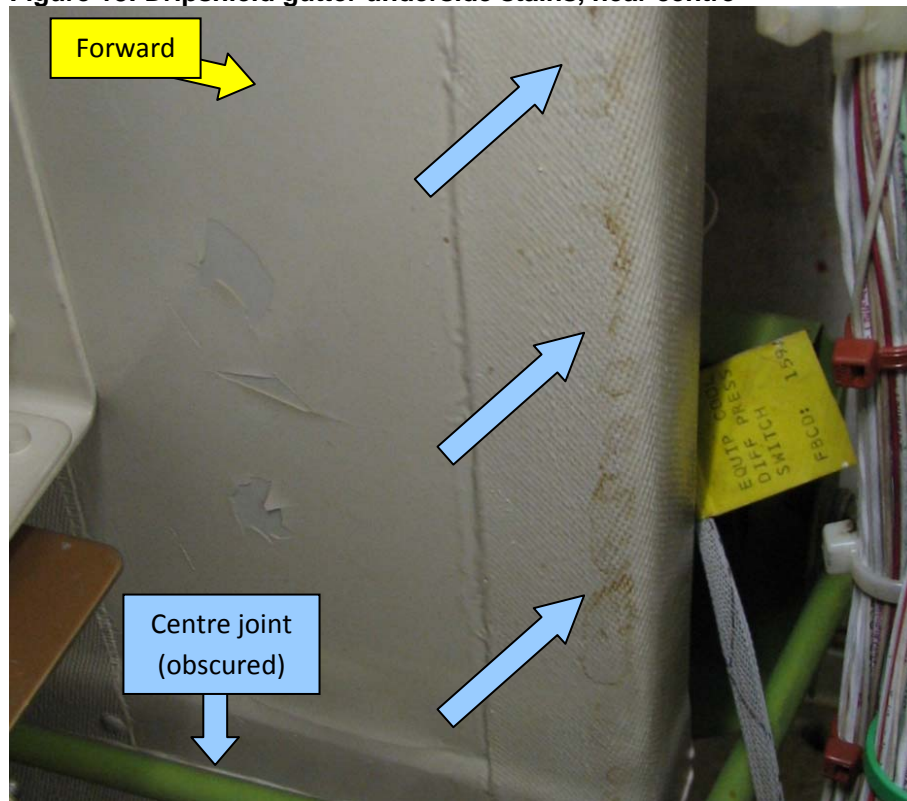
Figure 18: Dripshield gutter underside stains, near centre

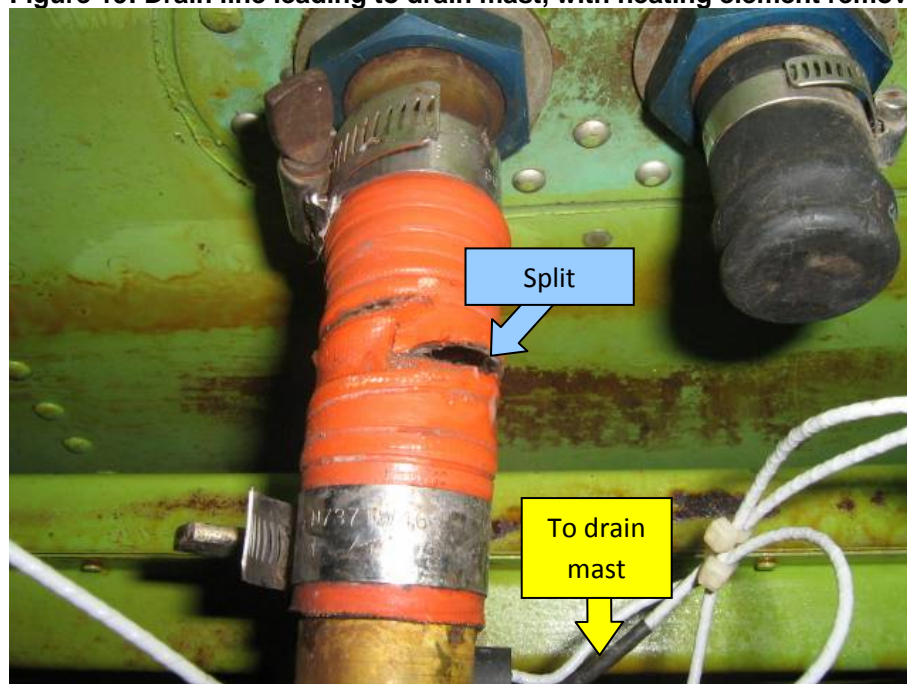
Subsequent inspections found that a drain line ribbon heater around a drain line to the forward grey water drain mast was inoperative, and that a length of drain line at that location was split (Figure 19). The heater and hose were removed for examination and testing. The drain line heater element was found to be broken at two locations and was inoperable. The examination could not determine the cause of the damage. Tape that had been wrapped around the heater element showed marks consistent with excessive heat damage, although the investigation could not determine whether those marks were collocated with the heater element damage.

Figure 19: Drain line leading to drain mast, with heating element removed

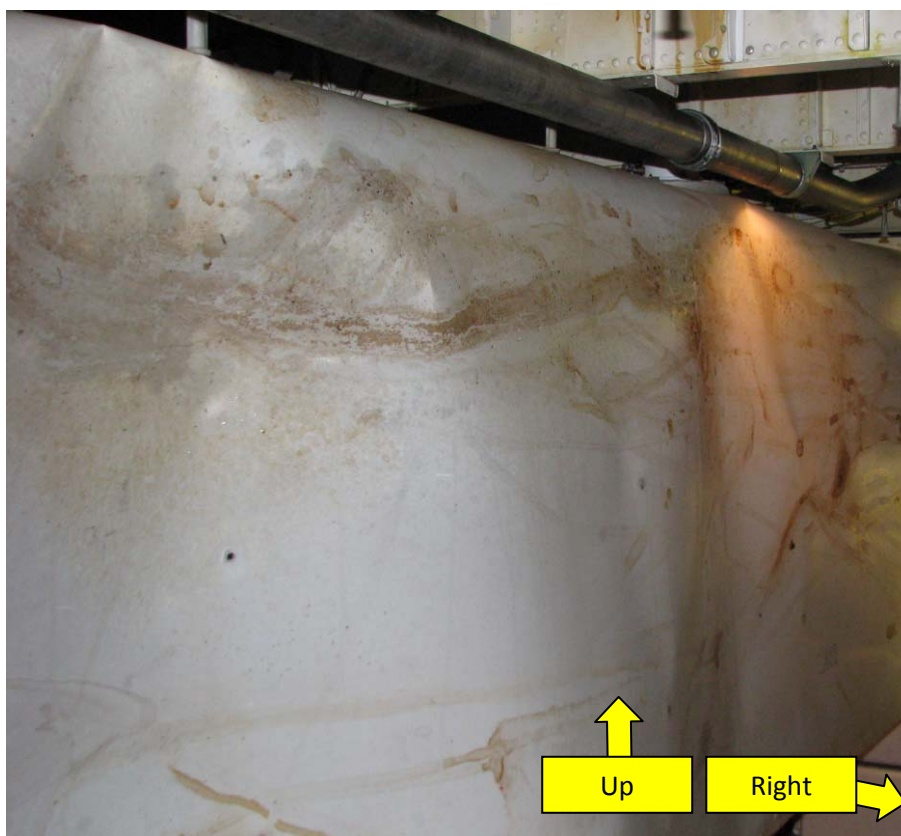
Water accumulation had occurred around the forward galley area prior to the maintenance activity. The carpets immediately aft of the forward galley on both sides of the cabin were saturated. Inspection of the under floor area around the galley revealed several litres of water that had collected in the ceiling lining of the forward cargo bay. That lining had extensive brown liquid staining on its upper surface (Figure 20), although it was not determined whether that staining was due to fluids spilt during maintenance or during the operation of the aircraft. There was no evidence of water spillage from the lining onto the electrical panels at the forward end of the cargo bay, or into the MEC.

Figure 20: Forward cargo lining upper surface

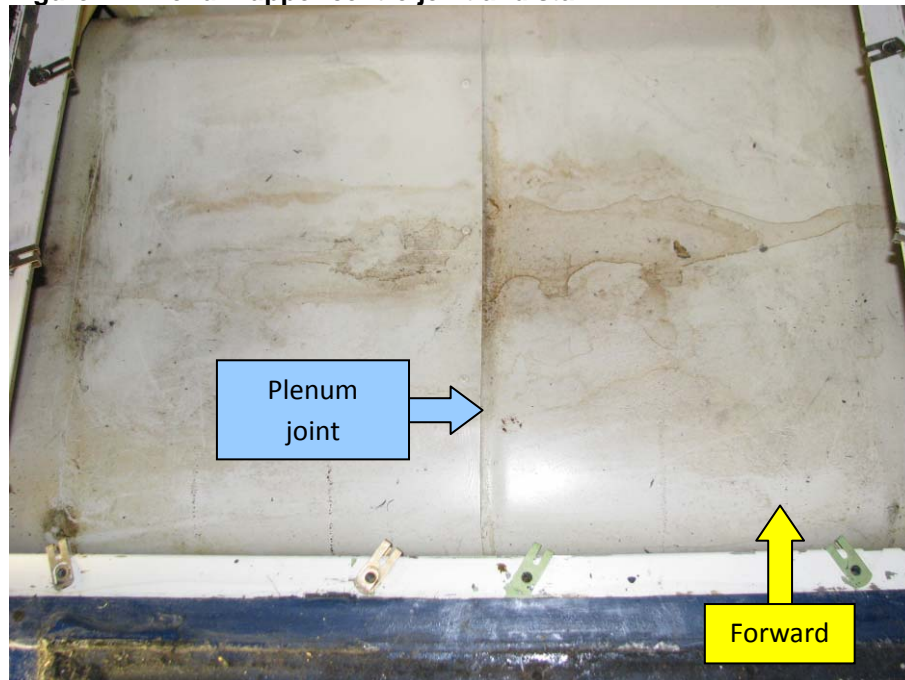
The upper centre joint of the plenum over the E1/E2 equipment racks was sealed at the time of the inspection and appeared watertight (Figure 21). The top of the plenum had brown staining consistent with liquid pooling at the edge of the centre joint. The right joint was slightly split. Internal inspection of the plenum using a borescope showed some dry dust accumulation around the vent holes and did not reveal any liquid staining inside the plenum.

Figure 21: Plenum upper centre joint and stain

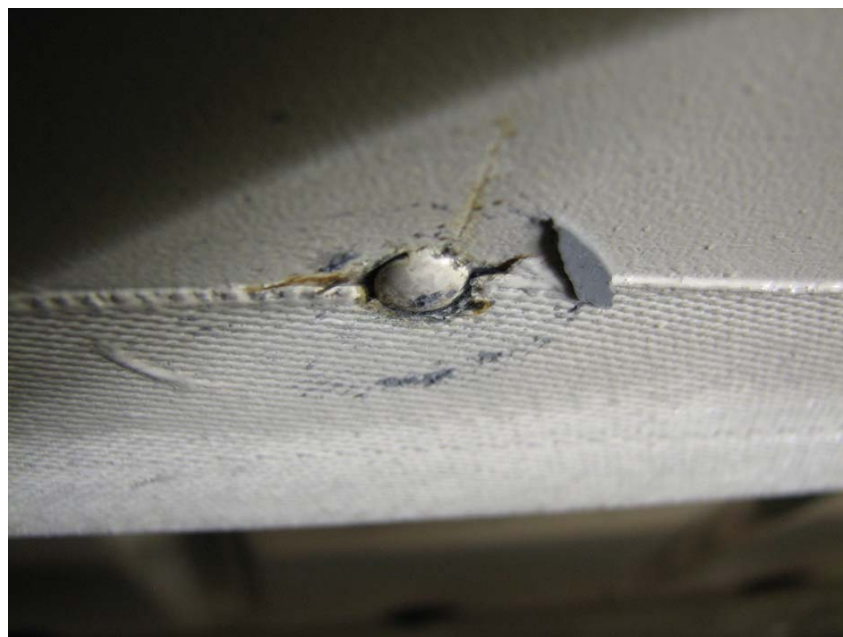
The dripshield gutter joints and some of the fasteners had been sealed at the time of inspection (Figure 22). Testing of a section of dripshield gutter resulted in a very slow leak (less than one drop every 15 minutes) through the unsealed dripshield fasteners, and a fast leak (several millilitres per second) through one of the unsealed dripshield gutter joints. However, the investigation was unable to test the gutter joint in the state that existed at the time of the occurrence.

Figure 22: Dripshield fastener detail, sealant removed

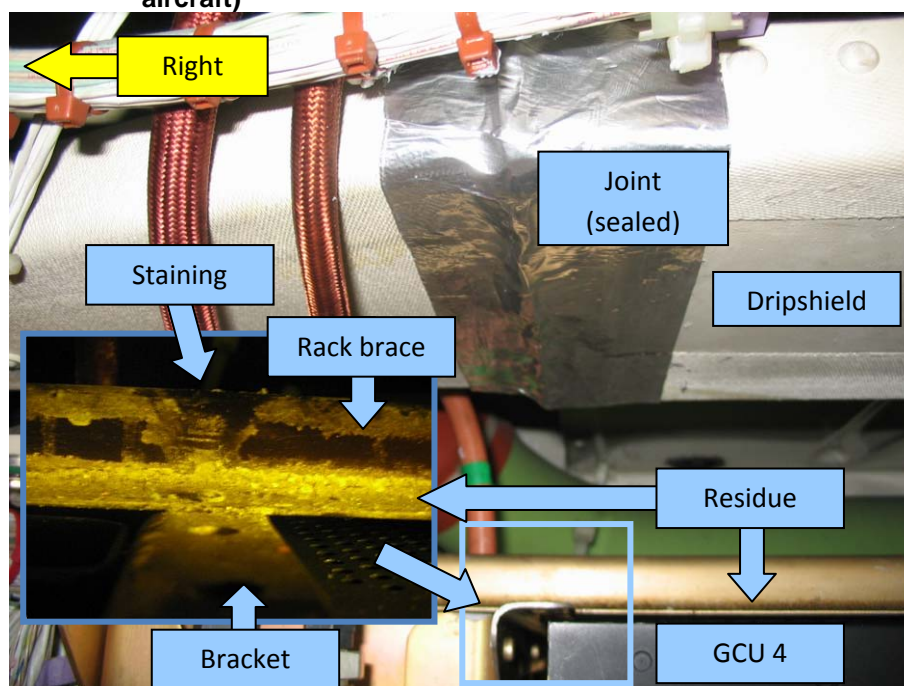
Forensic light inspection of the E1/E2 equipment rack showed staining beneath the right side dripshield joint consistent with liquid flowing from the joint onto the rack brace (Figure 23). The rack brace under the left side dripshield joint did not show any evidence of liquid staining.

The rack brace also showed significant residue on both sides of the E1/E2 equipment rack brace consistent with liquid contact and evaporation. The residue was most concentrated nearest the edges of the rack under the dripshield gutter joint and extended inward to about the area of each BCU. The presence of residue was also evident in photographs of the rack that were taken on 8 and 10 January.

Figure 23: Dripshield joint and drip marks (looking towards the rear of the aircraft)

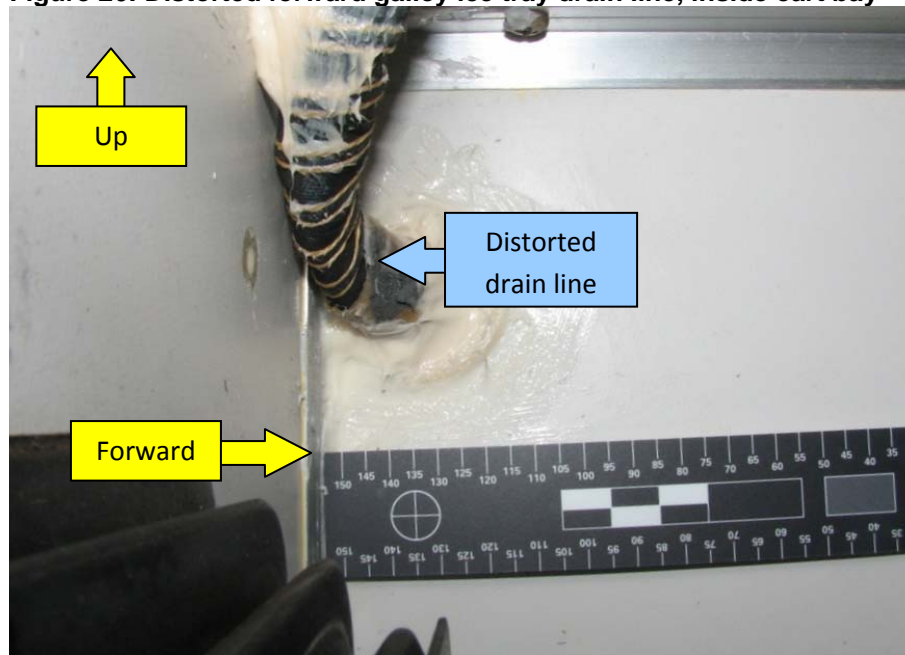
The ice tray drain line in one of the forward galley cart bays was crushed, consistent with contact by the rear of a service cart (Figure 26).

Figure 26: Distorted forward galley ice tray drain line, inside cart bay

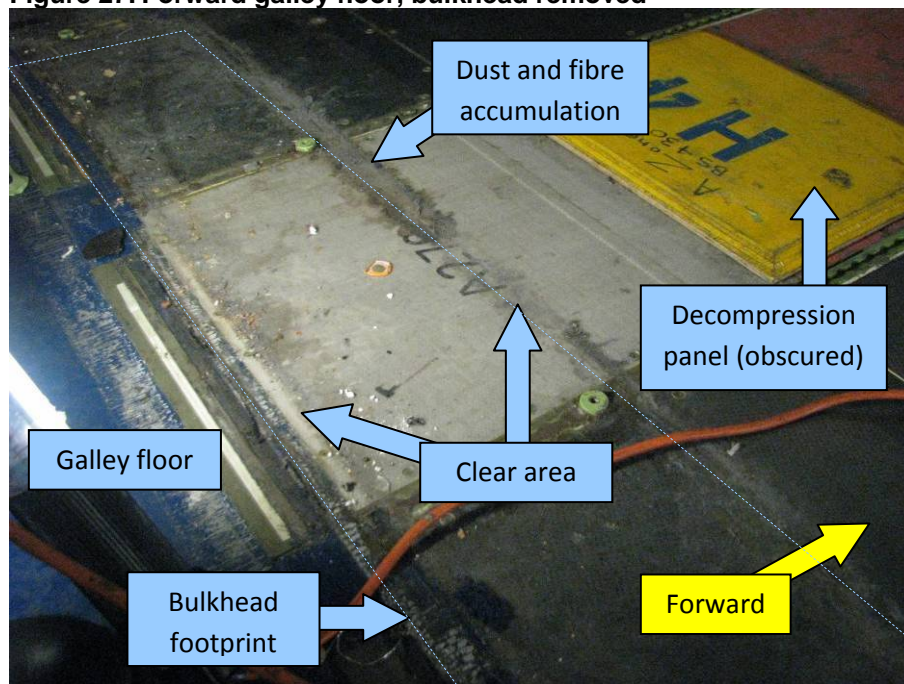
The galley floor sealing had partially deteriorated in some areas at the rear of the galley. Corrosion was identified on the floor beams and seat racks behind the galley.

Figure 27: Forward galley floor, bulkhead removed

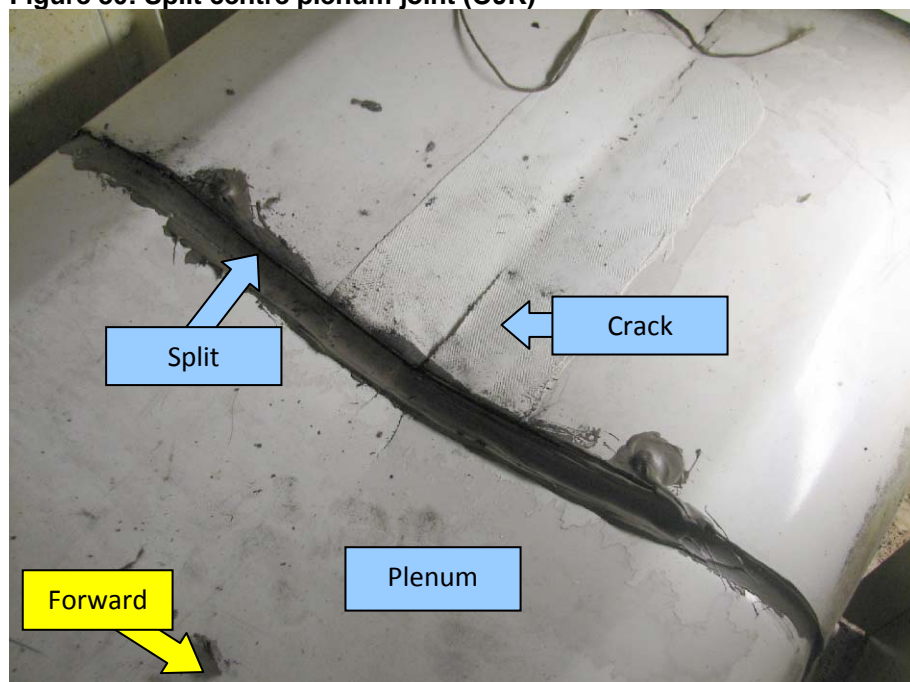
The upper plenum joints on OJK were split and did not appear watertight (Figure 30). There was also a longitudinal crack in the central section of the plenum where a repair had been performed. Damage and distortion in that section of the plenum was consistent with excessive weight being placed on the plenum from above.

The substance used to seal the joints was of a different appearance to that on OJM. An application of light pressure on one side of the left plenum joint indicated that the seal had split.

Figure 30: Split centre plenum joint (OJK)

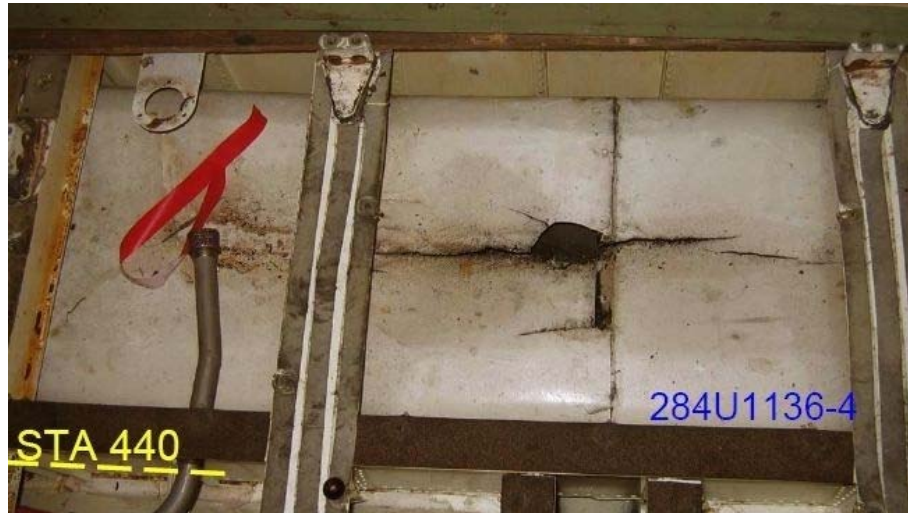
The aircraft manufacturer has received a number of reports of damaged dripshields in other 747-400 aircraft (examples shown in Figure 31 and Figure 32). At the time of the drafting of this report, the aircraft manufacturer had received 69 reports, 52 of which indicated damage to the dripshield or gutter.

Figure 31: Plenum (unknown 747-400 aircraft)

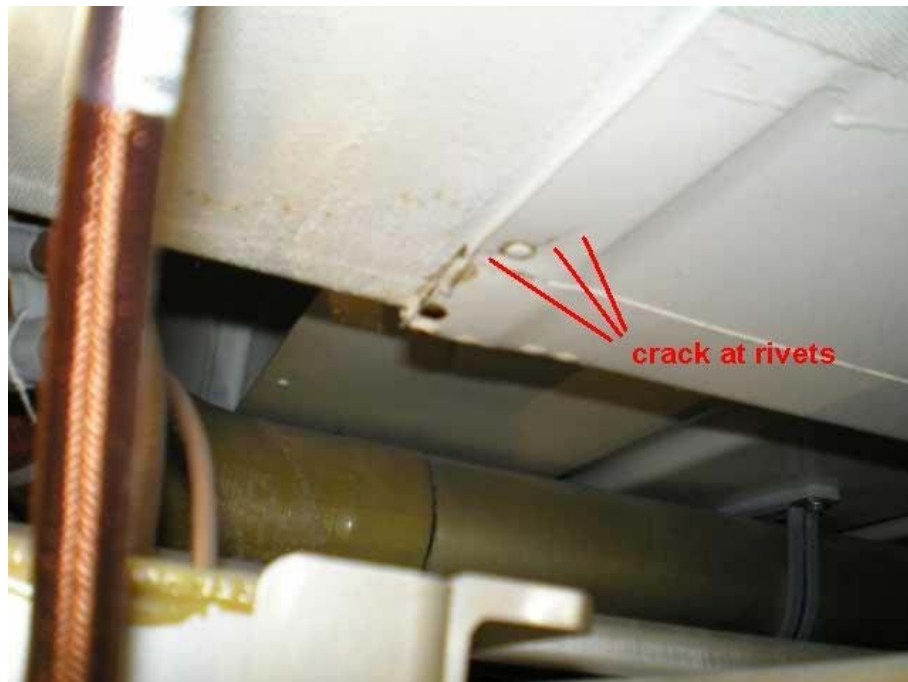
Figure 32: Dripshield gutter joint (unknown 747-400 aircraft)

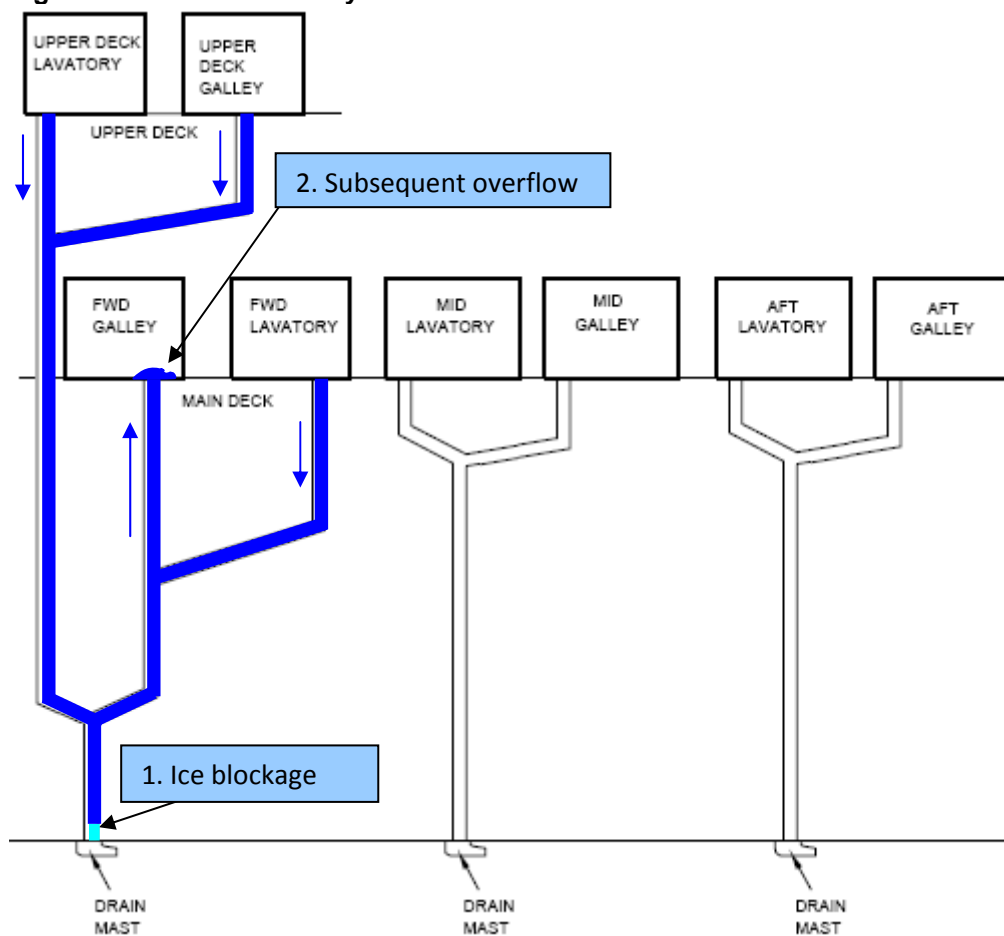
Figure 34: Forward drain system overflow

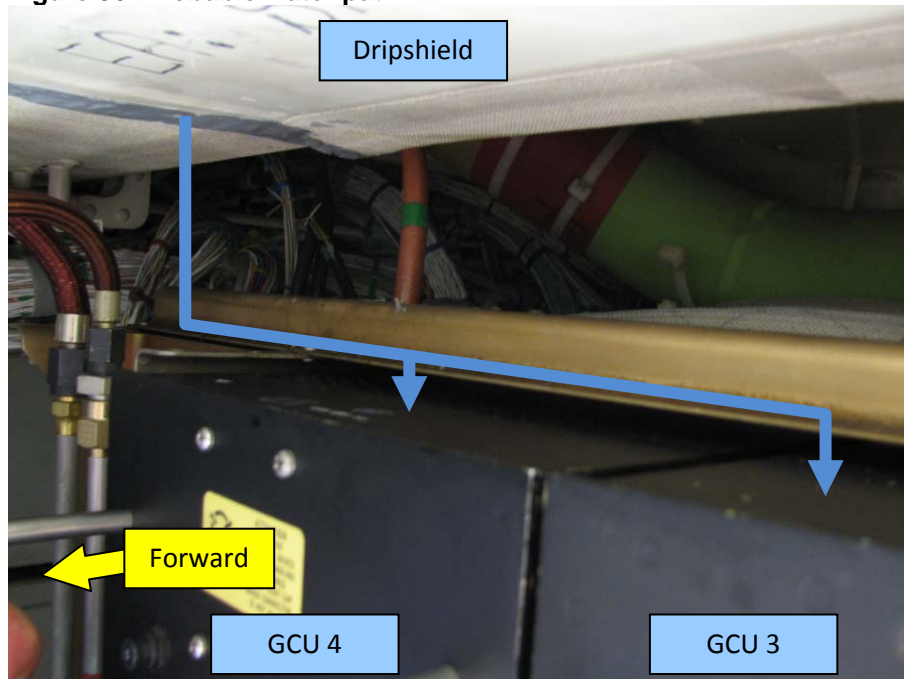
Figure 36: Probable water path
