ATSB TRANSPORT SAFETY REPORT  
Aviation Occurrence Investigation AO-2011-051  
Final

# Controlled flight into water, VH-RUR

## Lilli Pilli, New South Wales

### 24 April 2011

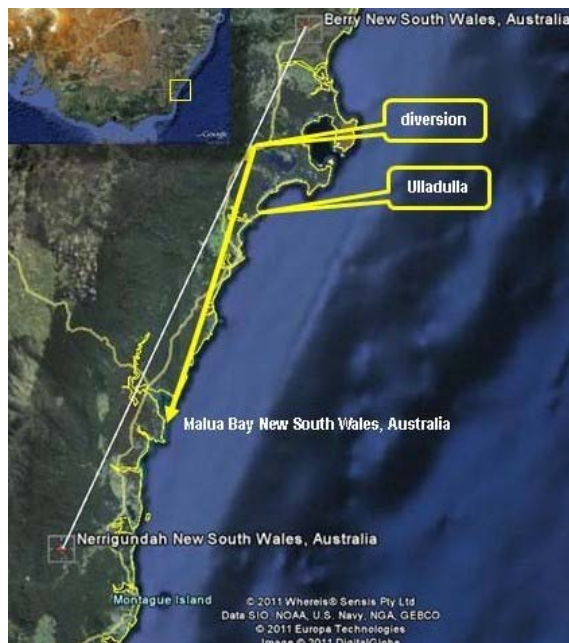
Figure 1: Flightpath<sup>6</sup>

At about 1753, when the helicopter was about 10 NM (19 km) north of Ulladulla (Figure 1), the pilot observed what he described at interview as cloud, moderate rain and low visibility between him and the destination. The pilot decided that the weather conditions ahead were unsuitable to continue the remaining 20 NM (37 km) to Berry under the VFR and initiated a turn back to maintain visual meteorological conditions. Based on that position and time, the estimated groundspeed for the flight was about 100 kts.

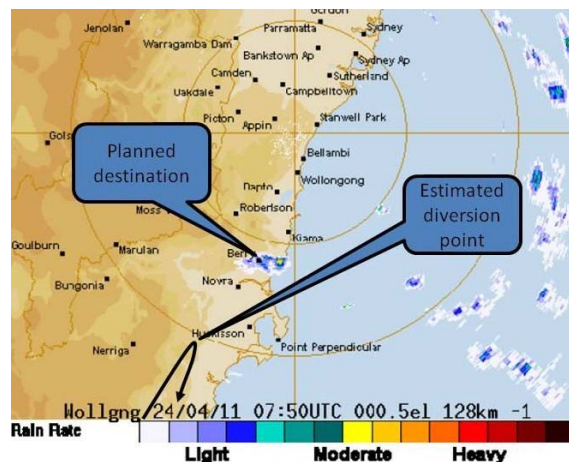
Figure 2: 1750 weather radar image<sup>7</sup>

Aviation meteorological information, including a number of radar images of the Berry area around the estimated time of arrival at Berry, was provided by the Bureau of Meteorology. The radar image that was captured for 1750 (0750 UTC) showed low-to-moderate rainfall in the Berry area at that time (Figure 2).

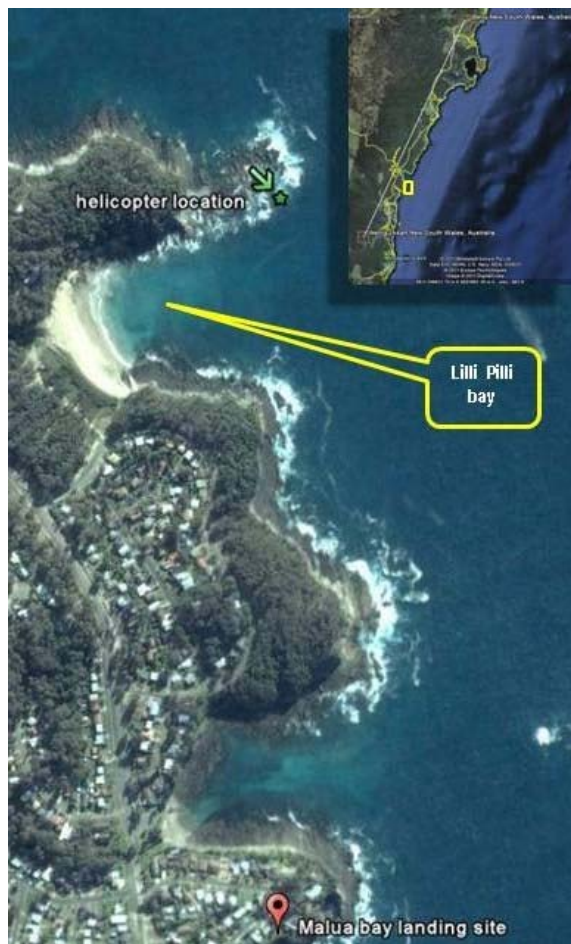
Figure 3: Malua Bay HLS and accident location<sup>6</sup>

The helicopter collided with the sea near rocks off the northern headland of Lilli Pilli Bay, about 1 km north of the landing site (Figure 3). A witness who observed the collision reported immediately contacting the police on emergency 000. The relevant police operational log recorded advice of the accident at 1817.
