Loss of tailrotor control, VH-UHD

Nangar National Park, New South Wales

23 December 2009

Abstract

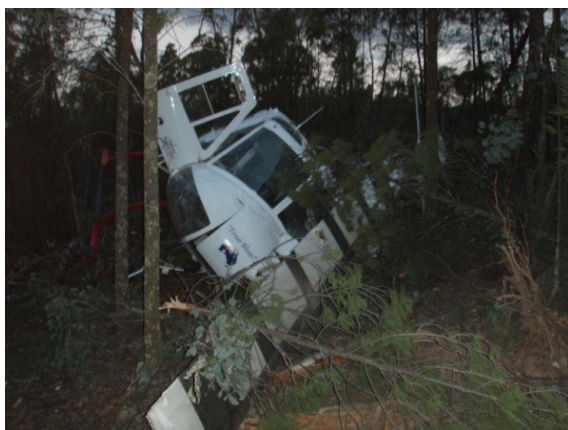
Figure 1: Accident site

As the helicopter descended through the tree canopy, the pilot rolled the throttle to idle and increased collective pitch to cushion the ground impact. The helicopter impacted the ground at low forward speed and came to rest on its left side (Figure 1). A nearby firefighter witnessed the accident and helped the pilot from the wreckage.

The pilot sustained serious back injuries and the helicopter was seriously damaged².

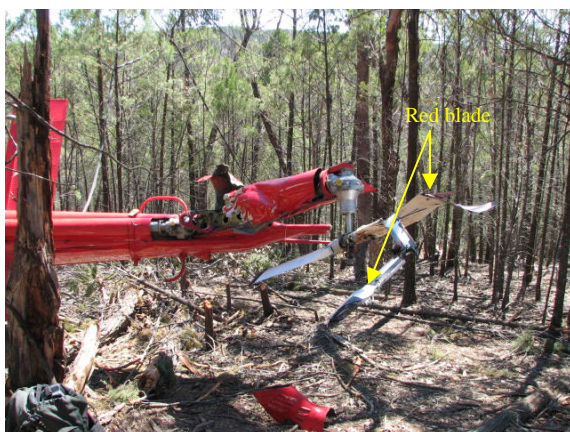
Figure 3: Shattered tailrotor blade

The tailrotor blades struck the helicopter's vertical fin twice, destroying the tailrotor driveshaft cover and severing that section of the driveshaft. Those impacts also shattered the 'red'¹² tailrotor blade (Figure 3). The 'white' tailrotor blade had failed structurally at its tip.

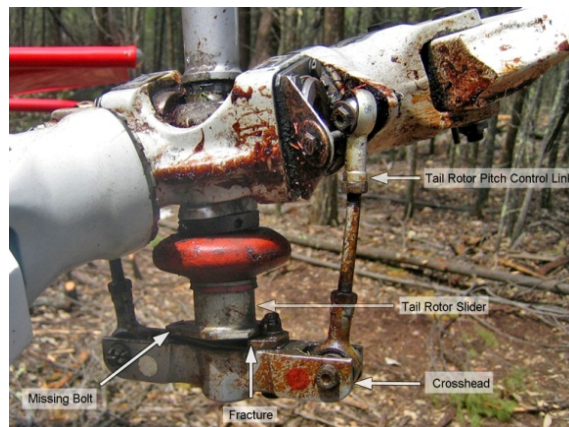
Figure 4: Slider and crosshead

Representatives of the helicopter owner examined the tailrotor on-site and found that the pitch change slider had fractured at the flange-to-barrel transition on the red side of the slider. In addition, one attachment bolt was missing from the slider-to-crosshead attachment (Figures 4 and 5). A search of the accident site by the owner's representatives did not locate the missing bolt.

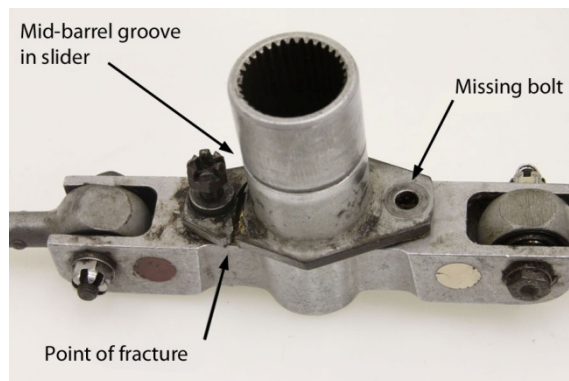
Figure 5: Slider showing missing bolt and fracture

The fatigue cracking in the flange-to-barrel transition of the slider was a result of low-cycle, high-stress conditions. The final fracture of the slider was due to overstress of the component from the application of bending forces.

- The tailrotor pitch control slider fractured as a consequence of bending under low-cycle, high-stress conditions that were likely produced by a slider/crosshead attachment bolt failure.
- The attachment bolt probably failed as a result of metal fatigue that was produced by excessive stresses associated with relative movement in the slider/crosshead attachment area.

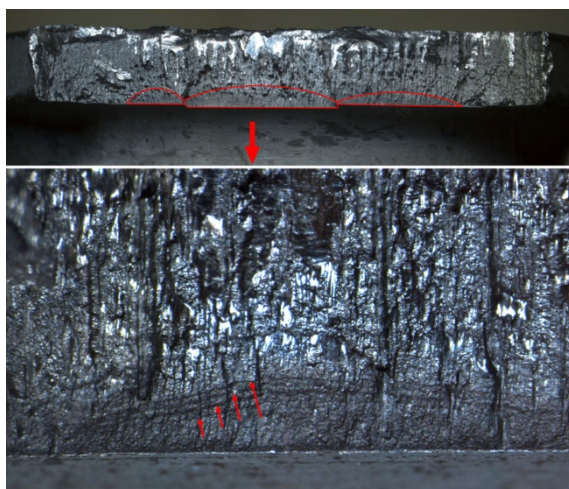
Figure 6: Fracture surfaces

The tailrotor slider fracture at the flange-to-barrel transition followed a circumferential path around the barrel, where the effect of the change in thickness of the structure was greatest. The fracture surfaces were examined at varying magnifications using an optical microscope.

The bulk of the slider flange had failed in a manner consistent with ductile overstress; however, there was evidence of cyclic fatigue cracking in the form of beach marks on the fracture surfaces. Those semi-circular fatigue cracks had initiated in the transition radius of the flange at three separate origins, and had propagated perpendicularly inward through the

Measurements indicated that the deepest fatigue crack had grown approximately 25% through the flange, to a maximum depth of 1.2 mm. The existence of multiple fatigue cracks, together with the relatively small size of the fatigue zone in relation to the region of overstress, indicated that the slider most probably failed through bending under low-cycle, high-stress conditions. Examination of the fracture surfaces with a scanning electron microscope found no material anomalies at any of the three crack origins that might have contributed to the crack initiation.

Some smearing of the fracture surfaces had occurred, consistent with metal-to-metal contact during the accident sequence. At the time of the examination, the fracture surfaces appeared to have been newly created, with no evidence of corrosion or polished features (Figure 6).

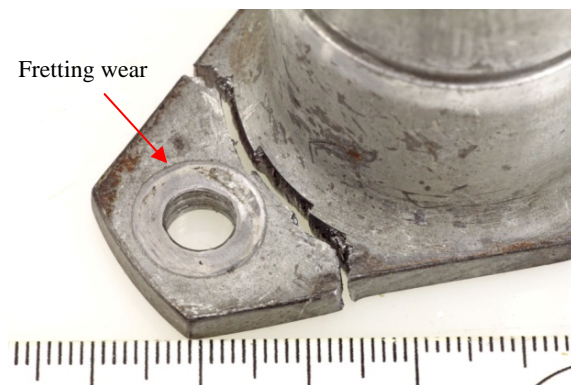
Figure 7: Fretting wear on slider flange

Other features of relevance on the slider body included localised surface fretting under the washer associated with each slider/crosshead bolt (Figure 7). Fretting of that nature indicated that the bolts had been moving during service. Additionally, as observed by the helicopter owner's representatives on-site, only one of the two NAS1304 attachment bolts that secured the slider and crosshead remained installed within the assembly.

In the context of the missing attachment bolt, the abnormal fretting wear under each slider/crosshead attachment bearing surface was consistent with relative movement in the slider/crosshead attachment area during service. That movement was likely the consequence of insufficient clamping force, as produced by the fastening torque of the castellated nuts onto each attachment bolt. The lack of clamping force in the slider/crosshead assembly created additional dynamic stresses on the components, with associated fatigue cracking in the barrel-to-flange transition. Although not able to be confirmed by examination of the missing bolt, such dynamic

stresses could be expected to create ideal conditions for fatigue cracking and the in-service failure of the bolt.
