ATSB TRANSPORT SAFETY REPORT
Aviation Occurrence Investigation
AO-2010-006
Final

Total power loss
11 km NE of Derby Airport, WA
29 January 2010
VH-NWO, Pilatus PC-12/45

**Total power loss
11 km NE of Derby Airport, Western
Australia
29 Jan 2010
VH-NWO, Pilatus PC-12/45**

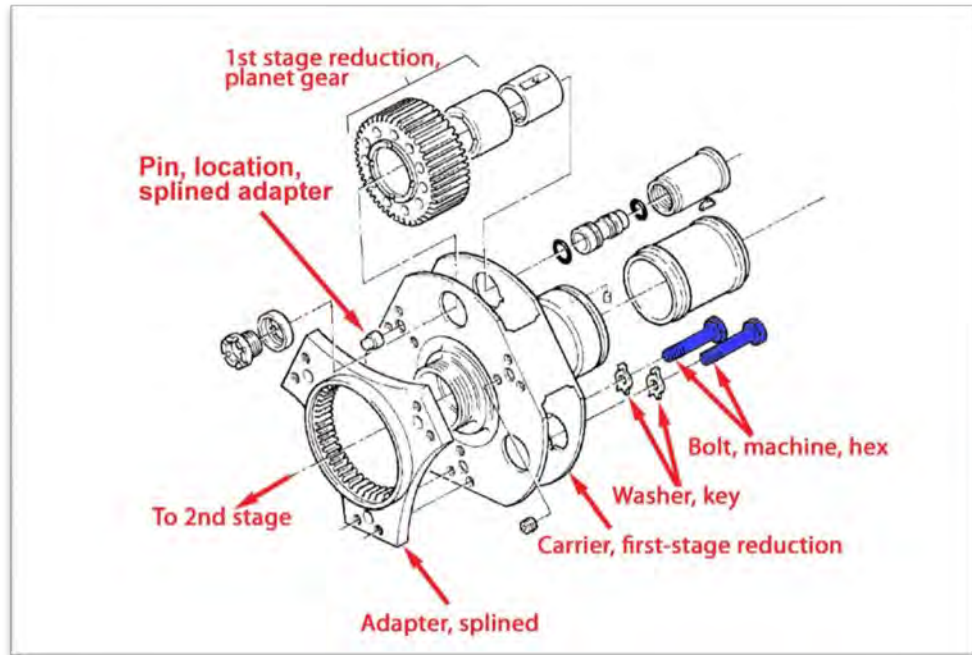
Figure 2: Schematic of the first stage reduction assembly, showing a closer location view of the failed bolts

The examination of the gearbox found that four of the six first stage reduction assembly carrier bolts (part number MS 9490-34) had failed due to fatigue cracking

at the head-to-shank fillet radius⁷ (Figure 2). Debris from the failed bolts was released into the first stage sun and planet gears, causing significant damage.

A fifth carrier bolt had fractured through the threaded area as a result of overstress, with the threaded portion remaining in the splined adapter.

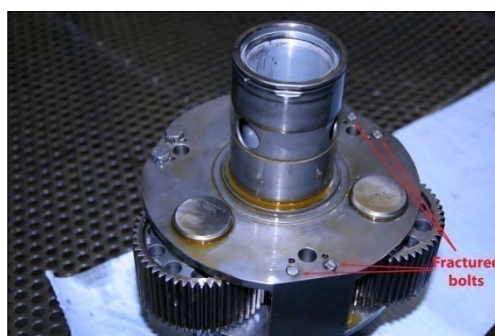
Figure 3a: First stage reduction carrier, showing the location of the fractured bolts.

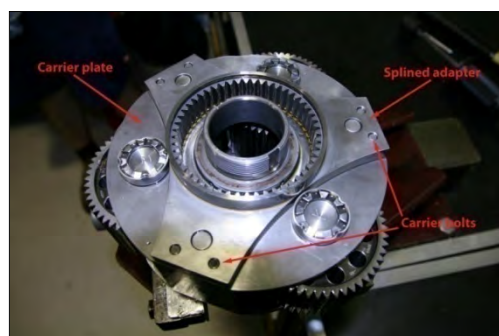
Figure 3b: Underside of the first stage reduction carrier, showing the splined adapter.

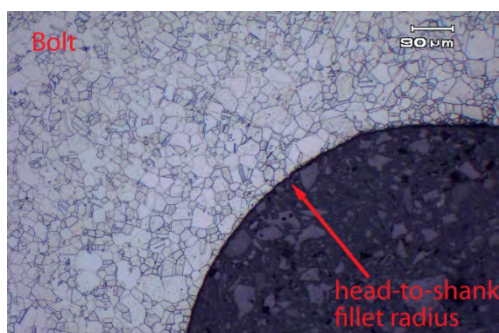
In October 2010, the engine manufacturer advised the ATSB of the identification of a number of in-service carrier bolts that had not been cold rolled⁸ at the head-to-shank fillet radius. That would have reduced the bolts' fatigue resistance, and increased the likelihood for the initiation of fatigue cracking at the head-to-shank fillet radius.

An MS 9490-34 bolt, which was confirmed as having undergone cold rolling of the head-to-shank fillet radius during manufacture was examined by the ATSB. A comparison of the cold rolled bolt and the intact bolt from the aircraft's reduction gearbox revealed a significant difference between the surface microstructure at the respective bolt's head-to-shank fillet radius (Figure 4). That difference was consistent with the intact bolt not being cold rolled.

Figure 4a: Head-to-shank fillet radius of one of the failed bolts, with no evidence of cold rolling.

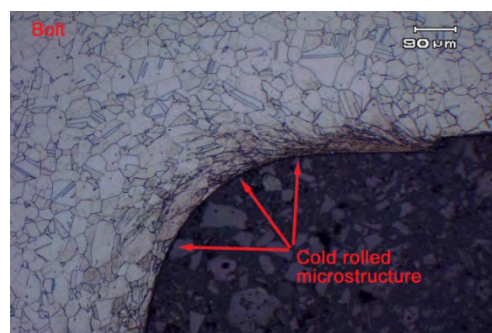
Figure 4b: Head-to-shank fillet radius exhibiting a cold-rolled microstructure.

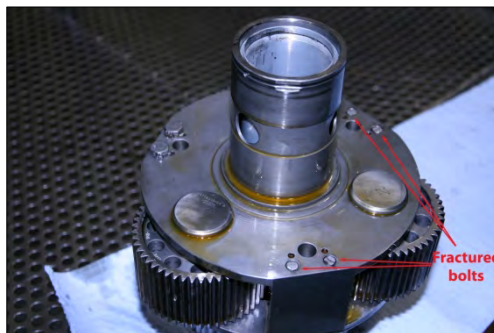
The assembly contained six bolts (Figure A2); four of the bolts had failed underneath the bolt head, one of the bolts had failed in the threaded region at a location between the carrier plate and splined adapter (Figure A3) while the final bolt remained intact.

Figure A2a: First stage reduction carrier showing the location of the under-head fractured bolts.

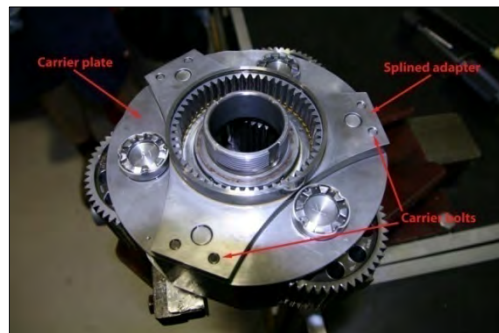
Figure A2b: Underside of first stage reduction carrier showing the splined adapter.

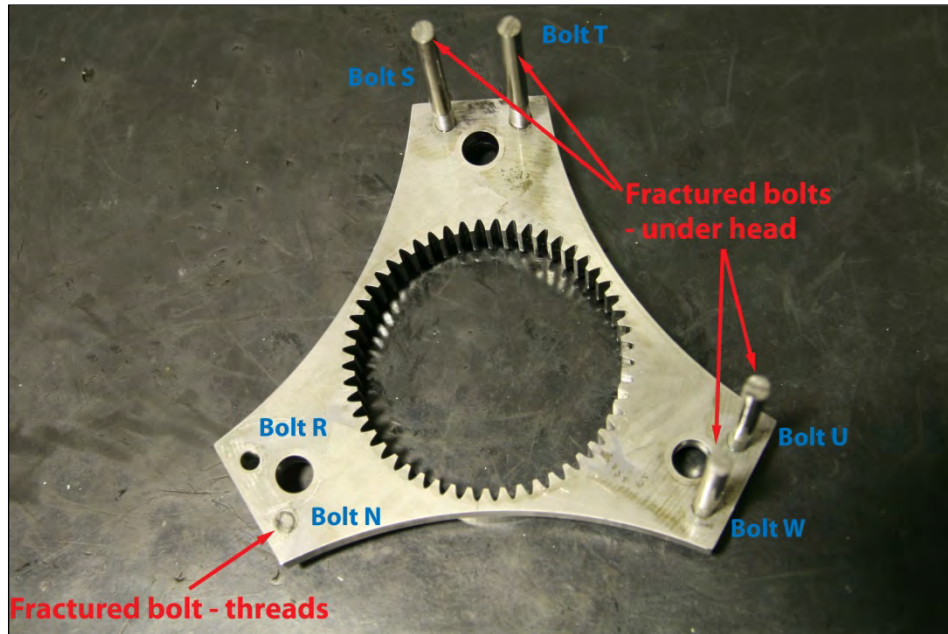
Figure A6: Splined adapter following removal from the carrier plate. Note the locations of the fractured bolts and their designations

The length of the exposed thread was measured on the bolts that had fractured under the head (S, T, U and W), prior to their removal from the splined adapter. All four bolts exhibited a similar level of engagement (Figure A3 and A6). The bolt that had fractured in the threaded region (Bolt N) showed slightly less thread engagement when viewed from the underside, when compared against the bolts that had fractured beneath the head.

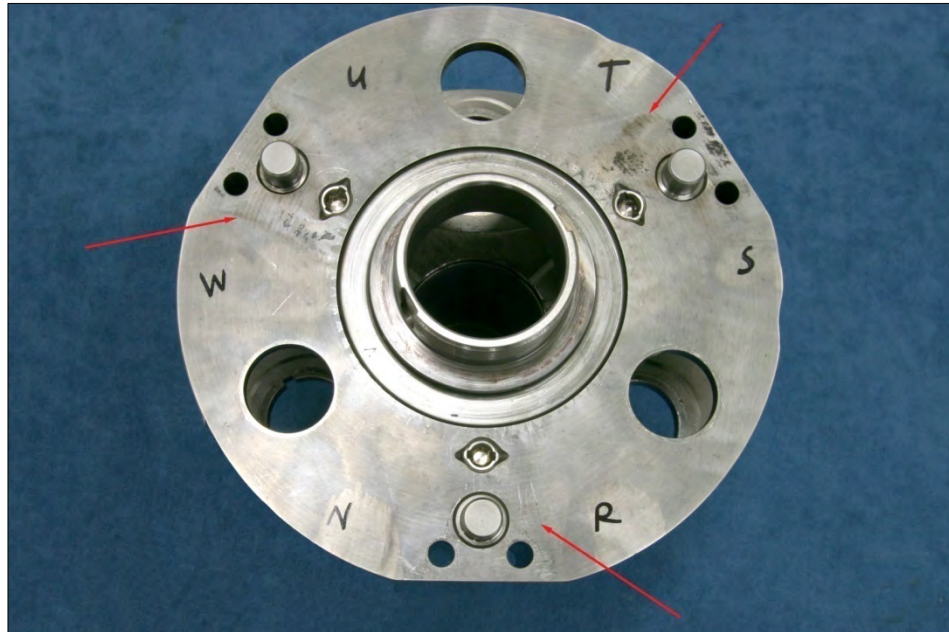
Evidence of fretting wear and scuff marks was observed on the mating surfaces between the carrier plate and the splined adapter (Figures A4 and A5). The wear appeared to be slightly greater towards one side of each of the three carrier plate arms. This was consistent with the torsionally-induced movement of the splined adaptor with respect to the carrier plate during service.

Figure A7: Carrier plate after removal of the splined adapter. Note the fretting wear adjacent to bolt pairs

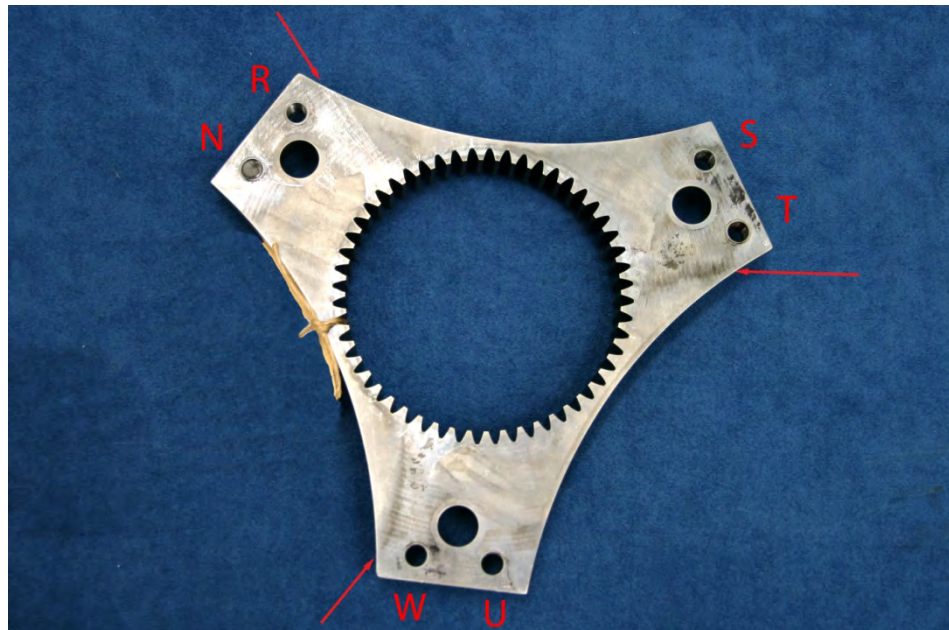
Figure A8: Splined adapter, following removal from the carrier plate, showing the face in contact with the carrier plate

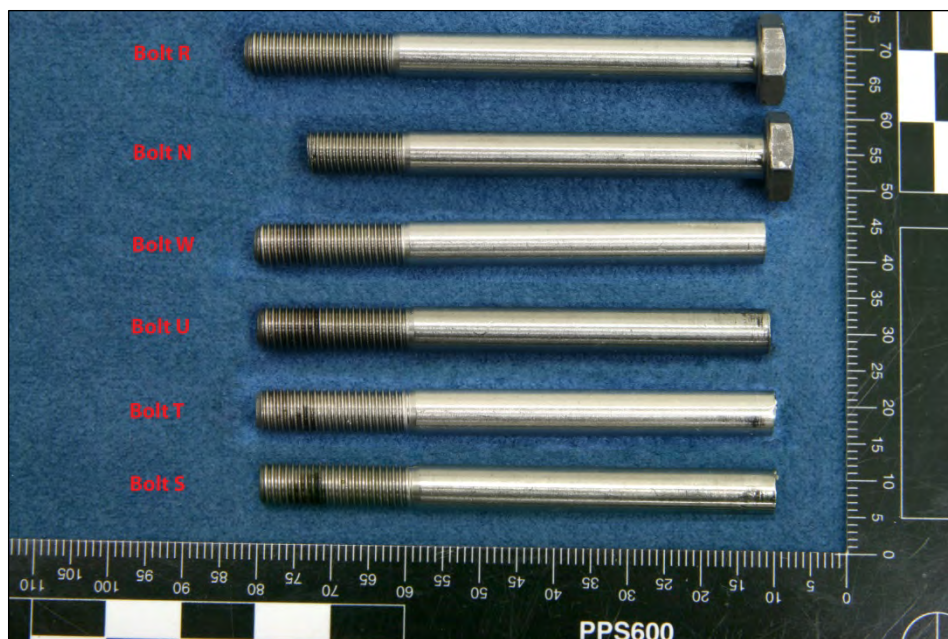
Bolts S, T, U and W had all fractured at the head-to-shank fillet radius (Figure A6) while bolt N failed through the threaded section.

Figure A9: Carrier bolts following disassembly of the first stage reduction carrier. Note that Bolts S, T, U and W failed under the bolt head, Bolt N failed through the threaded section, while Bolt R remained intact

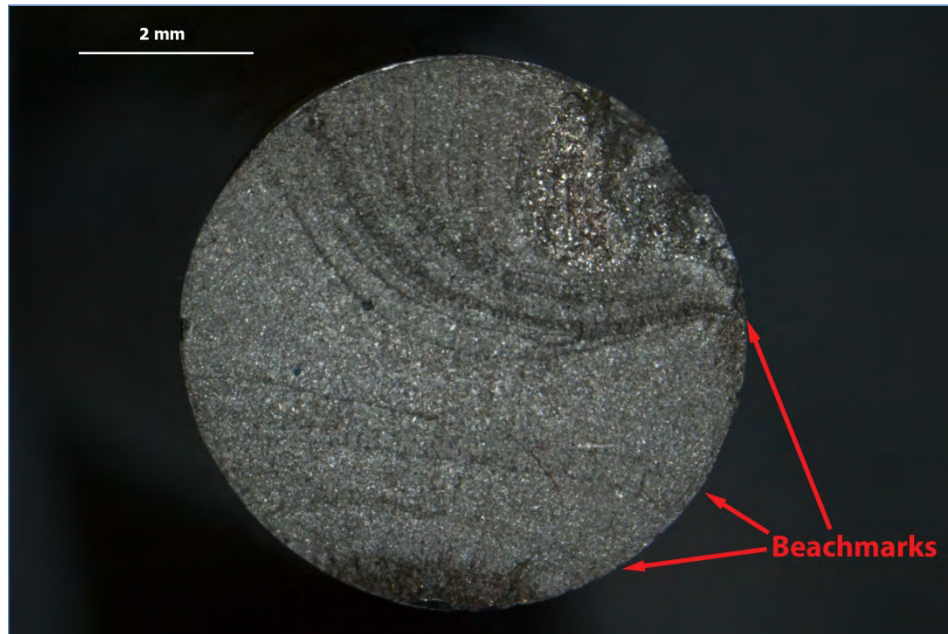
The fracture faces of Bolts S, T, U and W also exhibited similar features. In all cases, the surface was smooth, flat, and perpendicular to the principal axis of the bolt. Evidence of cyclic fatigue crack growth in the form of beach marks was observed. Beach marks (indicative of reverse bending fatigue cracking) extended radially from opposite sides of the bolt towards the centre, and extended across a significant proportion ($>2/3$) of the fracture surface area (Figure A7). A small region across the centre of the bolt exhibit features consistent with an overstress failure mode.

Figure A10: Fracture face of Bolt S showing evidence of reverse bending fatigue

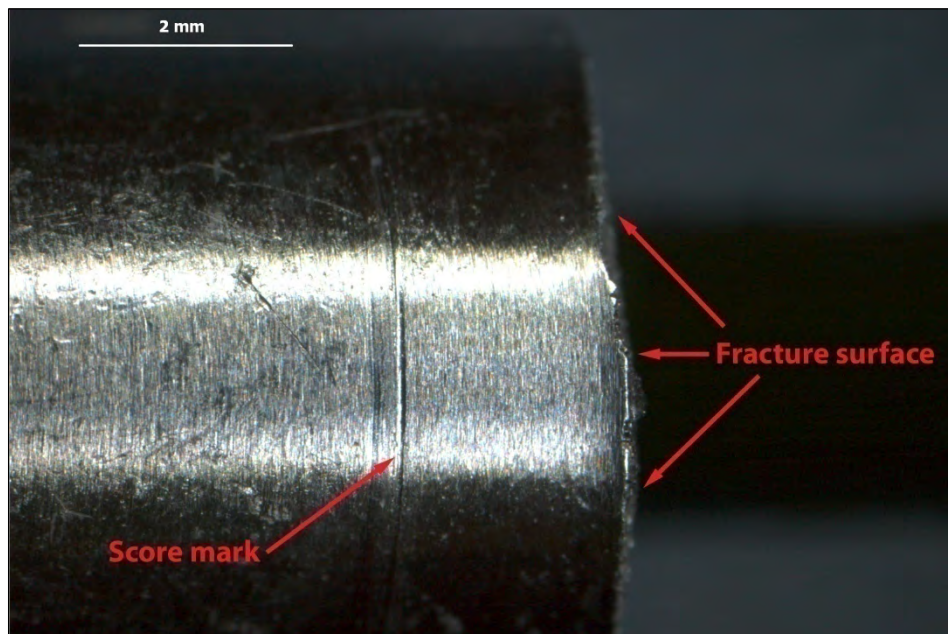
A circumferential score mark, located approximately 2mm from the fracture surface, was identified on all six carrier bolts (Figure A8). The score mark was coincident with a location between the carrier plate and the tabbed key washer (refer Figure A1).

Figure A11: Shank of a fractured bolt showing the typical score mark 2mm from the under-head fracture

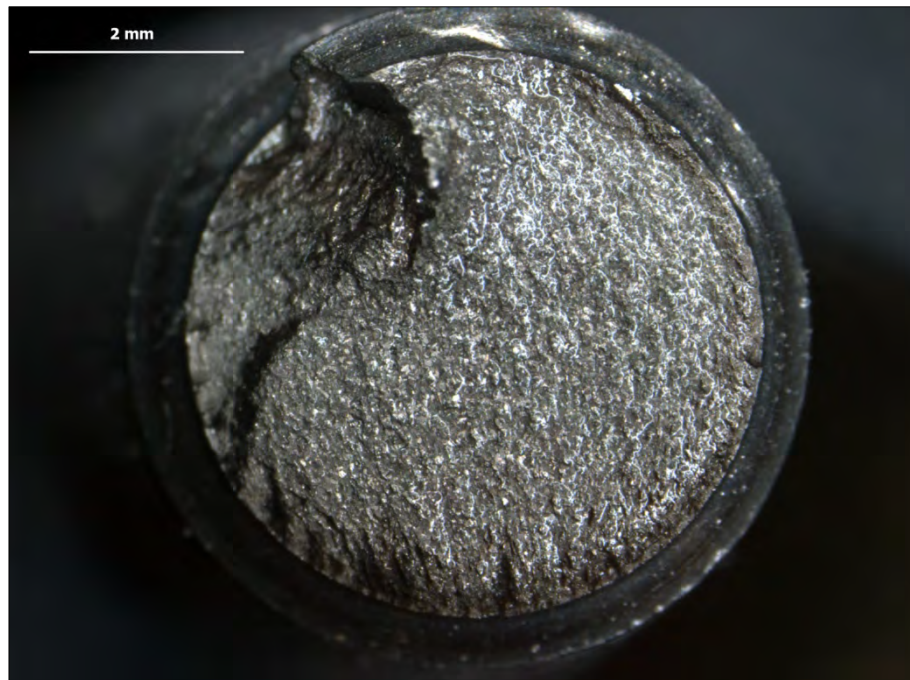
The fracture face of Bolt N exhibited different features to the other four fractured bolts. While the surface was smooth, flat and oriented perpendicular to the length of the bolt, no evidence of fatigue failure was observed. The fracture face was

coincident with a thread root and appeared to be consistent with a bending overstress failure.

Figure A12: Fracture face of Bolt N

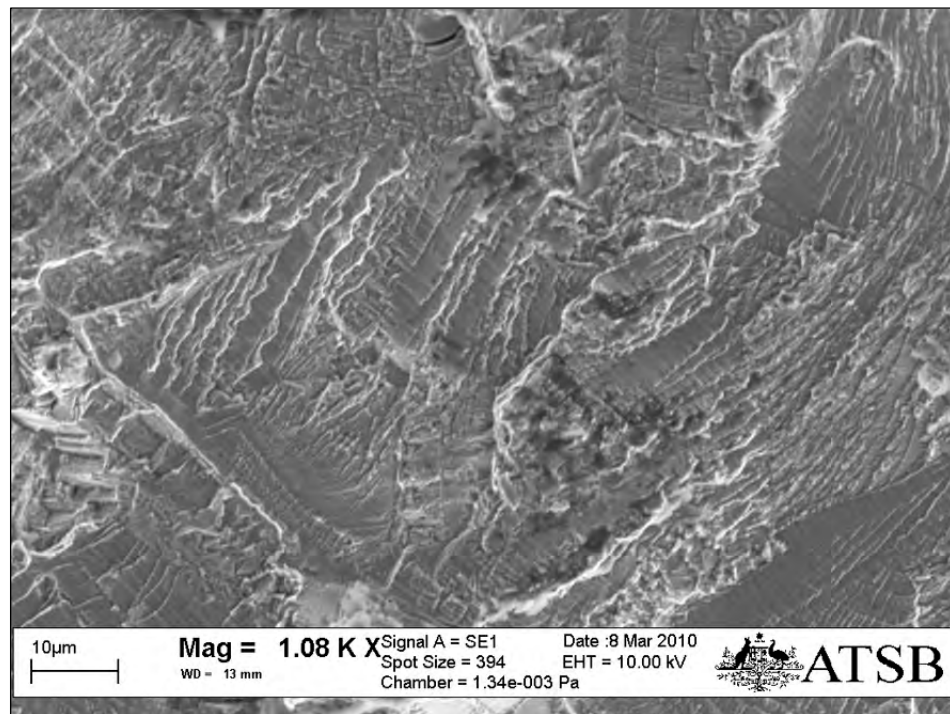
The fracture face (Bolt S) exhibited finely spaced striations at the outer edges, indicative of a low-stress, high-cycle fatigue cracking mechanism (Figure A10). No anomalies that may have contributed to crack initiation were detected at the likely origin points. A faceted fracture surface was observed towards the centre of the bolt, consistent with an overstress failure.

Figure A13: Scanning electron microscope image of the fracture face of Bolt S showing the fatigue striations

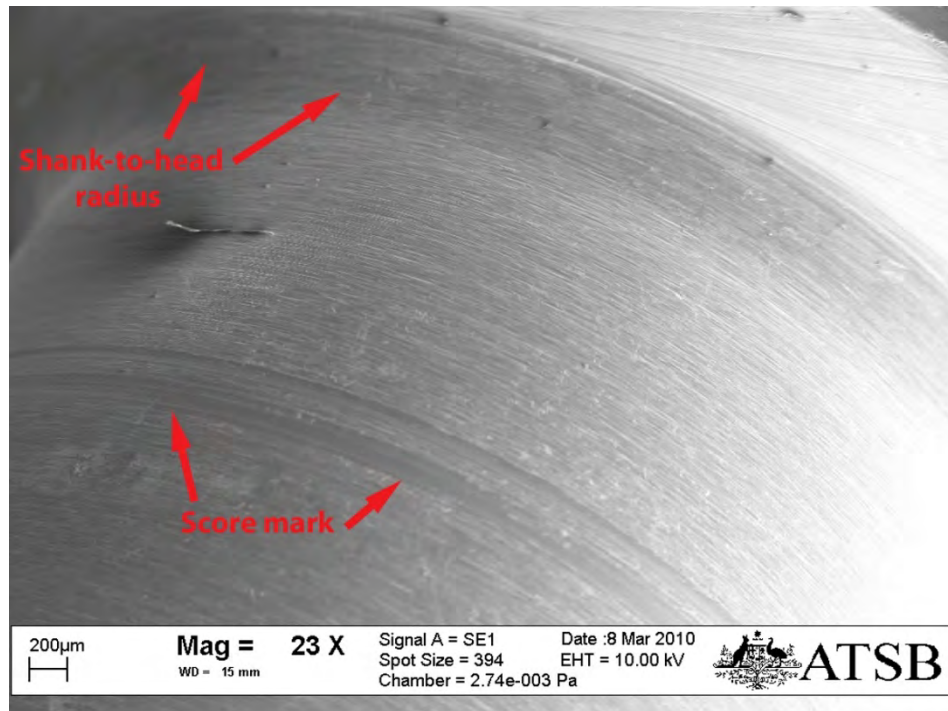
The region under the head of Bolt R (Figure A11) was examined for any anomalies that may have led to initiation of a crack at this location. The shank-to-head radius appeared to be relatively smooth, with a continuous change in section. The visually-observed score mark also appeared to be a wide, shallow groove, which was of a consistent depth and thickness around the entire circumference. Evidence of machining was observed on the bearing surface with a small step between it and the head-to-shank fillet radius.

Figure A14: Low magnification scanning electron microscope image showing the shank-to-head radius of Bolt R. Note the smooth appearance of the radius, and the machining marks observed on the radius and the under-head bearing surface

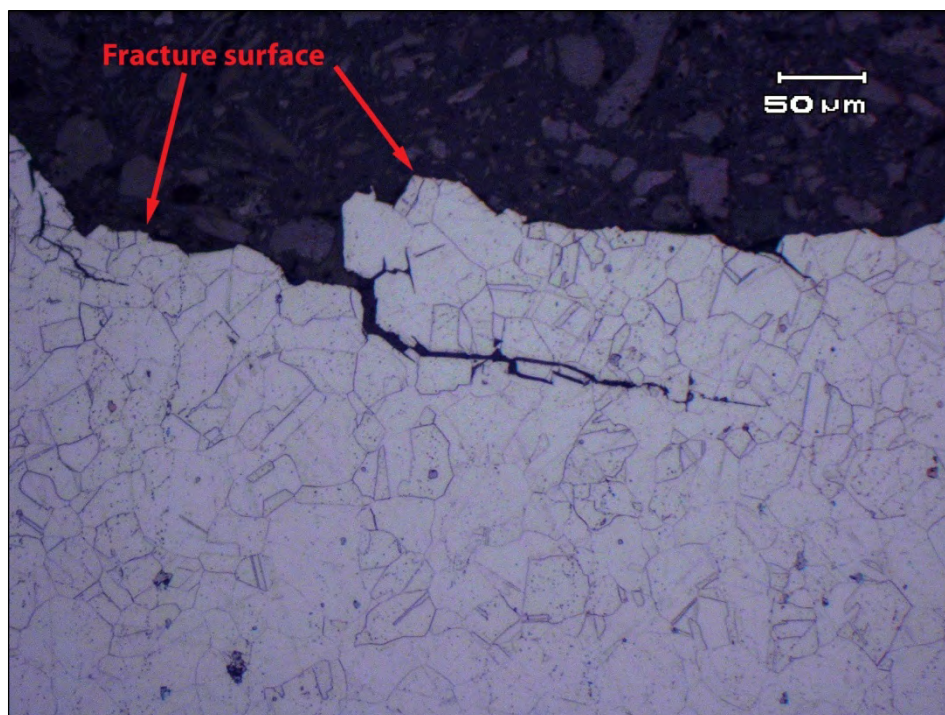
Figure A15: Bolt S fracture surface

The fracture path morphology was essentially transgranular in nature, but areas of intergranular crack propagation were also observed. A number of secondary cracks extending from the primary fracture face were observed. The secondary cracks were straight and had propagated in a transgranular manner (Figure A12).

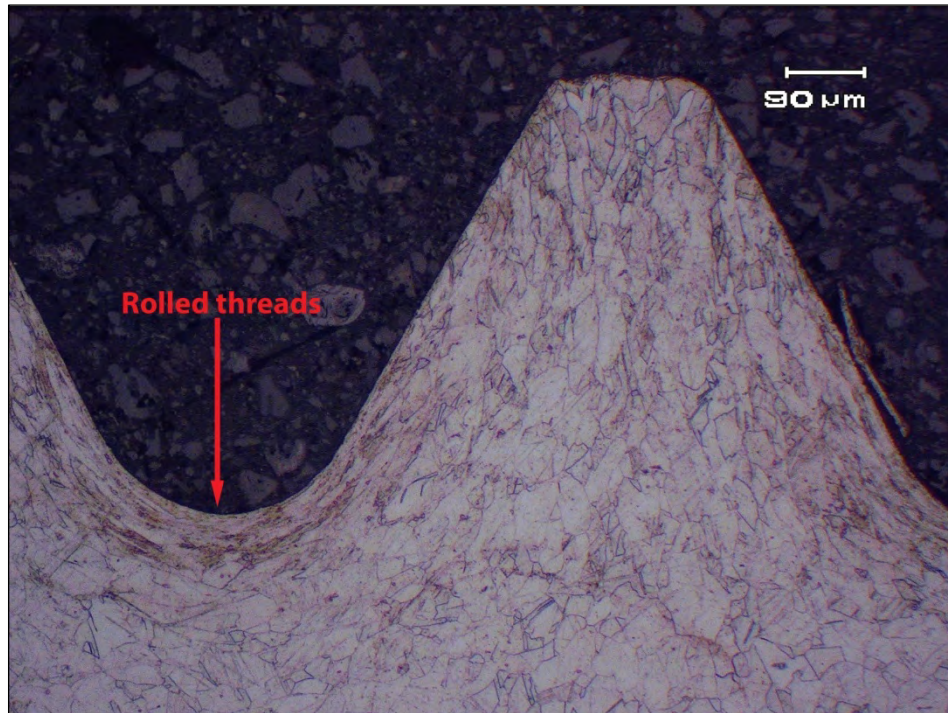
An examination of the threads of Bolt S revealed them to have been rolled rather than cut (Figure A13) - consistent with the process specified in SAE AS7477. The head-to-shank fillet radius showed an equiaxed grain microstructure, which indicated that the bolt had not undergone any form of post machining cold rolling or other localised compressive process such as shot-peening (Figure A14).

Figure A16: Bolt S threads showing manufacture by rolling. The thread profile looked smooth with no flaws observed in the sections examined

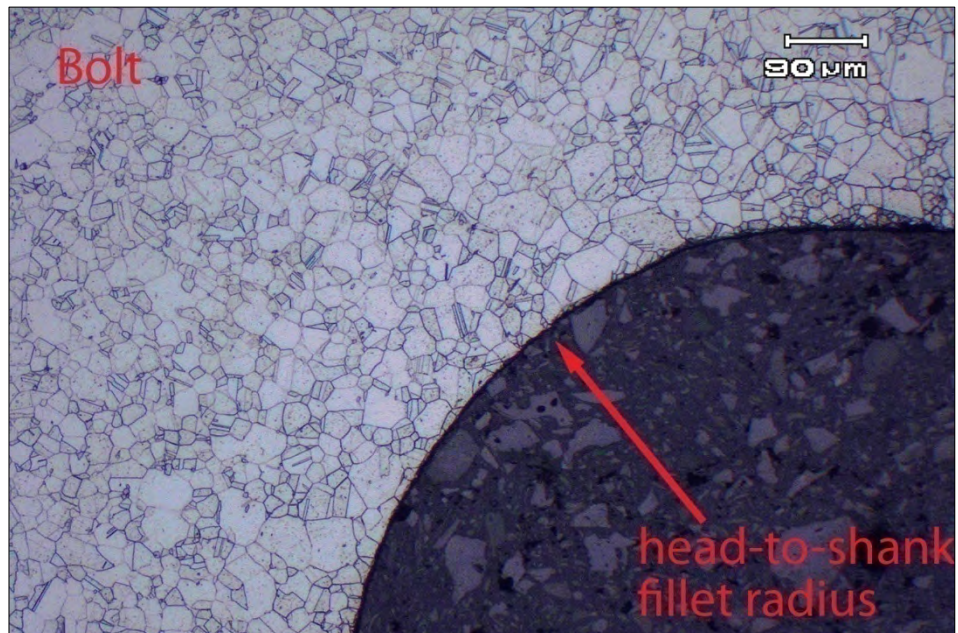
Figure A17: Bolt R head-to-shank fillet radius showed no evidence of cold rolling

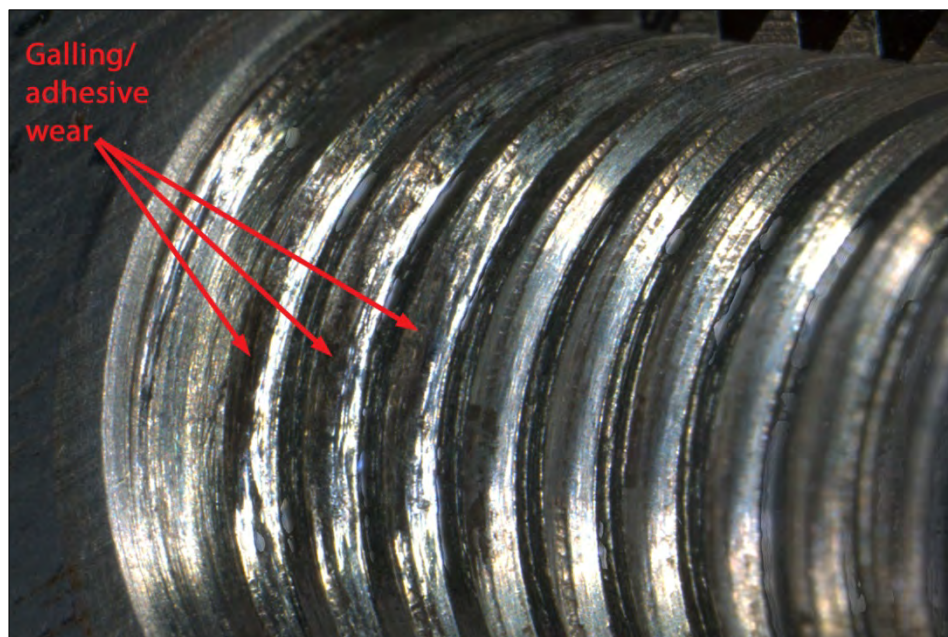
An examination of the thread crests and flanks revealed evidence of minor plastic deformation of the surface (Figure A17 and A18); likely to be consistent with the general surface features associated with the thread forming process. Some evidence of galling/adhesive wear was observed on the thread flanks towards the surface in contact with the bolt head.

Figure A20: Bolt hole T showing the galling/adhesive wear observed on the thread flanks

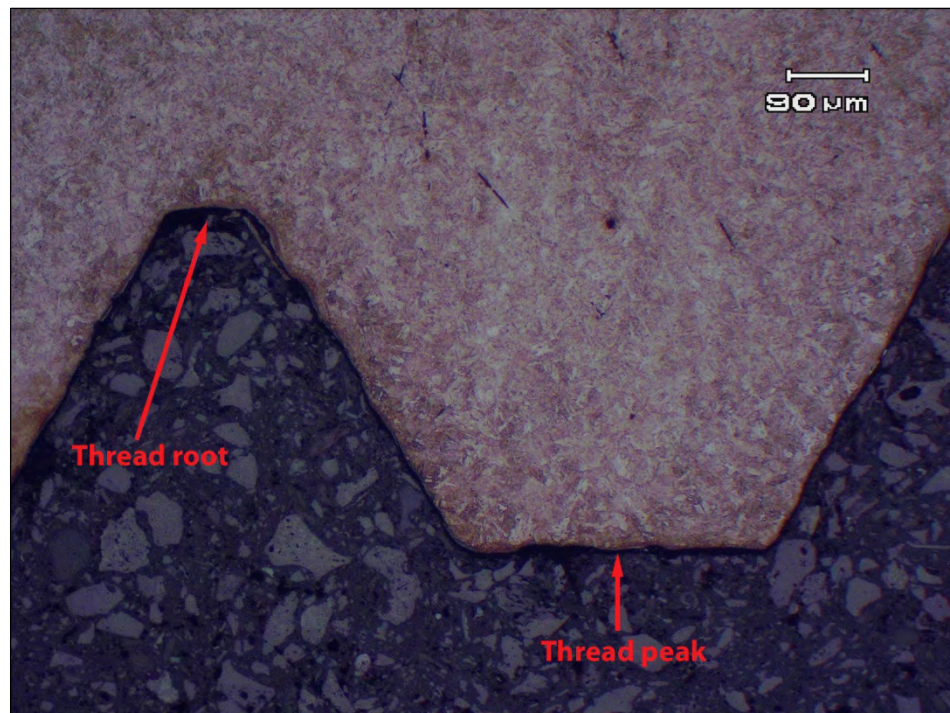
The surface irregularities observed previously on the thread crests and flanks was also evident on the adapter cross section (Figure A18).

Figure A21: Photomicrograph showing the thread profile, including square profile and flattened root contour. Also note the irregularity of the surface, particularly on the thread flanks
