## Parting of train 9827 near Gunning, NSW 30 March 2011

### Abstract

At about 2031<sup>1</sup> on Wednesday 30 March 2011 a southbound Port Kembla to Parkes empty bulk grain train experienced a train parting event at about the 285 track kilometre point<sup>2</sup> near Gunning (Oolong), NSW, on the down main Sydney to Melbourne rail line. There were no injuries or damage as a result of the incident.

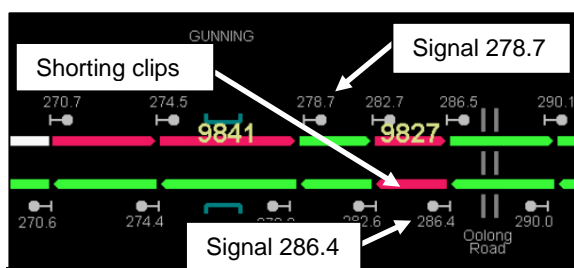
**Figure 2: Phoenix extract at 2033:36**

Train braking systems are designed so that in the event of a train separation, the brakes apply on all vehicles, providing a 'fail safe' condition. Once the train came to a stop at about 2032:03, the driver notified the network controller at Junee while he placed track circuit shorting clips<sup>5</sup> onto the Up Main line adjacent to the train (Figure 2)<sup>6</sup>. He then walked towards and placed audible warning devices on the Up Main track near the first approaching signal 286.4, about 300 m away.

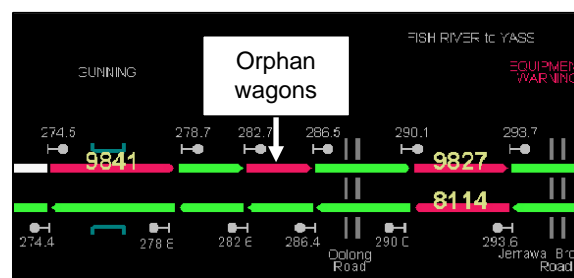
**Figure 3: Phoenix extract at 2109:01**

At 2054:54 the network controller advised trains 8114 and 9841 to proceed with caution near the area where train 9827 had stopped. After train 9827 cleared the section, the track circuit remained occupied. The network controller noticed the anomaly (Figure 3) and immediately contacted train 8114, on the Up Main line, to be very cautious and check the condition of the track 'just in case he has left wagons behind'.

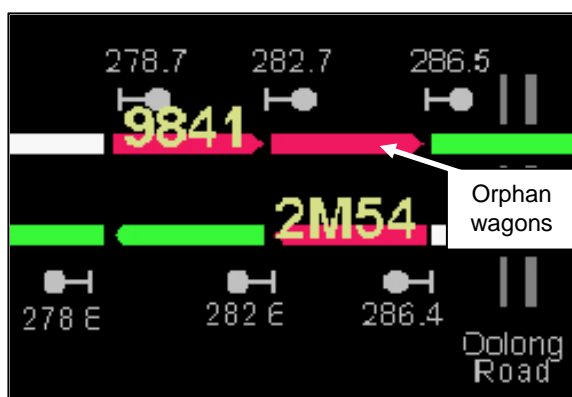
**Figure 4: Phoenix extract at 2142:58**

At 2133:39, train 2M54 on the Up Main line, stopped adjacent to the orphan wagons and secured them using the mechanical hand brakes. The crew also placed audible warning devices on the track, protecting them. At 2142:58 (Figure 4), the crew identified the orphan wagons to the network controller and noted that the end of train marker light was not illuminated.
