Aviation External Investigation – AE-2010-098

Final

**External Assistance to Recreational Aviation Australia –
Fuel Management System Data Recovery
19-4024 Supermarine Mk26, Spitfire Replica**

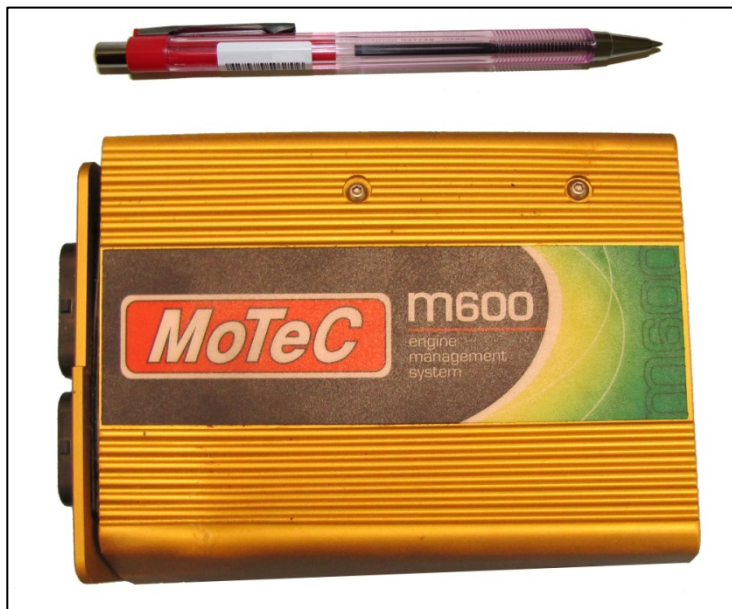
Figure 1: Motec M600 Engine Management System provided to the ATSB

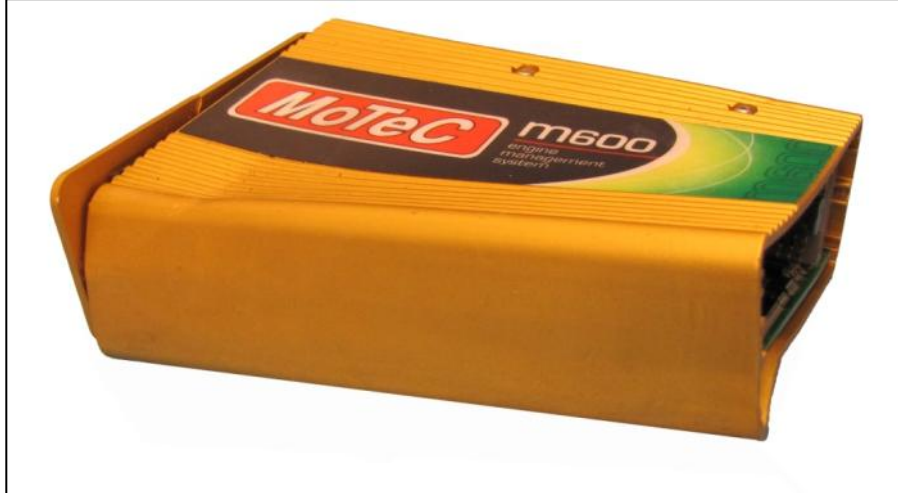
The aluminium case of the unit was visibly deformed (Figure 2). An internal examination revealed that the majority of the electronic components were in good condition: however, as a consequence of the forces exerted on the board, the main

Figure 2: Motec system with visible deformation

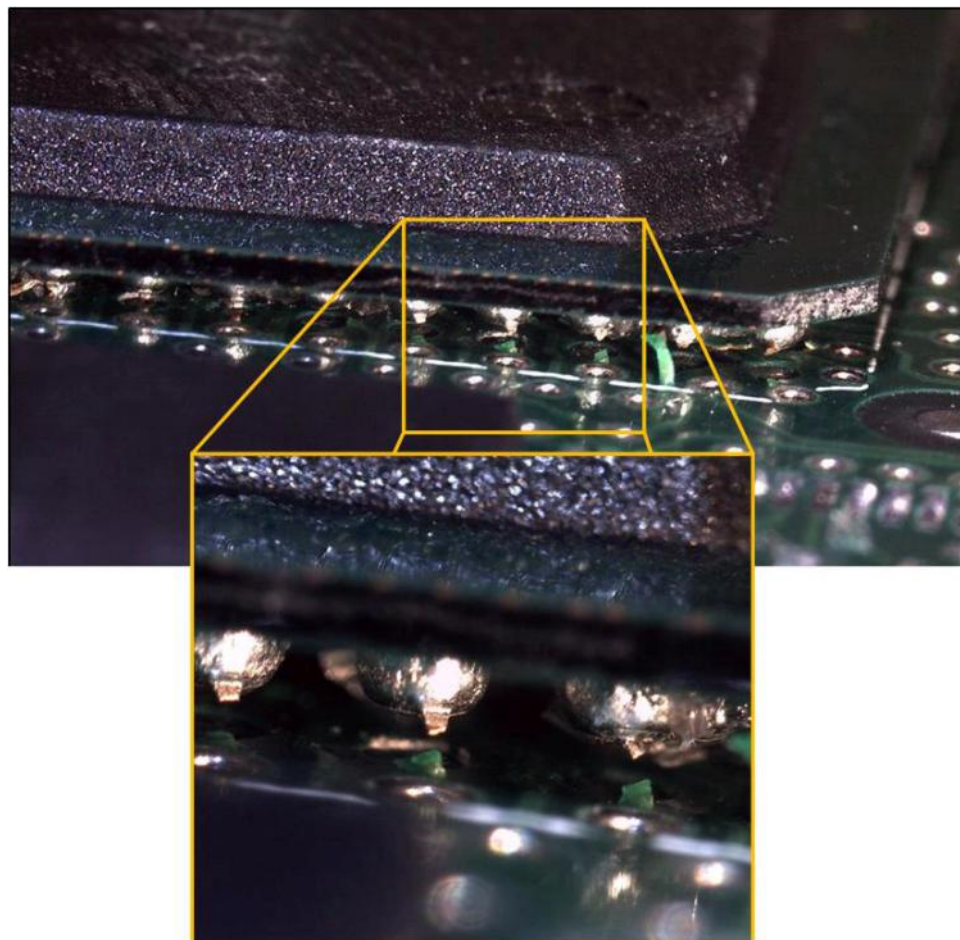
electronic control unit (ECU) device had lifted from the circuit board. Closer inspection revealed that the pads from the board were lifted with the ECU (Figure 3). Given this damage, the manufacturer advised that a normal download would not be possible.

Figure 3: Image of the lifted ECU and zoom of damage to the pads and circuit board

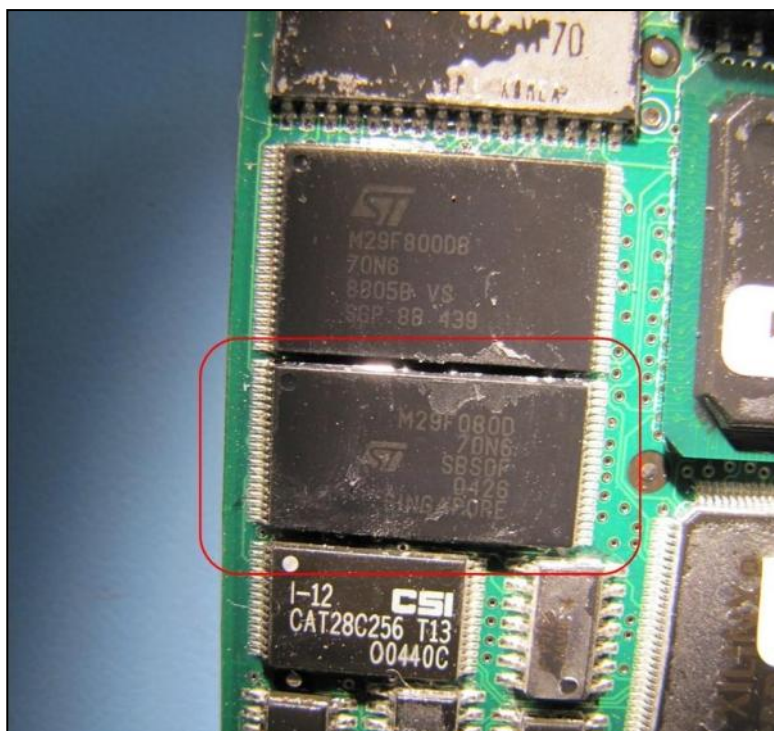
The manufacturer advised that the logged data was stored in the flash memory device identified in Figure 4¹.

Figure 4: Section of MoTeC M600 circuit board (memory device with logged data indicated by red rectangle)

A procedure was developed for the removal of the flash memory device from the damaged circuit board. The procedure involved the removal of the conformal board coating as per the manufacturer's instructions, then the removal of the flash memory from the circuit board using a hot-air rework station² in accordance with IPC³ standard 7711/21B-K⁴. Following this, the data was to be downloaded from the flash device via a universal flash memory reader⁵.

The procedure was tested successfully on an example circuit board provided by the manufacturer. The physical recovery was then performed on the accident board and the binary data was recovered successfully on 2 May 2011.

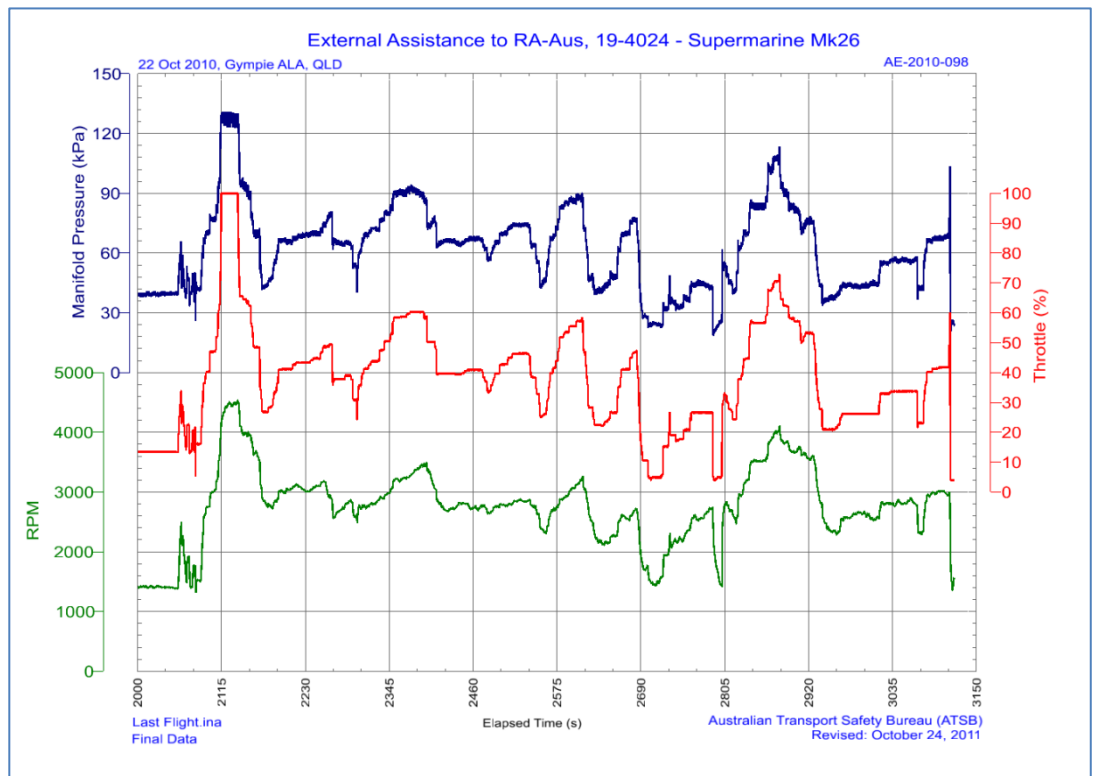
On the basis of the identified parameters, one takeoff was identified in the data (Figure 5), at approximately 2,115 seconds elapsed time. This was characterised by the recording of 100% throttle for 24 seconds.

The elapsed time between the takeoff and the end of the data was 1004 seconds (16 minutes and 44 seconds) and the end of the flight is the end of the recorded data recovered.

Figure 5: Flight identified in the data

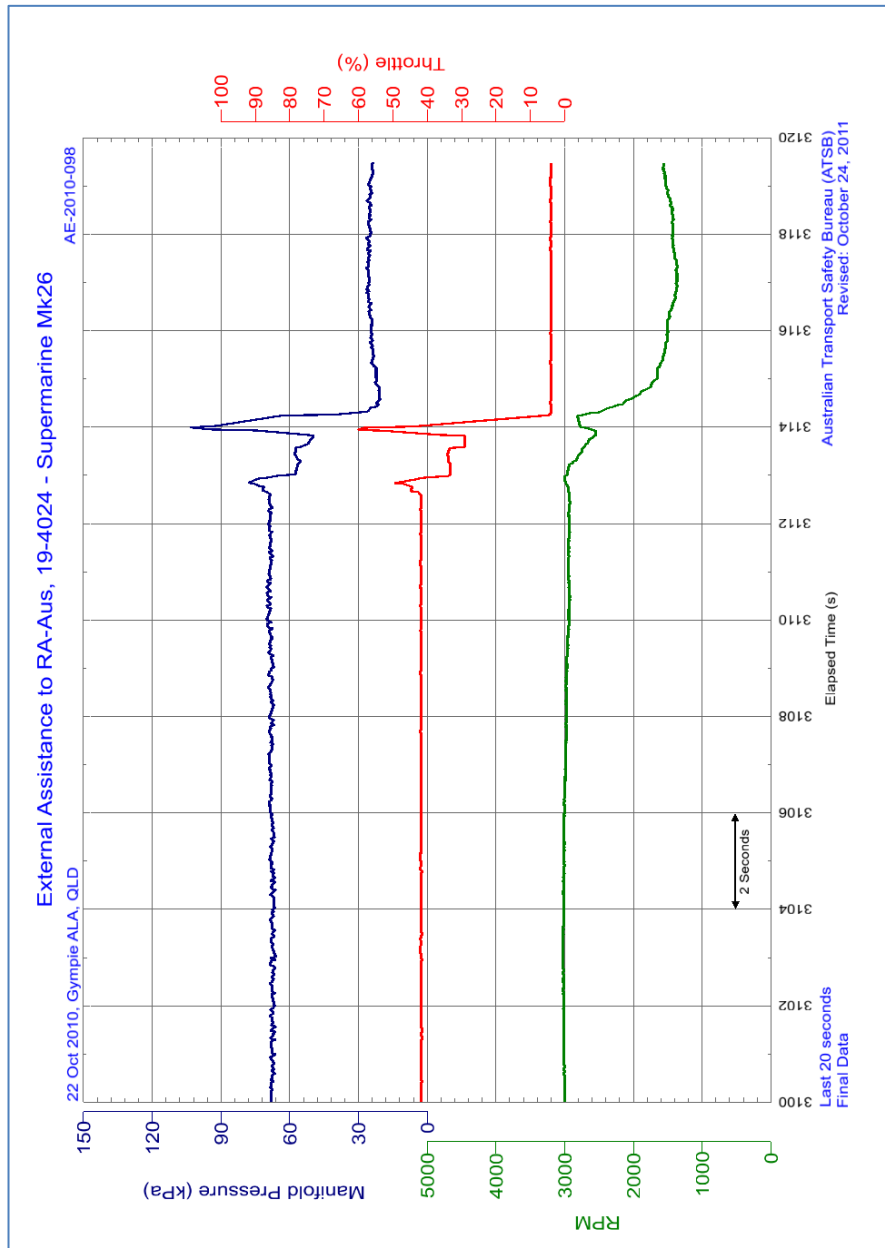
The flight ends with an abrupt reduction in throttle (Figure 6) with a corresponding reduction in RPM and Manifold pressure. Due to the lack of data from previous flights, it was not possible to determine if this was in line with normal operation for the given phase of flight.

Figure 6: Last 20 seconds of recorded data
