ATSB TRANSPORT SAFETY REPORT
Aviation Occurrence Investigation
AO-2008-084
Final

**In-flight breakup
PZL M18A Dromader, VH-IGT
58 km SW of Nyngan, NSW
29 December 2008**

The investigation found that the outboard 1.8 m of the right wing separated from the aircraft resulting in a loss of control and subsequent impact with the terrain. The separation of the right wing section could not be conclusively attributed to any particular factor.

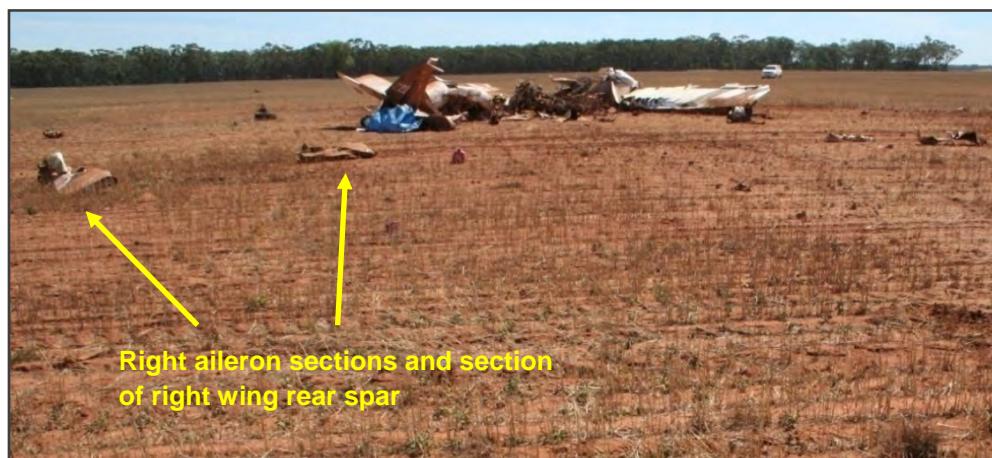
Figure 21: Location of right aileron pieces and section of right rear spar

The right aileron had broken into two sections and was connected to a section of the rear spar. Those items were located near, but beyond the main wreckage (Figures 21 and 22). The aileron and rear spar were covered in soil that was consistent with the wetted soil that had been sprayed out by the fuel and hopper contents upon impact. The overall deformation was consistent with upward bending with the fracture slightly inboard of the fracture of the right wing. The aileron sections and control system did not exhibit any of the damage characteristics associated with aeroelastic oscillation or control surface flutter, such as the liberation of mass balances, trim tab separation, control surface over-travel in both directions, or reverse bending or twisting of the immediate structure.

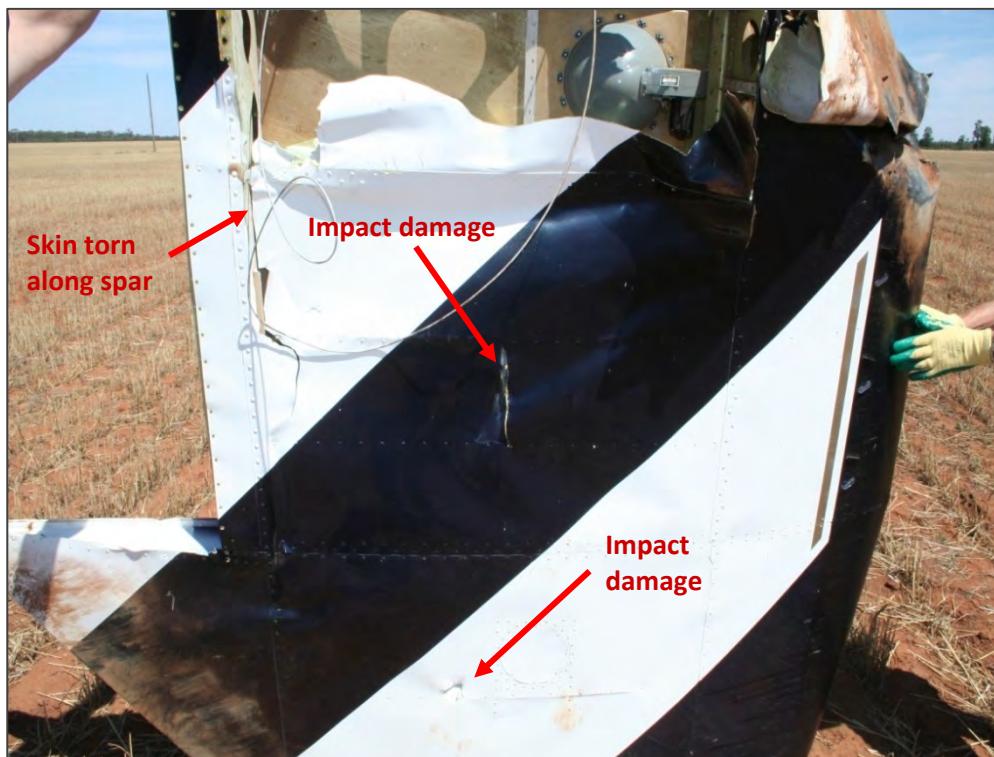
Figure 24: Top of outboard section of right wing

There was an impact mark and a cut in the upper skin surface that were consistent with having contacted the lightbar, windshield and/or windscreen wiper (Figure 24).

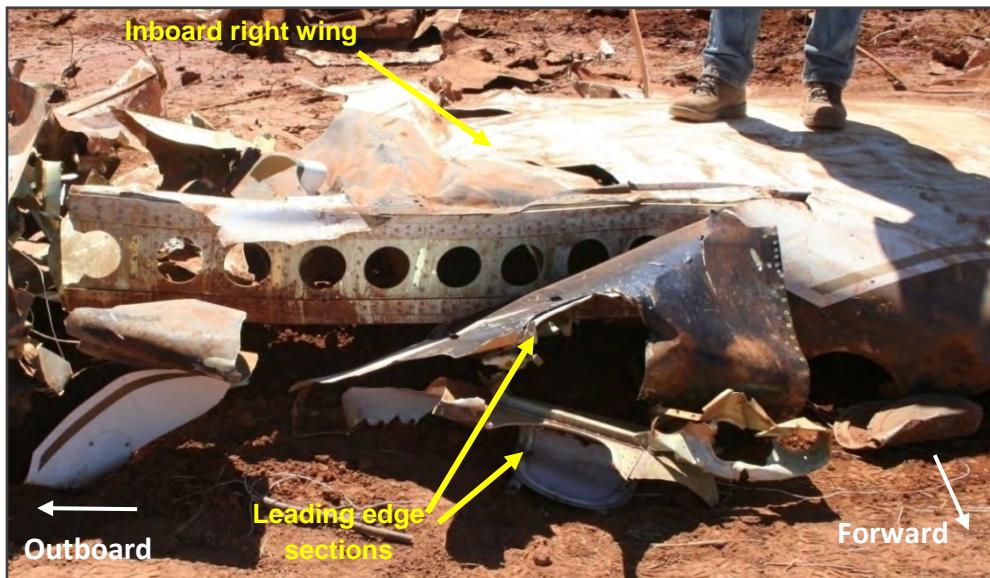
Figure 25: Leading edge sections

Another two sections of the right wing leading edge skin that had separated from the aircraft were located in the wreckage trail between the outboard section of the right wing and the main impact point and wreckage. Reassembly of the sections of right wing on-site indicated that those sections were the upper and lower portions of a small section located between the section on the outboard wing piece and the portion that remained with the inboard wing; hence, there were no missing sections of wing skin (Figure 25).

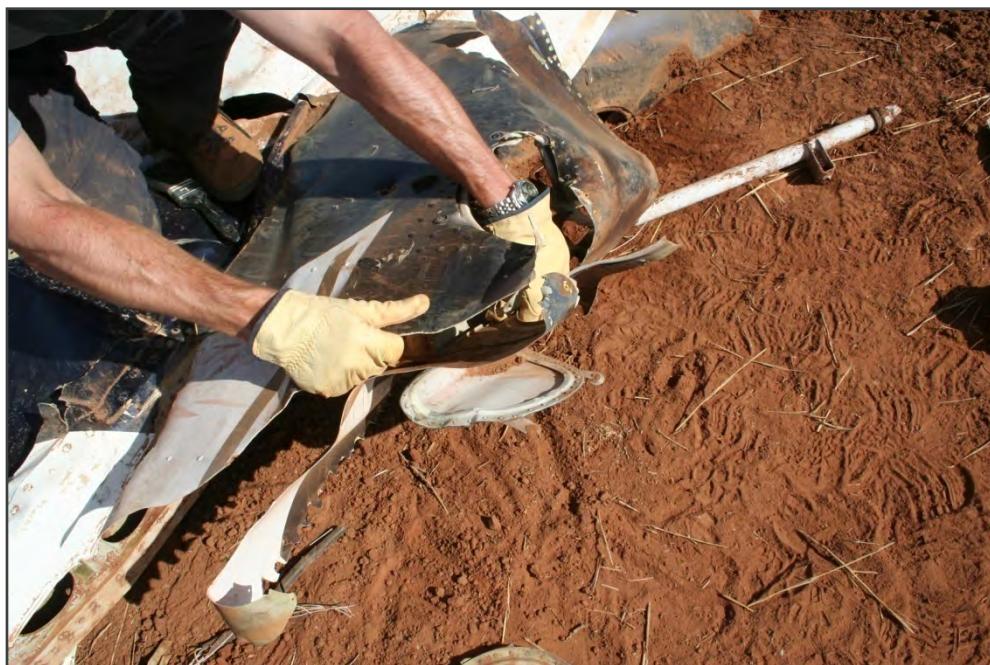
Figure 26: Leading edge deformation

The reassembled sections suggested that the outboard region had been 'squashed' downward before being torn into two pieces (Figure 26). Some of the vortex generators in that region had been folded over, consistent with a vertical force. The upper skin had been torn along the upper spar by a downward force and the lower skin had been pulled away from the spar, tearing between the rivets that secured it to the spar. There was no rearward deformation that would have been consistent with impacting the ground, or another object, at flying speed. Along with the location of the sections, this indicated that the section of leading edge separated with the outboard section of wing.

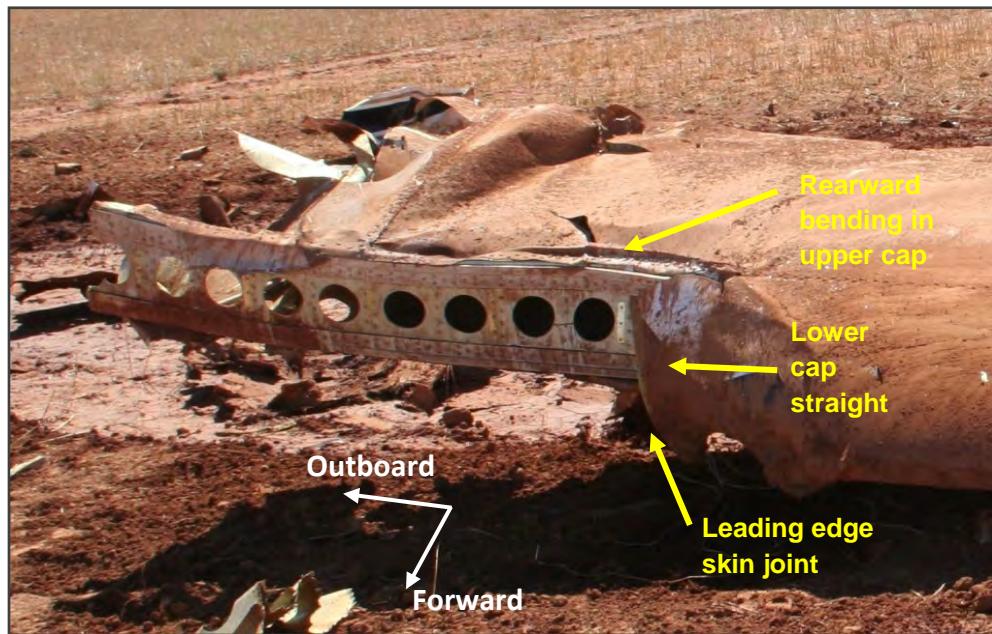
Figure 29: Right wing main spar (inboard section)

The inboard section of main spar was exposed where the leading edge had separated. The upper spar cap was permanently deformed such that the exposed length had an 'S' shape (Figure 28). This shape was formed by the upper cap bending rearwards at two points. The lower spar cap did not have the same rearwards bending at the inboard point, instead presenting a slight upward bending deformation (Figure 29).

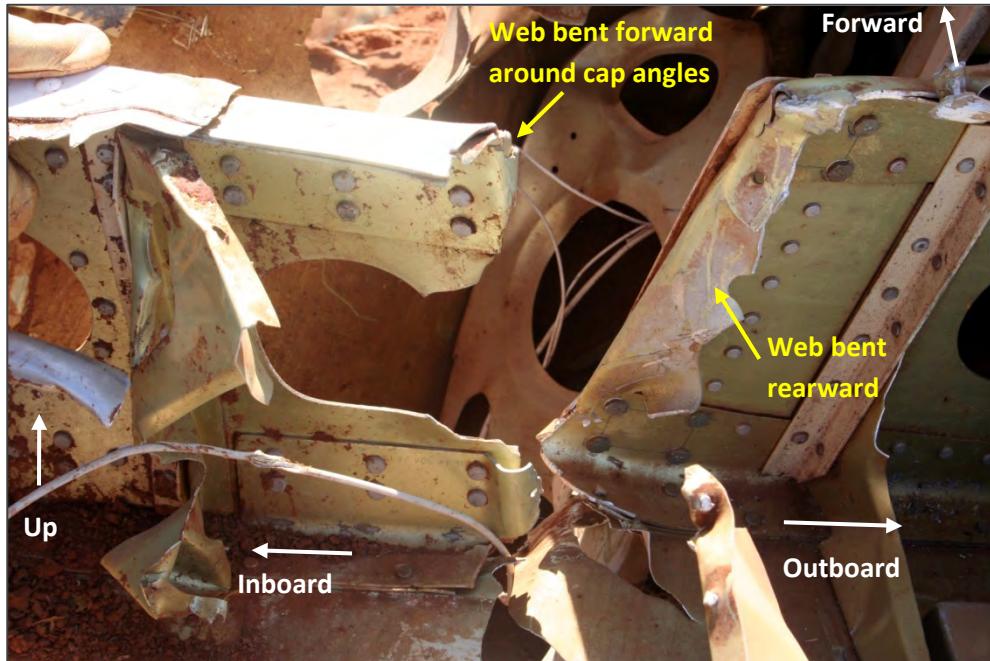
Figure 30: Right wing outboard and inboard main spar fracture (looking forward)

All fracture surfaces were examined on-site and appeared to have been freshly created during the accident sequence, with no evidence of pre-existing fatigue or obvious corrosion damage. The fractured sections of the right wing main spar had deformation that was consistent with the deformation on the outboard section (Figure 30). However, whereas the web of the outboard section was bent rearwards, the web of the inboard section was bent forward around the ends of the heavy spar cap angles. Score marks were visible on the inboard section of the main spar that were consistent with an arc transcribed about the fracture on the lower spar cap (Figure 31).

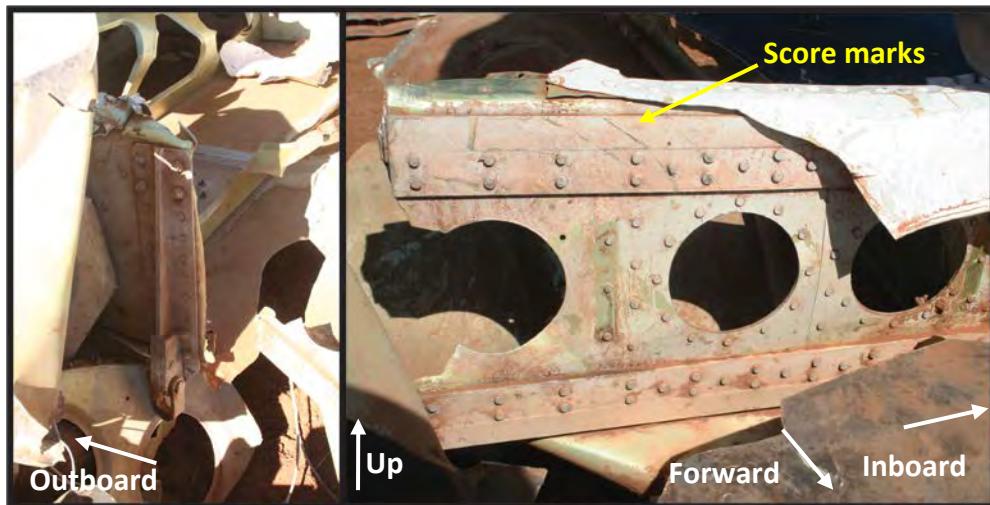
Figure 31: Right wing outboard and inboard main spar fracture (looking rearward)

As the upward displacement of the wingtip increased, and deformation at the buckle increased, the material began to tear. The tearing progressed down the web until it reached the lower cap (Figure 41 and 42), at which point the wingtip separated from the wing. The outboard section of main spar slipped forward of the inboard section and rotated about the lower spar cap. Sections of skin that were still attached to the outboard section scraped down the inboard section leaving the scoring identified in Figure 31.

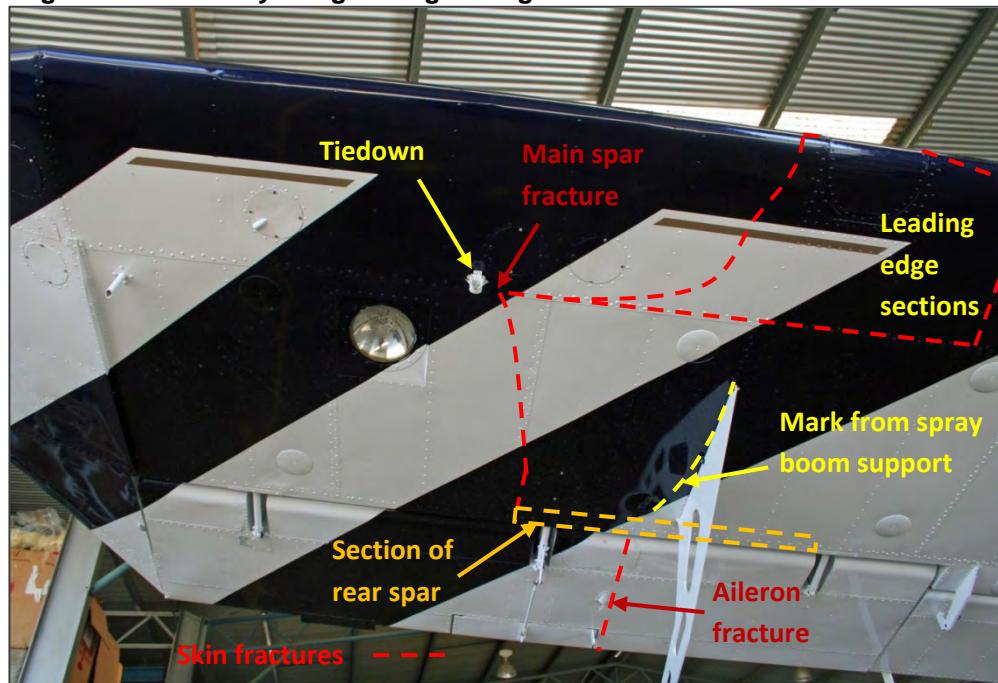
Figure 36: Summary of right wing damage

Figure 36 summarises the damage to the outboard section of the right wing, showing the approximate lines of damage in the lower side of the wing.

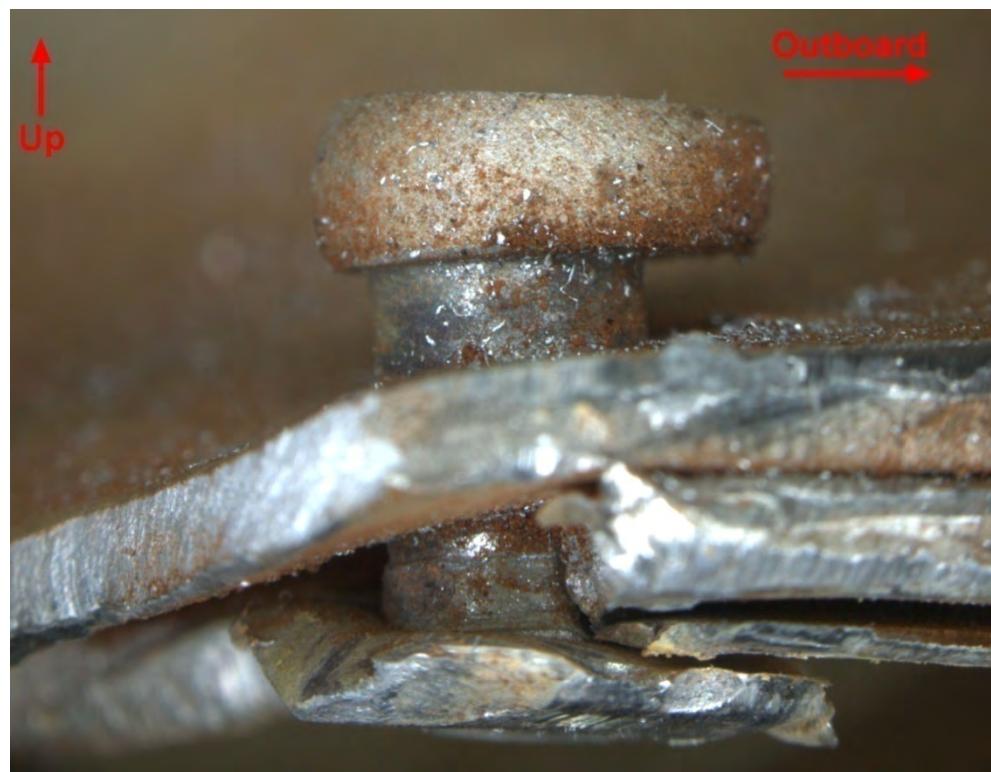
Figure B9: Elongated rivet from the main spar lower cap - adjacent to the fracture surface

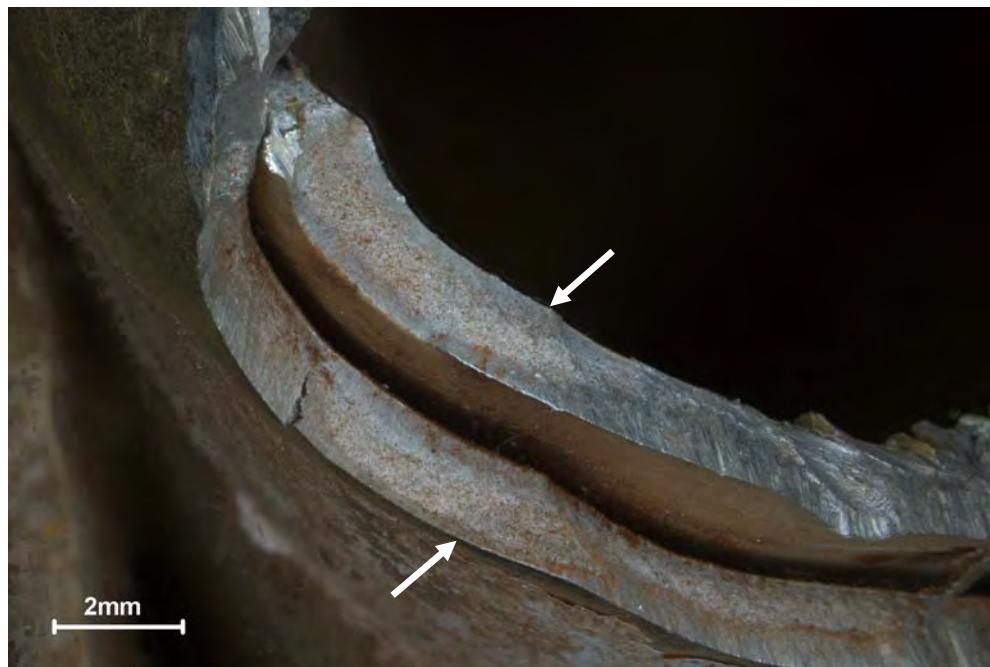
Figure B10: Detailed view of the fracture surface from the main spar lower cap region - ductile shear features present

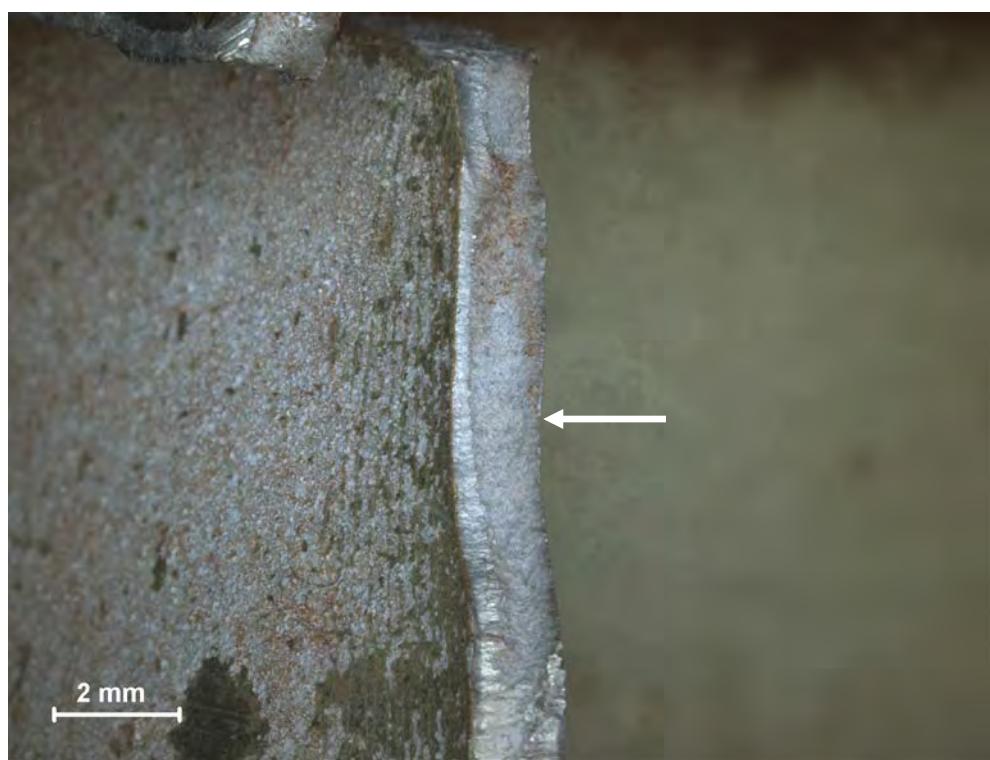
Figure B11: Detailed view of the fracture surface from the main spar web region - ductile shear features shown

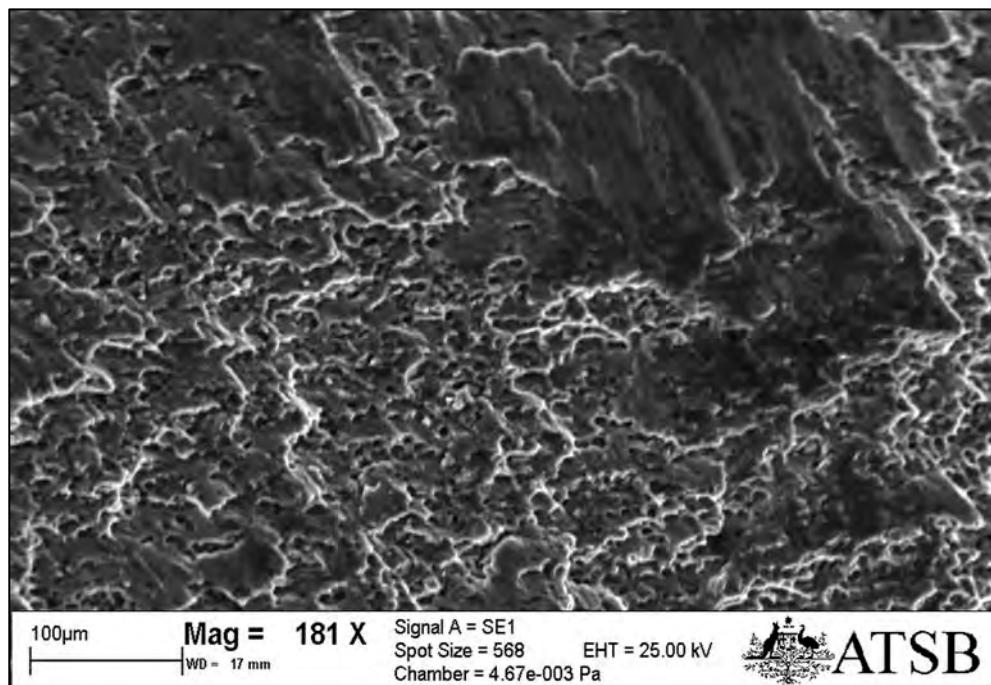
Figure B12: SEM micrograph showing ductile shear failure of wing spar material

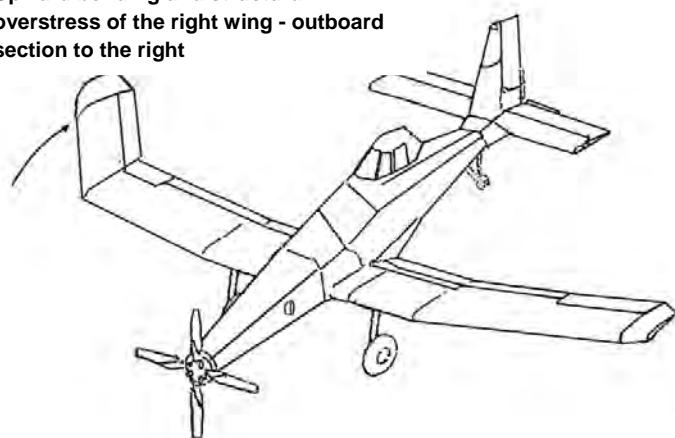
2. **Upward bending and structural overstress of the right wing - outboard section to the right**

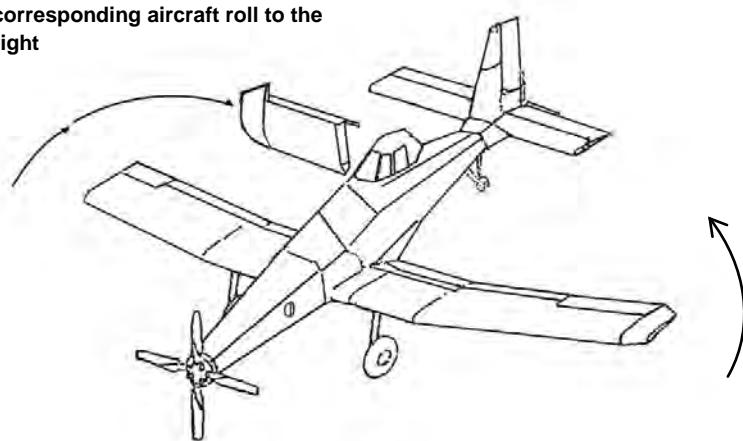
3. **Separated wing section impacts the cockpit canopy, with corresponding aircraft roll to the right**
