# Derailment of freight train 4DA2 near Cadney Park, South Australia 25 November 2010

At about 0618<sup>1</sup> on Thursday 25 November 2010, freight train (4DA2) operated by FreightLink Pty Ltd<sup>2</sup> derailed on the Central-Australia Railway line, near the 826<sup>3</sup> km mark, about 5 km south of Cadney Park (Figure 2) in South Australia.

The investigation determined that a severe weather event, very strong winds associated with thunderstorm activity, were of a sufficient magnitude to initiate the rollover and subsequent derailment of a group of lightly loaded double-stacked container wagons.

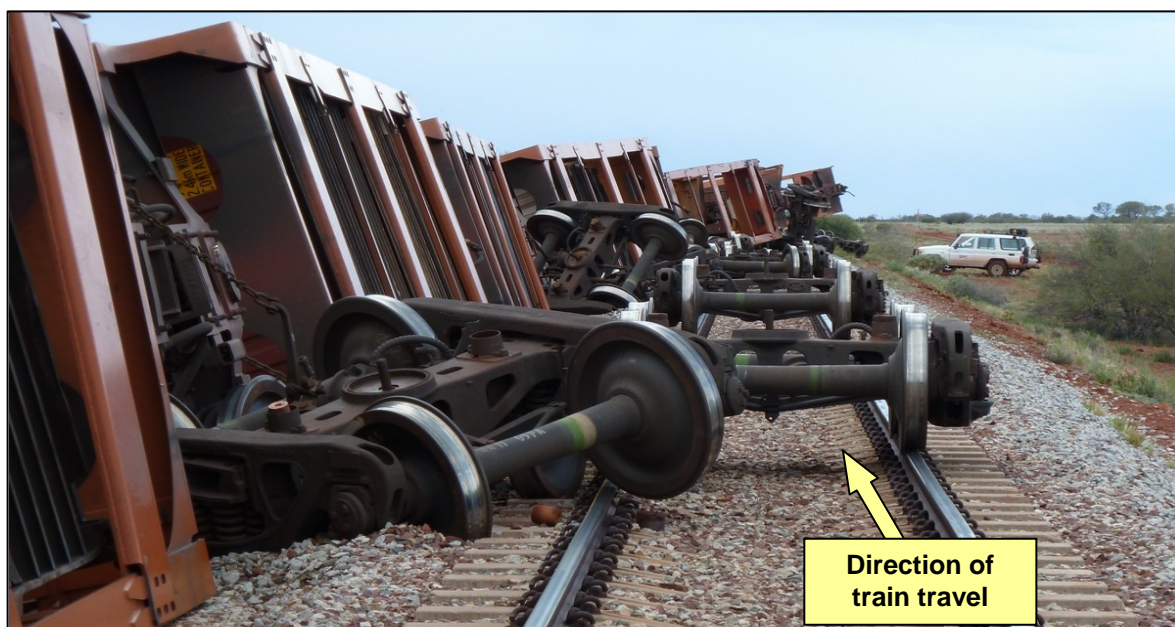
Figure 1: Derailment site looking towards Adelaide

There were no injuries as a result of the derailment but there was significant damage to

rolling-stock and about 300 m of track required replacement.

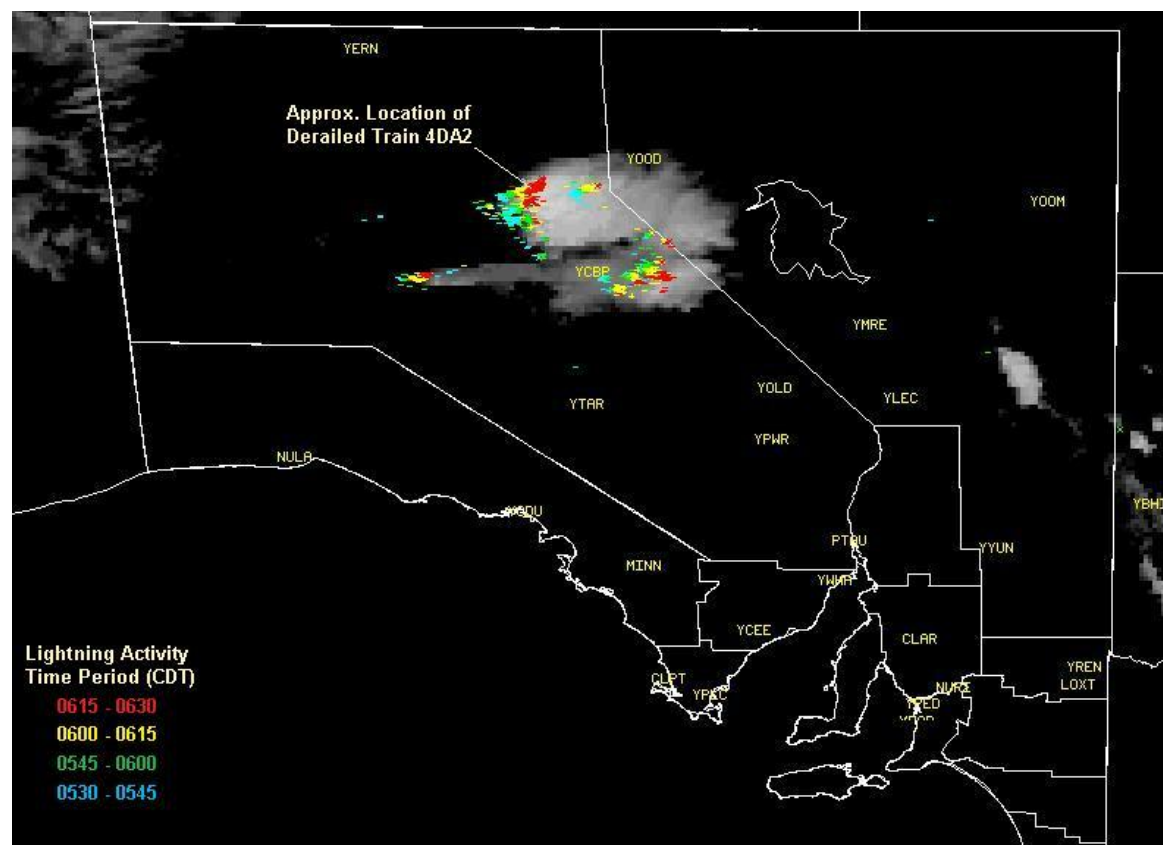
**Figure 3: Satellite image with overlay of lightning activity for 0530-0630**

The BoM was able to supply three satellite images covering hourly intervals (Figure 3) around the time of the derailment. All three images show evidence of significant lightning activity and in their response the BoM advised:

... there were thunderstorms in the area at the time of the derailment, moving from the west-south-west.

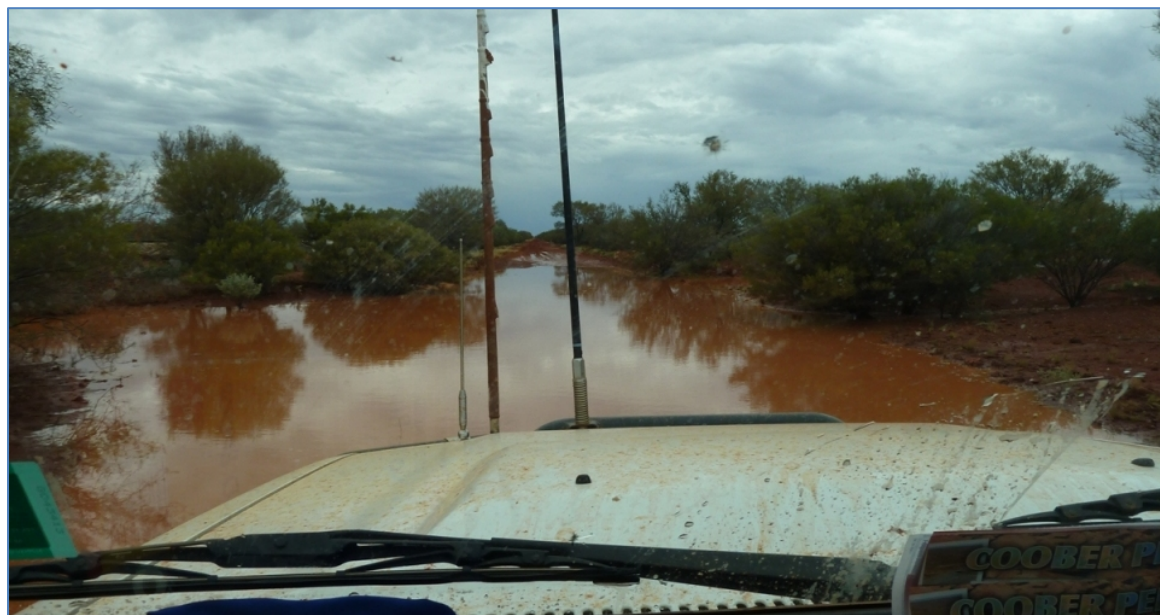
**Figure 4: Sections of the railway maintenance road with evidence of heavy flooding**

To access the derailment site it was necessary to use the railway maintenance road. In driving along the road it was evident that the area had experienced very heavy rain (consistent with the observations made by the train drivers) with many sections of the road still covered by water (Figure 4).

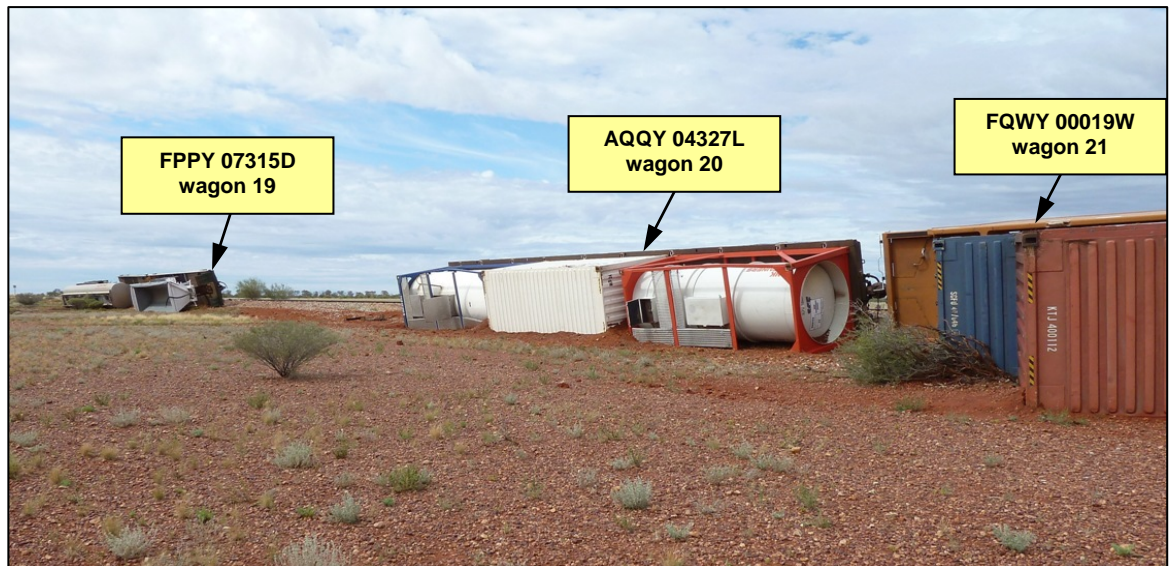
Figure 5: Derailed wagons FQWY 00019W, AQQY 04327L and FPPY 07315D

Examination of the derailment site focused on wagon FQWY 00019W, the 21st (Figure 5) in the consist, a double-stacked container wagon (this

unit was considered the likely initiator of the derailment) and the track in the immediate vicinity of this wagon to establish the likely point of derailment (POD).

FQWY 00019W was the first in the series of 13 double-stacked container wagons, all of which had rolled over. The two wagons ahead of FQWY 00019W (AQQY 04327L and FPPY 07315D see Figure 5) probably derailed as a consequence of being dragged over by FQWY 00019W.

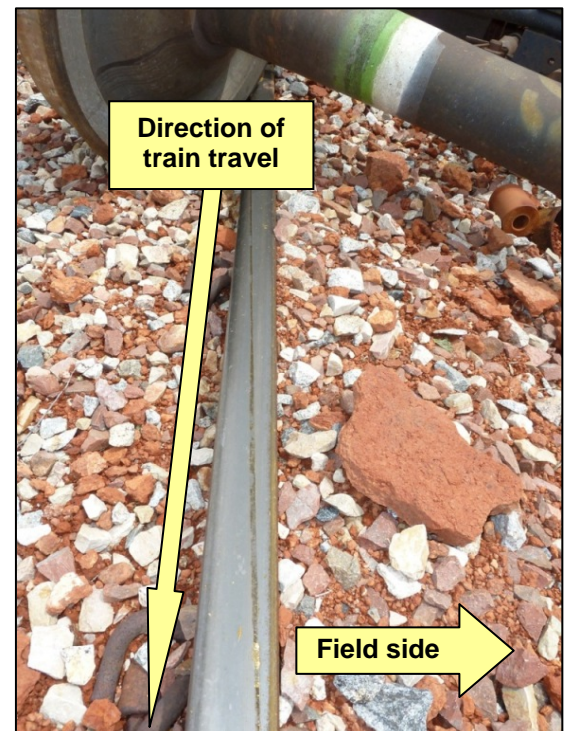
Figure 6: Wheel contact mark

- A single diagonal wheel contact mark<sup>8</sup>, about 2 m in length, (Figure 6) was found on the head of the eastern rail about 70 m before the resting place of derailed wagon FQWY 00019W. The mark extended from the inside to the outside of the rail head. This indicated that a wheel had ridden up and over the rail at this point. It then dropped off on the field side of the eastern rail. From this point on the ballast was gouged into the sub-grade as the wheels and bogie side frames of derailed wagons dragged along the track, breaking the sleeper ends in the process. About 10 m after the POD the derailed wagons also began to push the eastern rail in towards the western

rail causing gauge narrowing and escalating the derailment process.

Although the wheel flange marking identified in Figure 6 was characteristic of a flange climb derailment, train speed and handling were not considered to be factors that would have given rise to this type of derailment and were discounted accordingly.

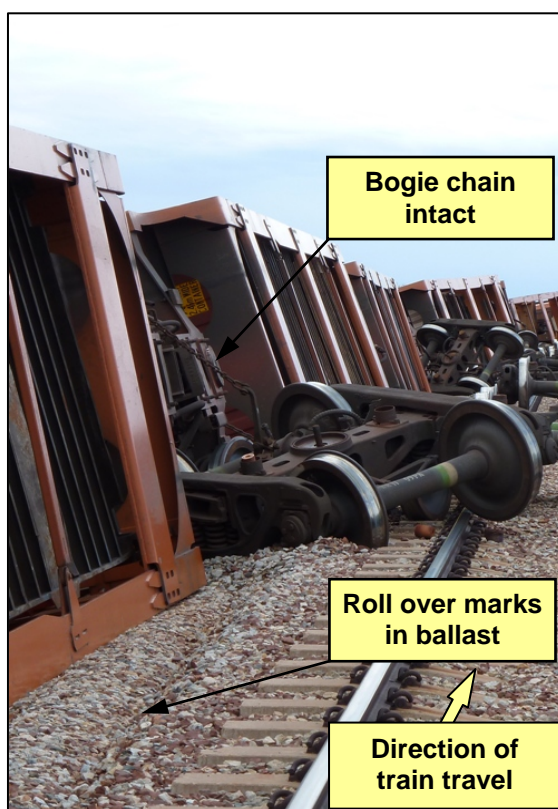
**Figure 7: Roll over marks in ballast**

- Wagons further behind this group of five vehicles appeared to have been travelling slowly or were almost stationary when they rolled over as evidenced by the lack of drag marks (Figure 7) in the ballast and adjacent ground surface where they came to rest. It was also noted that most of the bogies were adjacent to their respective body bolsters or had been dragged off the track but remained attached to the wagon with the bogie safety chain.

A further examination of the derailment site established that there were many locations where the ballast profile on the field side of the eastern rail was only disturbed by the side frame of well-wagons when they rolled over. In these locations (Figure 7) ballast was not dragged along the length of the track, therefore it was reasonable to conclude that wagons, particularly those located towards the rear of the train, had slowed down substantially and were almost stationary at the time they rolled over.

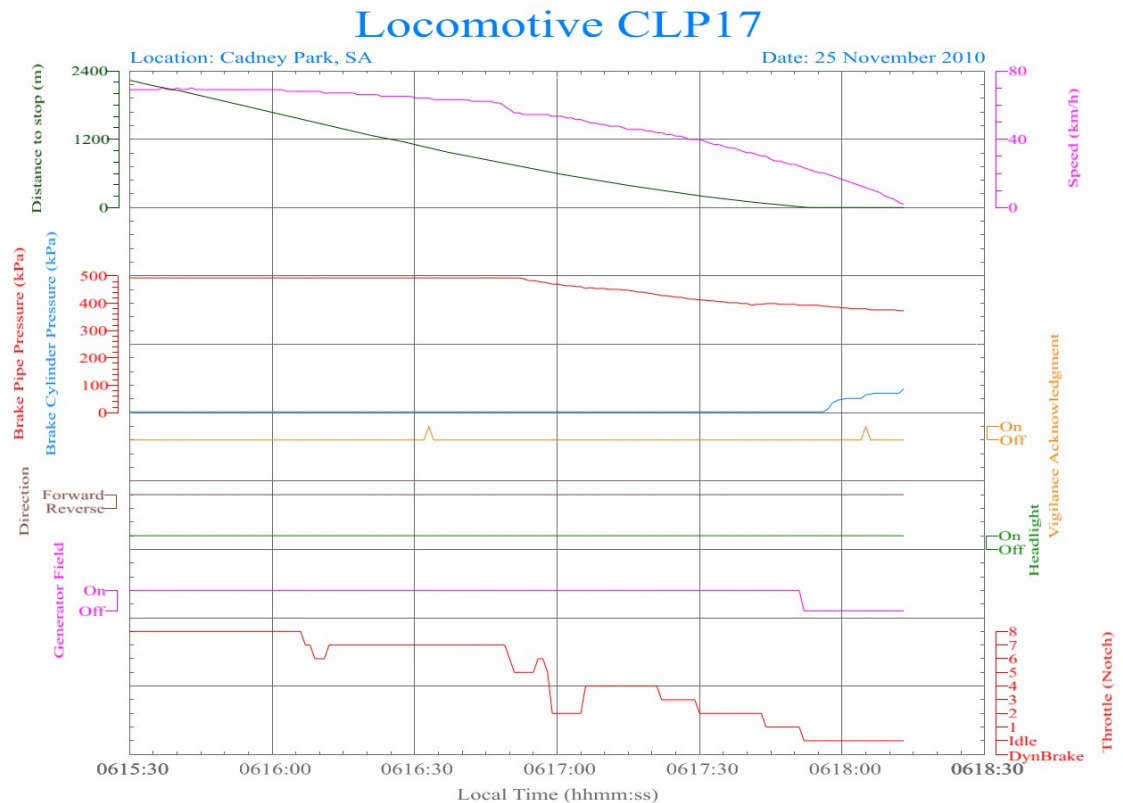
Figure 8: Extract of locomotive log CLP17

A reconstruction of events based on the data log of lead locomotive CLP17 (Figure 8) corroborated the statement given by the driver and co-driver of train 4DA2. Analysis of the data shows that about 10 km before the POD, train 4DA2 was travelling at a speed of about 90 km/h and therefore below the allowable track speed. The driver slowed the train to 60 km/h on approaching Cadney Park for the crossing loop. On clearing the crossing loop he commenced accelerating the train, placing it in notch eight, full throttle. The train reached a speed of about 70 km/h and then appeared to slow slightly. At 0616:20 the driver placed the train into notch seven, about 40 seconds later the train lost brake pipe pressure indicating that it had probably parted and may have become derailed. At that time the driver slowed the train bringing it to a stand about 800 m after the first loss of brake pipe pressure. Information extracted from the locomotive data logger also supports the train driver's post-derailment account of trying to keep the train stretched.

An examination of available evidence indicates that train 4DA2 was handled in an appropriate manner and that the actions of the driver did not contribute to the derailment. However, it was noted train drivers receive no formal training with respect to understanding severe weather events, the associated derailment risk and mitigation strategies.

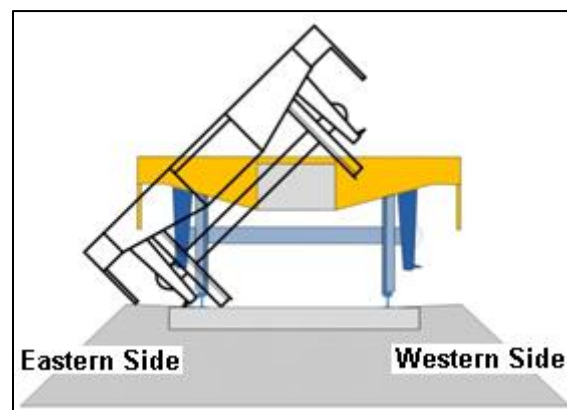
**Figure 9: Overlay of rolled FQWY wagon**

Wheel contact damage on the field side (eastern rail) of the sleepers was close to the POD. Damage beyond this point was more representative of scrape marks caused by a bogie side frame (Figure 7 and Figure 9) as it rotated into the ballast and then pushed the eastern rail in towards the western rail.

On examining the western rail (gauge side opposite the POD) there was no evidence of damage to resilient clips, steel resilient clip anchor housings and sleepers within the four foot. This tended to suggest that complete wheel unloading had occurred on the west facing side of wagon FQWY 00019W.

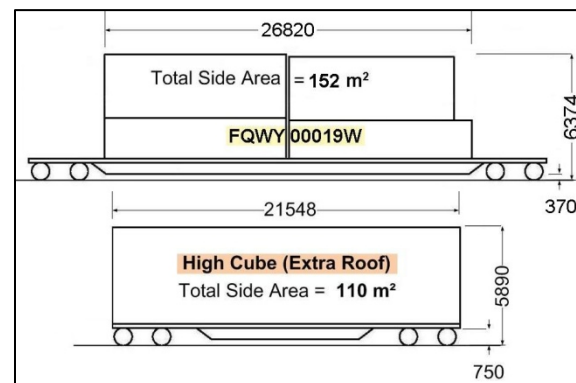
**Figure 10: Wagon profile and area comparison**

The investigation found that wagon FQWY 00019W was loaded with two containers (14.63 m x 3.00 m and 12.19 m x 2.89 m) located in the bottom position and two containers (both 12.19 m x 2.89 m) located in the top position. This configuration exposed a significant side area of 152.26 m² (Figure 10) to the gust front.

Calculations established that the wind force needed to cause 100% wheel unloading of wagon FQWY 00019W travelling at a speed of 70 km/h was about 120 km/h. As previously identified by the ATSB static and dynamic wind force calculations do not take into account the tilting of a wagon body on the bogie suspension, nor do they consider the transmission of forces from adjacent wagons. Both of these factors could increase the risk of wheel unloading at wind speeds lower than those calculated.

With wagon FQWY 00019W travelling at a speed of 70 km/h dynamic wind force calculations established that a wind speed of about 120 km/h would have caused 100% wheel unloading, triggering the derailment of train 4DA2. The effect of dynamic vehicle oscillation would have accentuated any overturning moment effectively lowering the required wind force needed to capsize a wagon.
