ATSB TRANSPORT SAFETY REPORT
Aviation Occurrence Investigation
AO-2010-059
Final

Fuel starvation
Mordialloc, Victoria
7 August 2010

VH-KKW, Cessna Aircraft Company 152

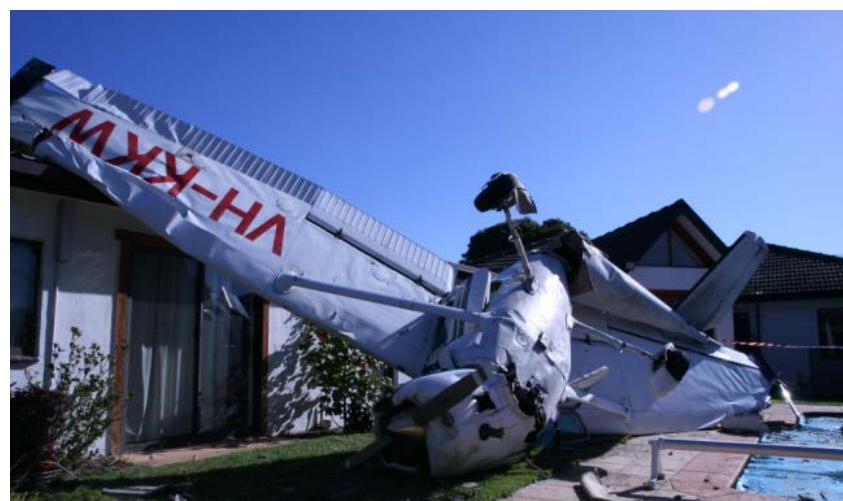
Figure 1: Aircraft wreckage

The pilot called the air traffic control tower advising there had been an engine failure and was issued a clearance to land on any runway ahead, '35 left or 04'. The pilot turned toward an adjacent field and maintained a controlled descent with the flaps retracted, until the nose landing gear and main landing gear contacted the roof of a house. That caused the aircraft to pitch down, before impacting the rear yard of the next house and coming to rest between the rear of that house and a swimming pool (Figure 1). The aircraft had been airborne for about 1.5 hours.

The aircraft was substantially damaged in the accident.

The aircraft contacted two houses before impacting the garden of the second house. The first house sustained significant damage to the roof along the ridge line. The second house sustained damage to a flat roofline at the rear of the house and impact damage to the garden and swimming pool handrail.

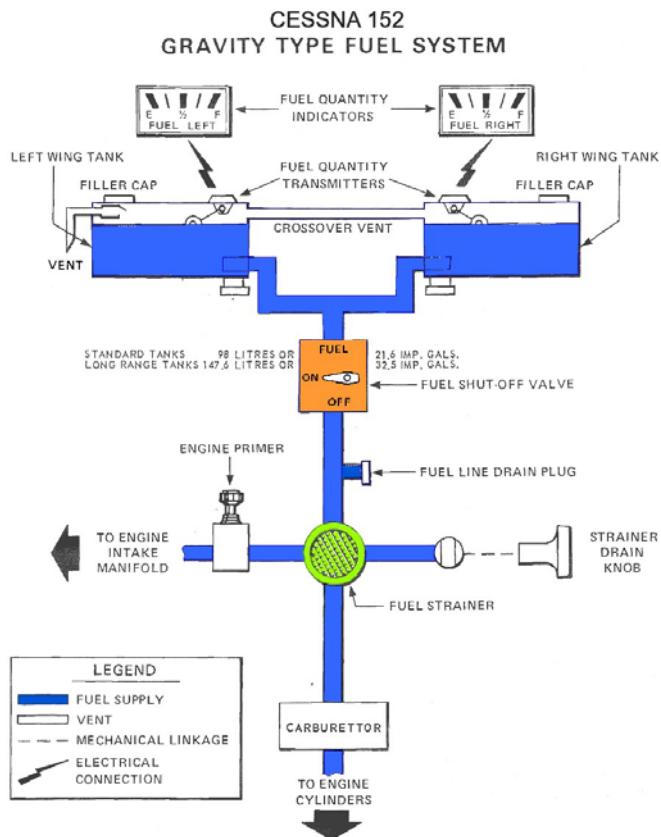
Figure 2: Aircraft fuel system

The aircraft fuel system was comprised of two long range (73.9 L) aluminium fuel tanks in the left and right wings. The system was gravity fed with fuel pick-up from the front and rear of each tank. Both tanks supplied fuel to a common line and fuel selector which had an 'ON/OFF' selection. Fuel then passed through a strainer/filter to the carburettor/engine (Figure 2).

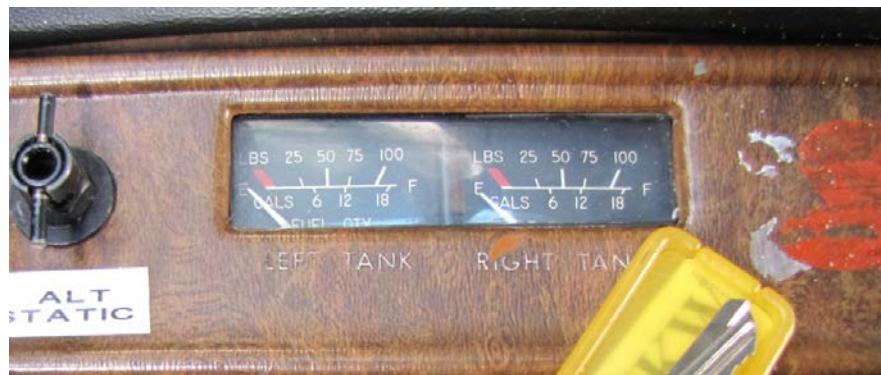
Figure 3: Aircraft fuel gauges

Fuel quantity was indicated by two gauges in the cockpit. Readings were obtained through fuel sender units (fuel quantity transmitters) located at the top of each tank that provided electrical signals to the gauges. The fuel gauges contained two scales: an upper scale in pounds and a lower scale in US gallons (Figure 3). A calibration card decal was installed on the instrument dashboard close to the fuel gauges. That card provided usable litre values for each of the gauge's gallon increments (Figure 4).

The right sender unit and gauge operated normally, providing an accurate fuel quantity indication in accordance with the current fuel calibration card. The left sender unit was found to contain high levels of corrosion. That unit did not operate smoothly and provided false (fluctuating) readings above its mid-range during testing. It did however, accurately indicate low and zero fuel quantities. While it is possible that corrosion occurred as a result of the sender unit being out of the fuel and in storage for a period of time before testing was carried out, the right sender unit was subjected to the same environmental conditions, but did not display similar corrosion.

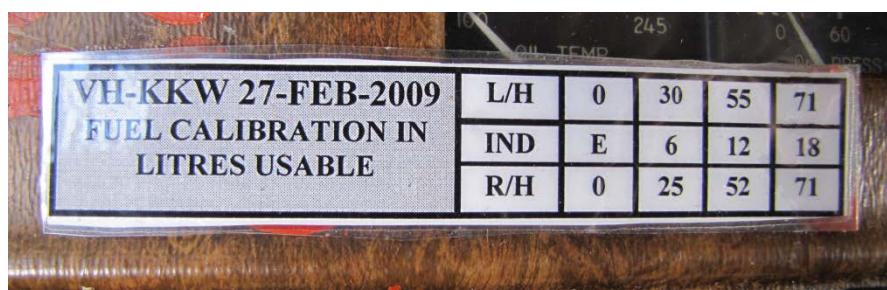
Figure 4: Fuel calibration card

The operator conducted an investigation into the incident. The aircraft fuel system was drained and the fuel dipstick and aircraft gauges checked for correct calibration. As a result, the operator identified discrepancies with the dipstick accuracy at low fuel level ranges. When the dipstick gave a reading of 45 L, the actual fuel on board was found to be 35 L. The fuel gauges and associated calibration card were also found to be inaccurate within their usable fuel range.

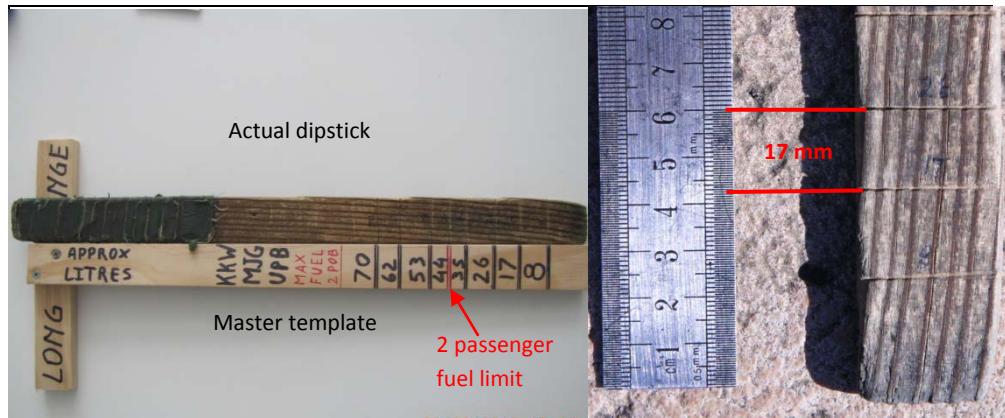
Figure 5: Aircraft fuel dipstick (and Master template)

A physical check of the fuel quantity was accomplished by placing an incrementally marked 'dipstick' (Figure 5) within each tank and reading the fuel level. The dipstick recorded fuel in litres, which was the unit of measurement used for all fuel calculations in accordance with the operator's procedures.

The operator held calibrated master dipstick templates (master) for aircraft within the fleet. From the master, individual dipsticks were manufactured and kept with each aircraft. The master for KKW was also the correct calibration for two other C152 aircraft in the fleet (VH-MJG and VH-UPB). KKW's dip stick's scale included 8, 17, 26, 35, 44, 53, 62 and 70 L indications. The graduations were not linear, with dimension between graduations ranging between 11 mm and 25 mm. The maximum recommended fuel per fuel tank for two passengers was identified (in red) on the master dip stick as 44 L.

The variation between the 17 and 26 L increments was only 17 mm. It is possible that had the pilot checked the right tank first, fuel moisture remnants from that high sided reading remained visible when the pilot observed the left (lower reading) tank, which obscured the left tank's true indication.
