ATSB TRANSPORT SAFETY REPORT  
Aviation Occurrence Investigation AO-2011-034  
Final

# Engine oil leaks VH-OQG and VH-OQC en route Singapore to London, United Kingdom 24 February and 3 November 2011

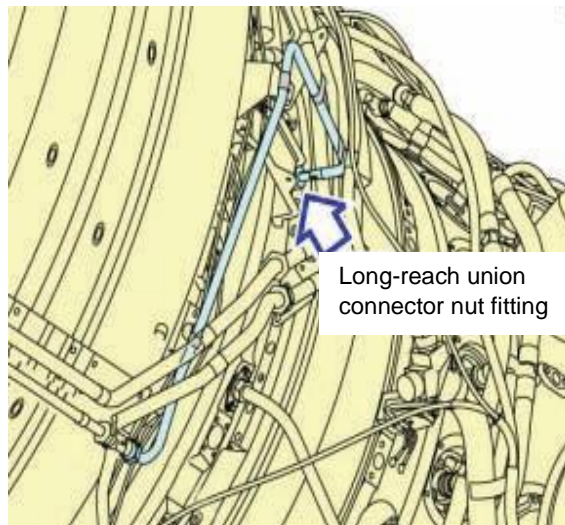
**Figure 1: External HP/IP oil feed pipe connection**

Maintenance personnel found that oil had leaked from the external oil feed pipe where it connected to the high-pressure/intermediate-pressure (HP/IP) turbine bearing support casing. The long-reach union nut connector was found to be 'finger tight'. Maintenance personnel replaced the oil feed pipe, tested engine operation and returned the aircraft to service.

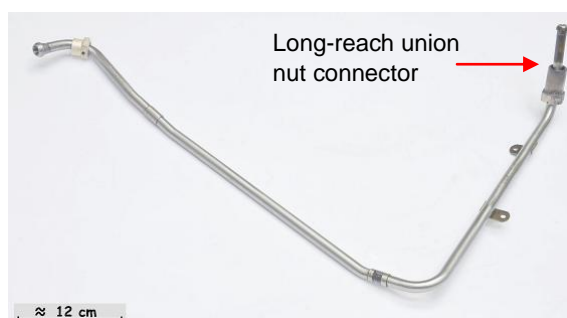
**Figure 2: External HP/IP oil feed pipe**

The external HP/IP oil feed pipe from OQG was released to the engine manufacturer for examination and testing (Figure 2). The long-reach union nut connector showed no evidence of thread degradation or material distortion. There

was, however, fine radial scoring 'gramophone' marking of the pipe's ferrule surface, along with surface pitting/bedding marks. The gramophone marks on the ferrule's surface finish did not conform to the engineering specification.

During the course of the investigation, a root cause analysis was carried out incorporating all of the reported oil leaks. During that process the below-specification high-pressure/intermediate-pressure (HP/IP) oil feed pipe ferrule finish was identified and the affected batches removed from service.

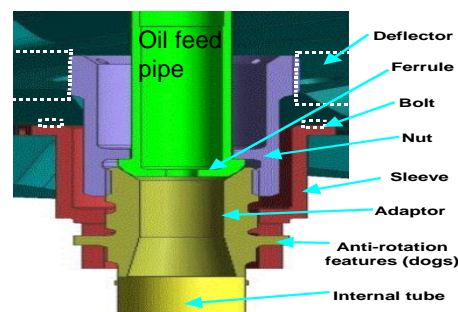
**Figure 3: Cross-section of the external HP/IP oil feed pipe connection to the engine**

In analysing the design of the pipe connection (Figure 3), the engine manufacturer found that the anti-rotation features (dogs) could allow the adaptor to move during the tightening of the nut. That could reduce the effective torque on the nut and consequent clamping force on the connection.

Oil leaked when the seal between the external HP/IP oil feed pipe ferrule and adaptor was compromised by the connector nut loosening and reducing the clamping force between the two parts. Loosening of the connector nut was initially associated with maintenance-related pipe disturbance and below-specification ferrule surface finish.

From ongoing analysis, the engine manufacturer identified higher-than-anticipated deflection loads on the external HP/IP oil feed pipe connection. The engine manufacturer indicated that was probably the common and significant factor in the loosening of the long-reach connector nut and the consequent oil leaks.

At the time of publishing this report, the engine manufacturer was in the process of modifying the way that the external HP/IP oil feed pipe was secured to adjacent pipes. In addition, the locking arrangement for the long-reach union nut connector/deflector assembly was being revised and oil tank quantity trends were being monitored for early identification of oil leaks.
