# Aviation Short Investigation Bulletin Fourth Quarter 2011

Issue 8

Aviation Short Investigations  
AB-2012-019  
Final

| Report No. | Publication date | ISBN |
|---|---|---|
| AB-2012-019 | 14 March 2012 | 978-1-74251-249-5 |

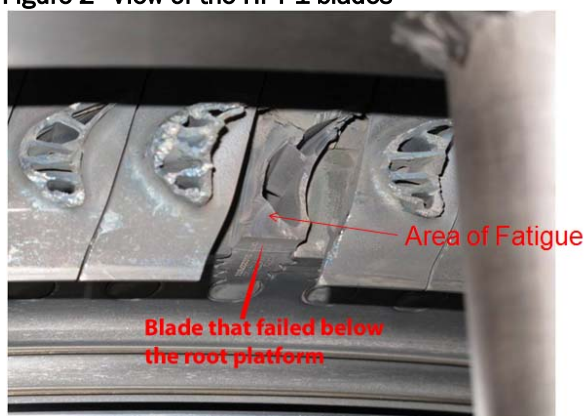
**Figure 2 View of the HPT 1 blades**

During the teardown examination, the LPT section proved difficult to remove due to case deformation. In the HPT module, four of the second stage blades had failed at  $\frac{1}{3}$  or  $\frac{1}{2}$  their height. All of that stage's blade shrouds were missing. Examination of the first stage of the HPT module found all of the blades had fractured. Further observation identified that only one HPT1 blade had fractured below its root platform (Figure 2). Microscopic examination revealed that blade's failure had initiated at the inner shank wall on the pressure side<sup>4</sup>.

The crack propagated via a fatigue mechanism through to the outer wall then spread laterally.

Failure initiation was considered to be driven by thermo-mechanical loads. The crack progressed due to a combination of these loads and the influence of corrosion/oxidation. The failure characteristics

were entirely consistent with those of previous HPT1 blades of this design standard.

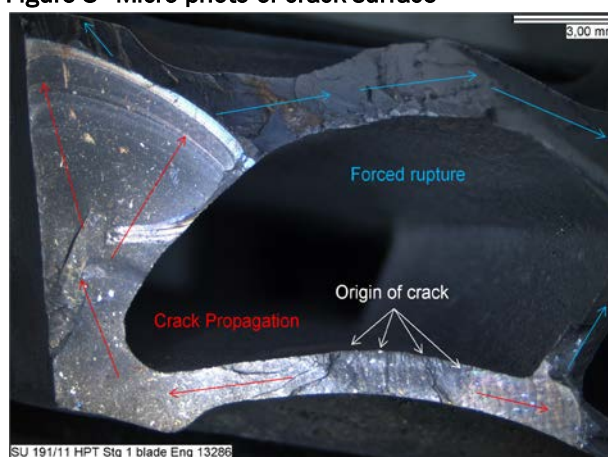
**Figure 3 Micro-photo of crack surface**

Final failure of the blade was through overload (Figure 3). The liberated blade created a domino effect on other blades and components, leading to an engine surge and damage extending into the engine compressor stages.

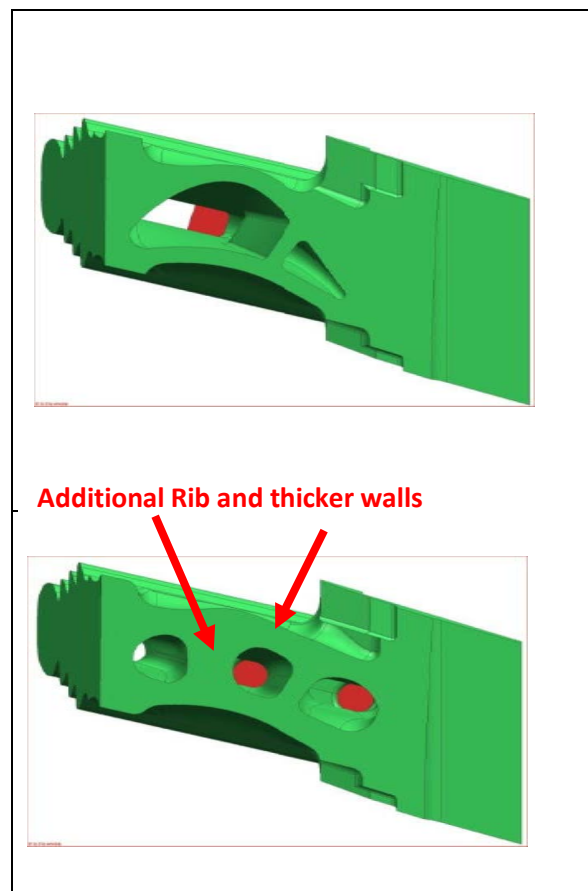
**Figure 4 Cross-section of LIP standard (top) and Mk II standard (bottom) blades**

A subsequent modification to the blades (designated 'Mk II') was introduced to lower the fatigue stresses within the blade, by adding a rib and increasing the shank wall thickness to further stiffen the cooling channel structure (Figure 4).

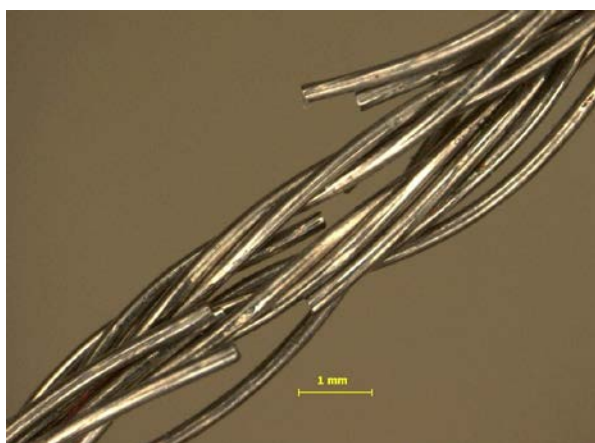
**Figure 2: Overstress and fatigue fractures**

The yaw damper and autopilot were re-engaged on the ground. The engineer stated that he then applied a light force to the rudder pedals and immediately heard a loud bang in the rear fuselage. Upon investigation, a rudder trim actuator control cable was found to have failed.

A metallurgical examination of the cable conducted by the Australian Transport Safety Bureau (ATSB) revealed that the cable had failed through a combination of fatigue and overstress (Figure 2). While there was some evidence of pre-existing wear or fraying (Figure 3), this was considered normal.

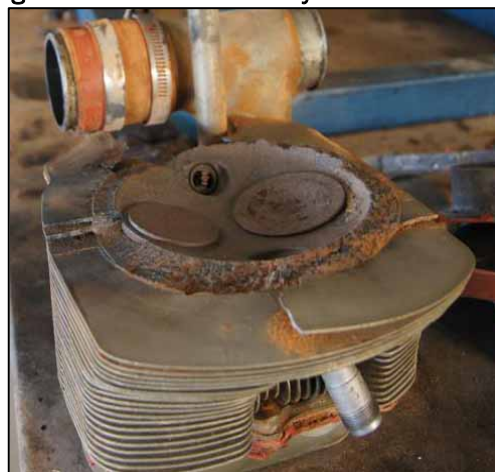
**Figure 3: Failed number-4 cylinder**

The cylinder head and the fuel injector supply line had fractured and separated. The aircraft was eventually recovered and the engine removed for further examination.

confirmed the failure of the number-4 cylinder. The cylinder body had cracked around the circumference in the area of the cylinder head (Figure 3).

A Service Difficulty Report (SDR) was submitted to the Civil Aviation Safety Authority (CASA), noting that the cylinders were manufactured by Engine Components Incorporated (ECI) and were 'non-genuine' parts<sup>4</sup>. Several manufacturers of non-genuine piston engine components, such as engine cylinders, exist within the industry. These components are typically approved by the US Federal Aviation Administration (FAA) Parts Manufacturer Approval process for use in aircraft engines and generally cost less than the original engine manufacturer components.

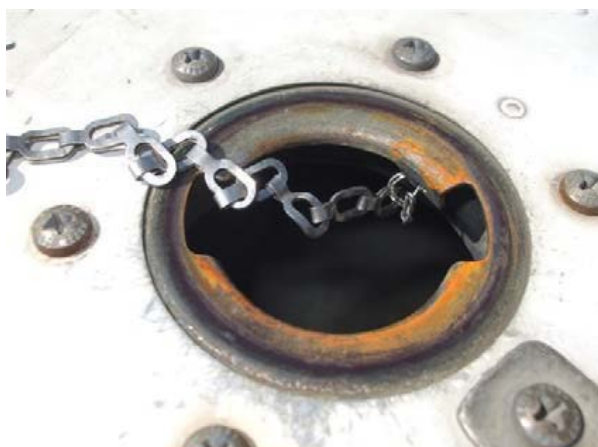
**Figure 1: Right fuel cap receptacle**

The right fuel tank receptacle lip showed signs of significant water contact in the form of surface rust (Figure 1). The receptacle was also found to be distorted, with the forward lip appearing to have been pushed down along its inner edge.

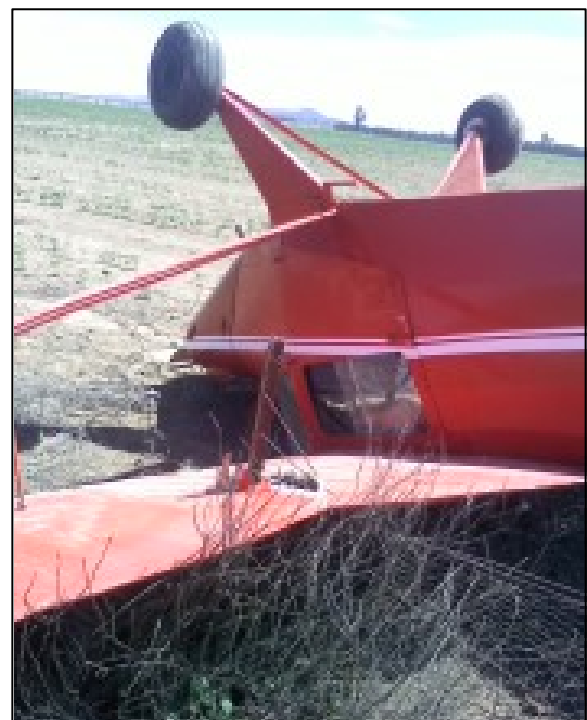
Figure 1: Wreckage close-up

The pilot was unable to regain control of the aircraft which subsequently struck a fence about 600 m down the runway on the left side of the runway and flipped over, coming to rest inverted. There were no injuries sustained, however, the aircraft incurred damage to the propeller, one wing strut and the wing surfaces (Figure 1).

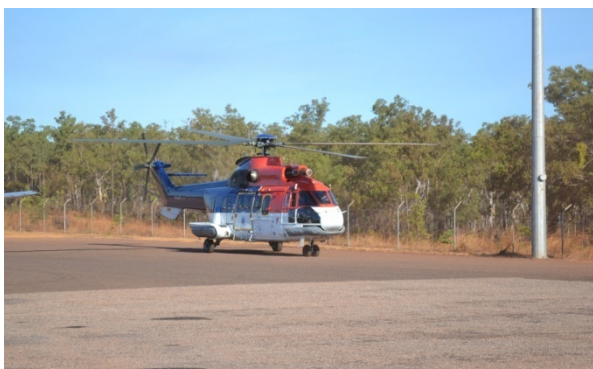
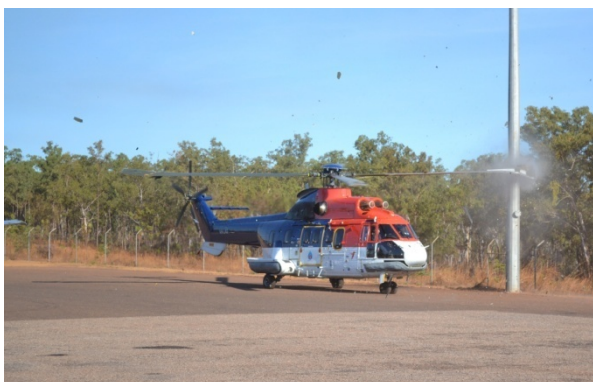
**Figures 4, 2, 3: Accident sequence** (Right wingtip of rear parked Metro appears in left of images)

Almost immediately there was a 'tick tick' sound then loud crunching sounds. The main rotor blades had struck the light pole (Figure 3) and started to break apart with debris flung about. The helicopter was rapidly propelled towards the light pole, toppling over onto its left side while vibrating vigorously and shedding blade debris in all directions.

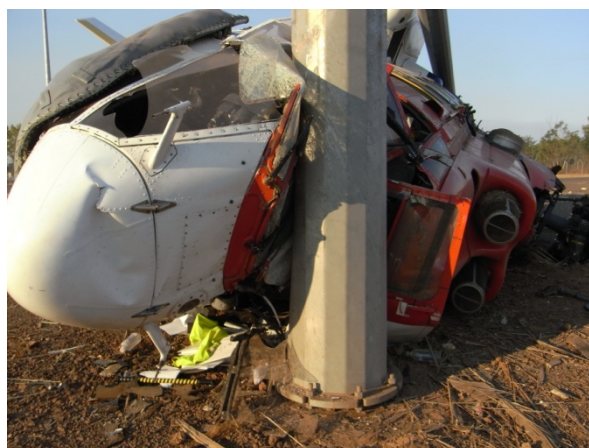
**Figure 4: Helicopter wreckage**

The priority for the PIC was to grab the overhead engine shutdown handles. But that was too difficult until the helicopter came to rest on its side (Figures 4 and 5). The PIC was then able to pull hard on the handle, successfully shutting down both engines.

The light pole bent where the main rotor blades had struck it. The upper section fell onto the helicopter with electrical wiring exposed, but unpowered. The left side of the cockpit was pushed inwards from contact with the light pole. The helicopter's tail section was also damaged.
