Marine Occurrence Investigation No. 289

MO-2011-009

# Steering gear breakdown on board the New Zealand registered tug *Tuahine* off Queensland 31 October 2011

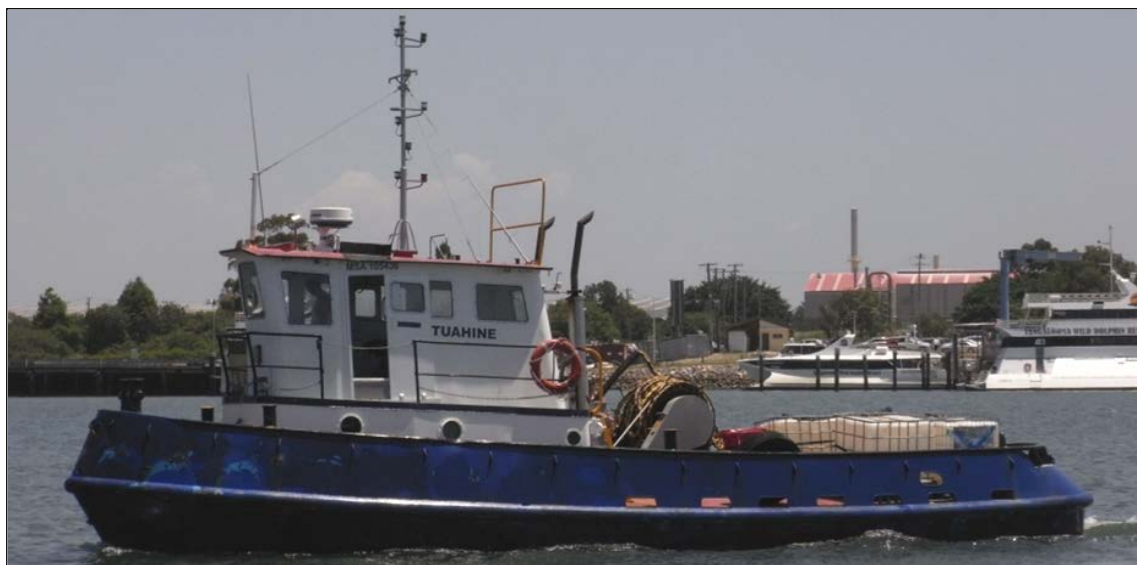
Figure 1: *Tuahine* in the Brisbane River

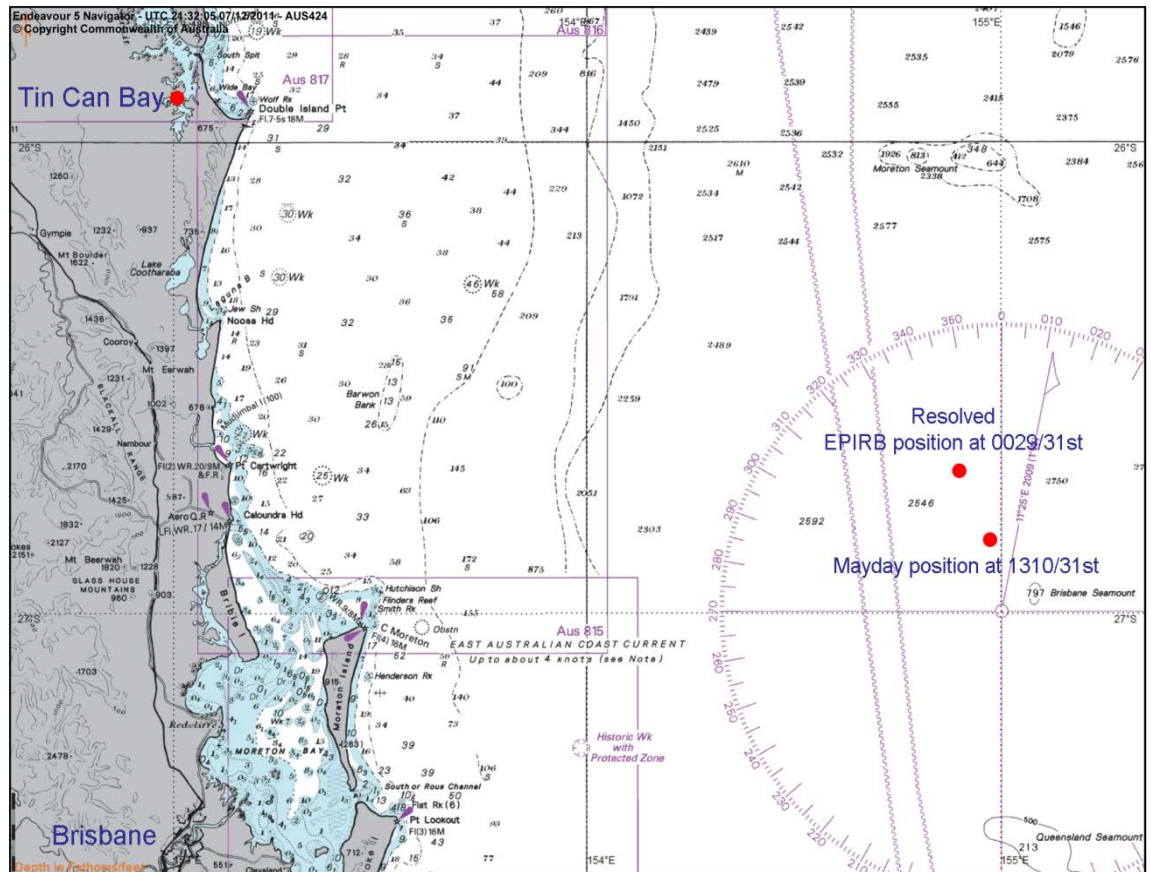
Figure 2: Navigational chart Aus 424 showing initial EPIRB location and mayday positions

The Australian Maritime Safety Authority's (AMSA) Rescue Coordination Centre (RCC) in Canberra received notification that the EPIRB had been activated. At 0029 on 31 October, the EPIRB position was resolved<sup>3</sup> to be 26° 41.88'S 154° 53.76'E (Figure 2), 79 miles<sup>4</sup> east-northeast of Cape Moreton.
