TRANSPORT SAFETY REPORT
Aviation Occurrence Investigation A0-2011-087
Final

Collision with terrain, VH-YOL

14 km north-west of Fitzroy Crossing

27 July 2011

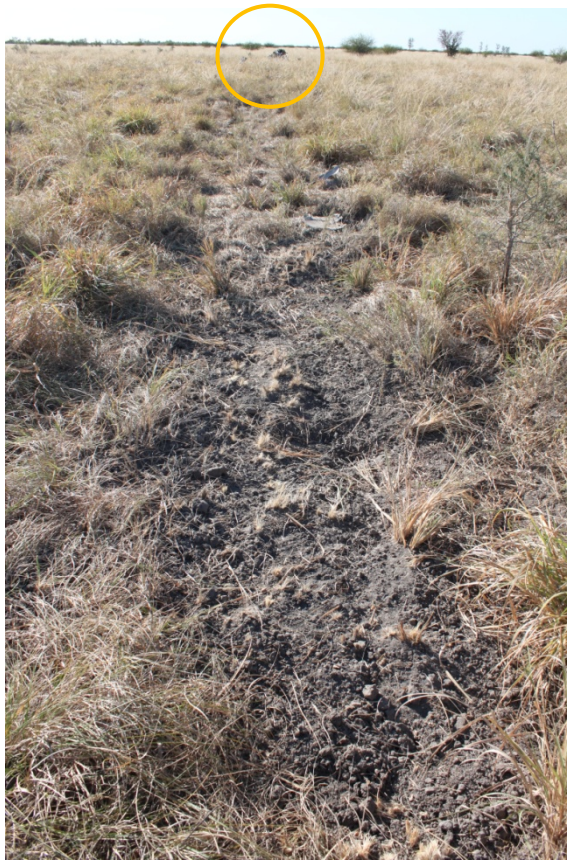
Overall, the wreckage debris field was about 80 m long from the first ground scrape and an average of 15 m wide. The wreckage trail was generally oriented on an easterly heading. An incision in the ground was located about 5 m into the trail and offset 2.5 m to the right, consistent with a main rotor blade strike. Based on the angle of that incision, the helicopter was banked about 25° to the right at that time.

Figure 1: Wreckage field overview (main wreckage circled)

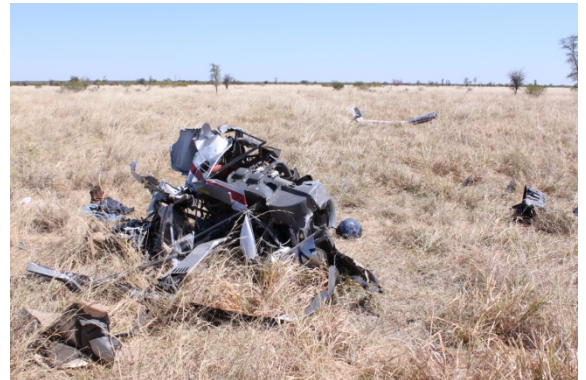
Figure 2: Main wreckage, looking back along the wreckage trail

On-site wreckage examination found no pre-existing defects or anomalies in the helicopter or its systems that would have contributed to the accident. The mechanical continuity of the engine was established and damage to the engine cooling fan assembly was consistent with engine rotation at impact.
