Australian Transport Safety Bureau

Aviation Occurrence Investigation A0-2010-066

# Uncontained engine failure and air turn-back Near San Francisco Airport, USA 30 August 2010

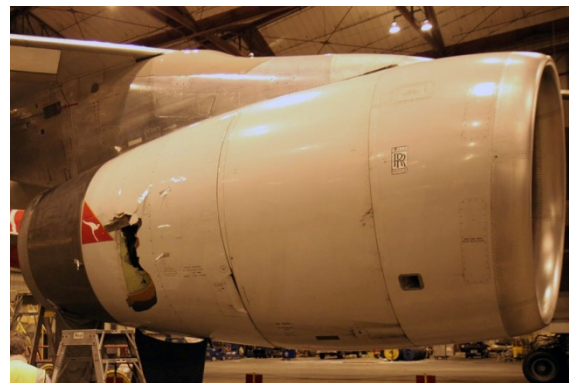
The number-4 engine had ruptured through the left and right sides of the turbine case and fairings, producing a large perforation in the right side of the engine nacelle (Figures 1 and 2) and

**Figure 1: Right side of number-4 engine**

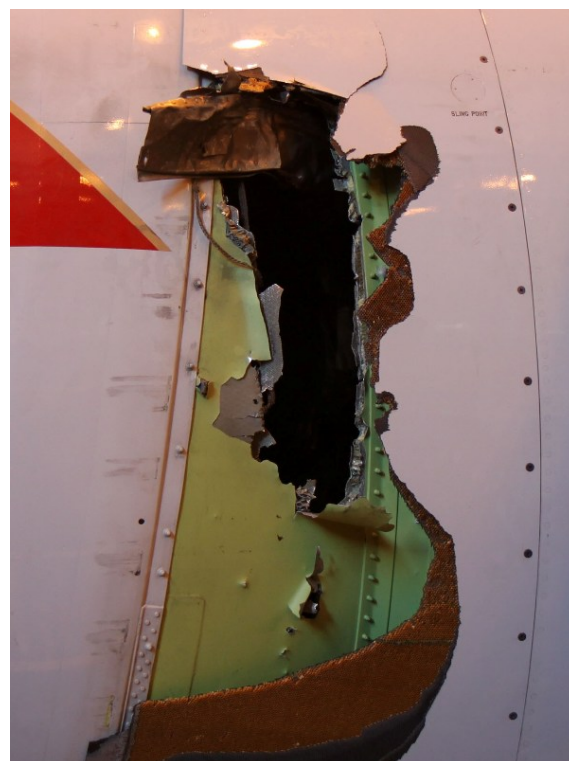
Debris ejected through the hole in the right side (outboard) of the engine had impacted the underside of the wing, producing superficial nicks and scratches to the wing skin. There was a puncture through the composite, leading-edge, variable-camber flaps and the associated torque tube was slightly bent. Operation of the flaps was not affected.

**Figure 2: Perforation in the engine nacelle, right side**

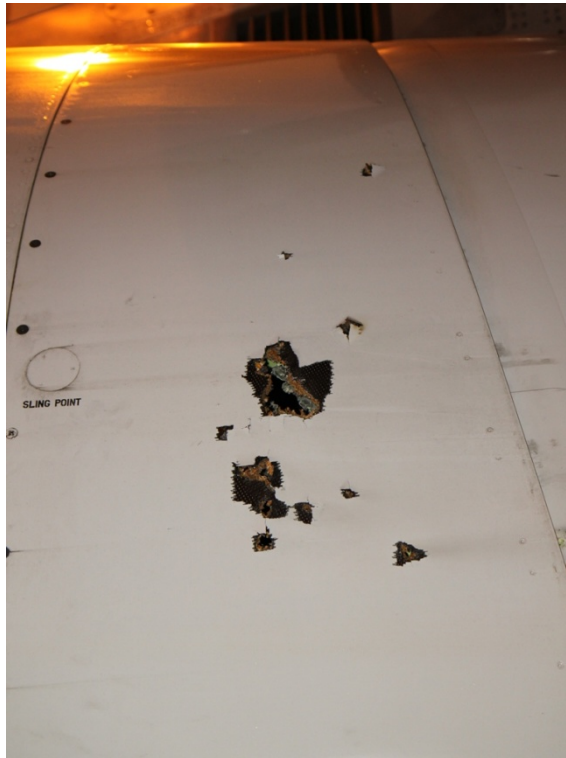
several smaller punctures through the left side (Figure 3).

**Figure 3: Punctures in nacelle, left side**

There was no airframe damage inboard of the number-4 engine. Despite the several small punctures in the left (inboard) side of the engine, the released debris did not have sufficient energy to contact the fuselage.

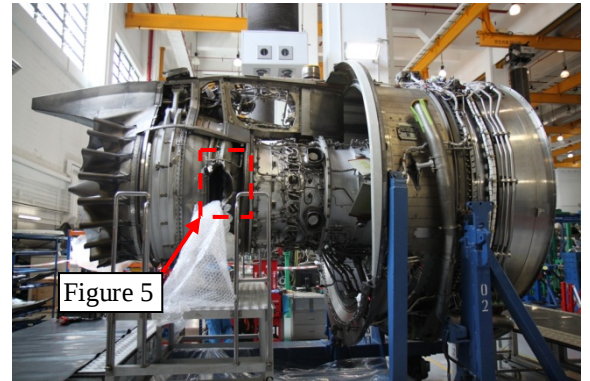
**Figure 4: Engine serial number: 13247**

Figure 4 presents the subject engine with the fairings removed. During the early stages of the examination, it was evident that the internal turbomachinery had been significantly disrupted, with extensive damage sustained by the intermediate-pressure (IP) and low-pressure (LP) turbine rotors

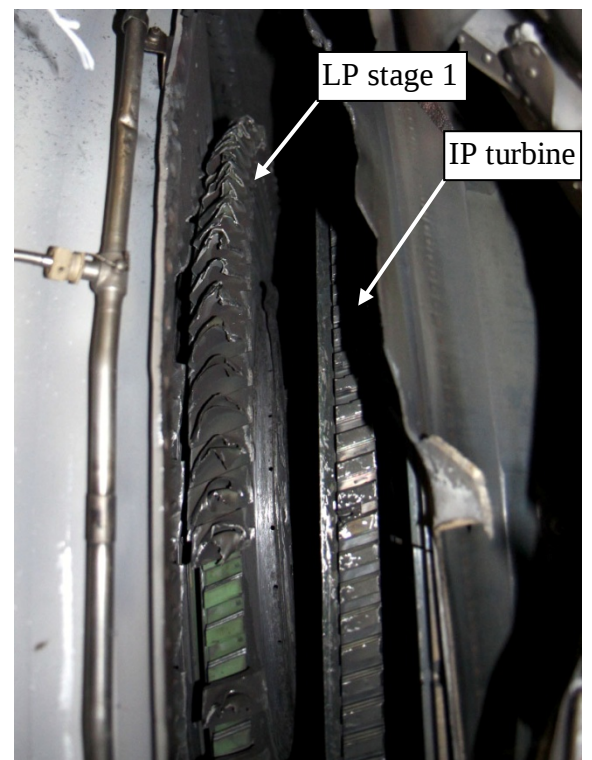
**Figure 5: IP and stage 1 LP turbine discs**

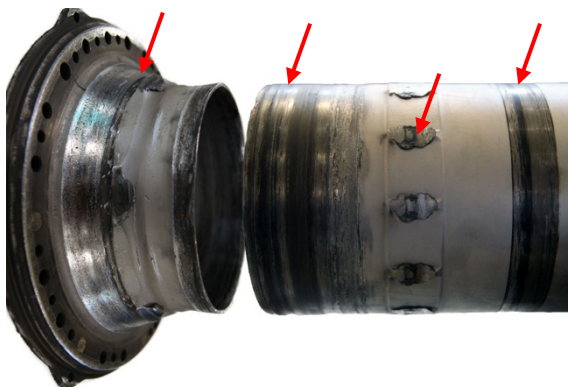
The IP turbine shaft was severed towards the aft end and there was evidence of heavy rotational wear on the inner and outer surfaces (Figure 8). The damage was consistent with the shaft having contacted adjacent components, including the LP turbine shaft (Figure 9).

**Figure 8: Composite image showing IP turbine shaft damage and separation**

- It was likely that vibratory stresses from the LP turbine blade loss resulted in the LP turbine support bearing collapse, allowing contact between the LP and IP turbine shafts.
- The IP turbine shaft severed as a result of contact between the IP and LP turbine shafts, which ultimately resulted in the uncontained failure event.

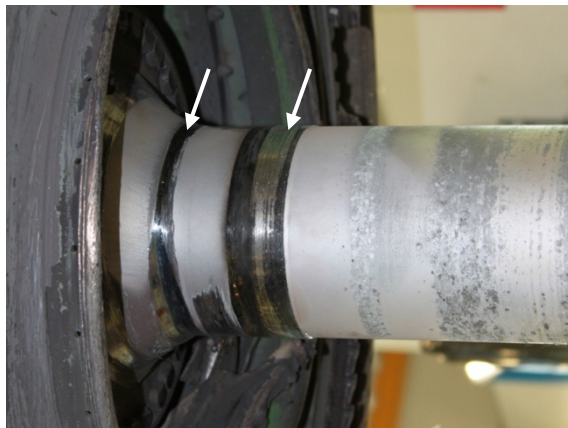
**Figure 9: LP turbine shaft showing evidence of contact with IP shaft**

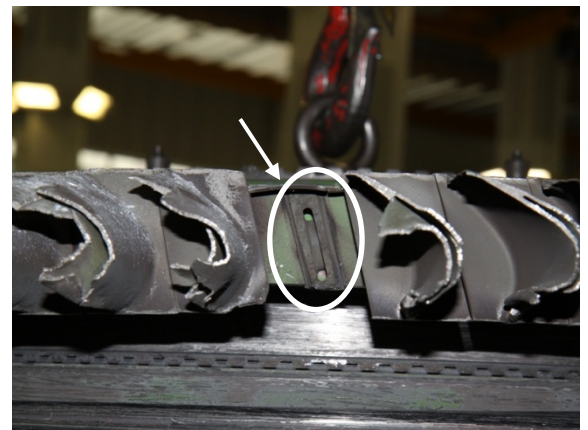
All of the IP turbine blades had separated from the disc. Apart from a single stage-2 LP turbine blade that had fractured through the blade root (Figure 10), all blades from the three LP turbine stages had either fractured through the airfoil section or separated entirely from the disc. The

**Figure 10: Stage-2 LP turbine disc showing fractured blade root**

The manufacturer is recommending that operators replace high service time stage-2 LP turbine blades.

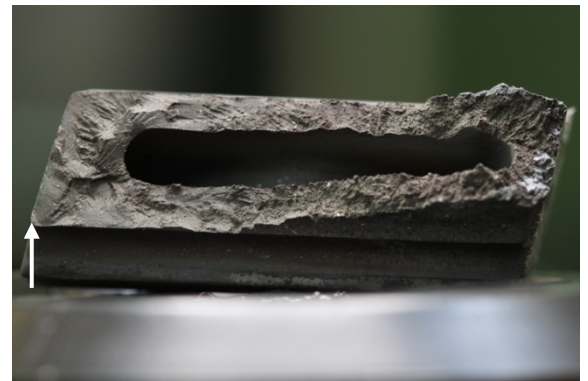
stage-2 LP blade fracture surface showed two distinct morphologies; consistent with high-cycle fatigue crack progression followed by ductile overstress fracture (Figure 11). The origin of the fatigue crack was at the trailing-edge corner of the blade root, between the blade platform and fir tree.

**Figure 11: Stage-2 LP turbine blade root. Fatigue crack origin arrowed**

Detailed examination of the turbine blade root found no evidence of material defects or other anomalies that may have contributed to the fatigue crack initiation. The manufacturer's finite element stress analysis showed that the fatigue crack origin coincided with the peak stress location within the blade.

The engine manufacturer's analysis of the circumstances contributing to the blade failure found that a flutter vibration phenomenon could contribute to reduced fatigue endurance of the stage-2 LP turbine blades at engine speeds above 100% N1<sup>6</sup>. Flutter stress levels were found to increase in an almost linear fashion up to the N1 operational limitation of 110.5%. The amount of accrued blade damage would therefore depend on the type of engine operation in addition to the blade service hours.
