ATSB TRANSPORT SAFETY REPORT
Aviation Occurrence Investigation A0-2010-104
Final

Breakdown of separation near Melbourne Airport, Victoria 5 December 2010

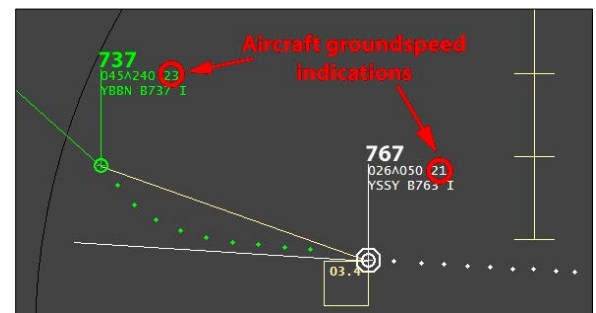
Figure 2: Proximity of the aircraft at 1419:47

At 1419.47, the 737 had commenced the SID-required turn at HOPLA with a groundspeed³ 20 kts faster than the 767. As indicated in Figure 2, the controller's air situation display provided a visual indication of the aircrafts' groundspeeds as well as their positions and altitudes.

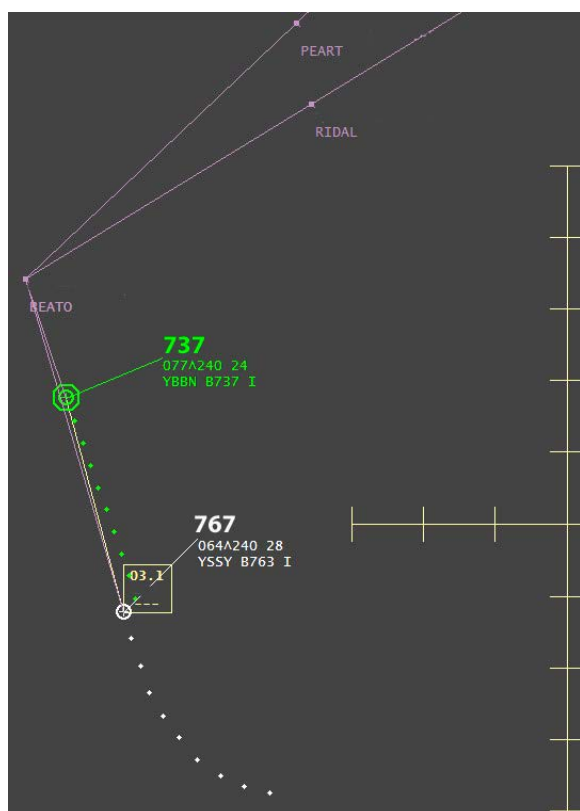
Figure 3: Proximity of the aircraft at 1421:01

At 1421:01, there was 3.1 NM (5.7 km) and 1,300 ft separation between the 737 and 767, with a closing groundspeed of 40 kts (Figure 3).

After noticing the situation, the Departures North controller cancelled the SID clearance issued to the 737 flight crew and instructed them to track the aircraft direct to position KASEY, which was the next flight planned position after NONIX, then as per their flight planned route. The controller later advised that he thought this action would take the 737 further away from the 767.

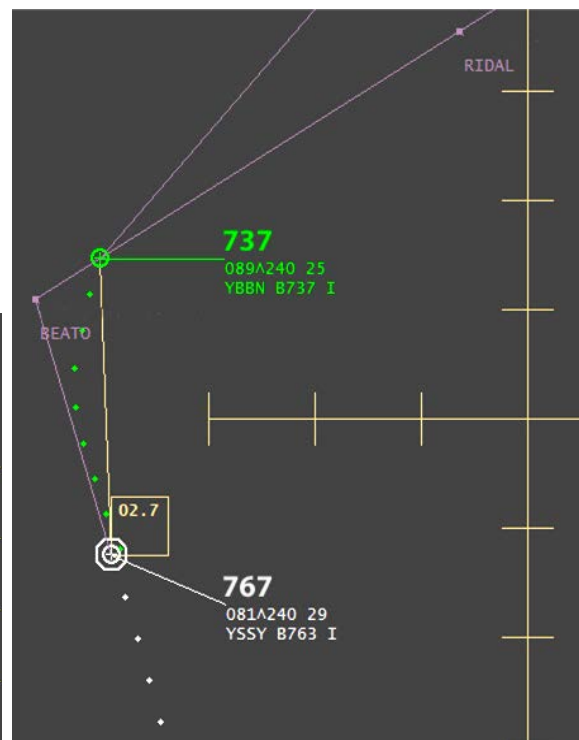
Figure 4: Proximity of the aircraft at 1421:30

When the controller reassessed the situation and realised that the separation had not increased, he took further actions. At 1421:30, he cancelled the SID clearance for the 767, and instructed the flight crew to turn right onto a heading of 050°. At that time there was 2.7 NM (5.0 km) and 800 ft separation, with a closing groundspeed of 40 kts (Figure 4).

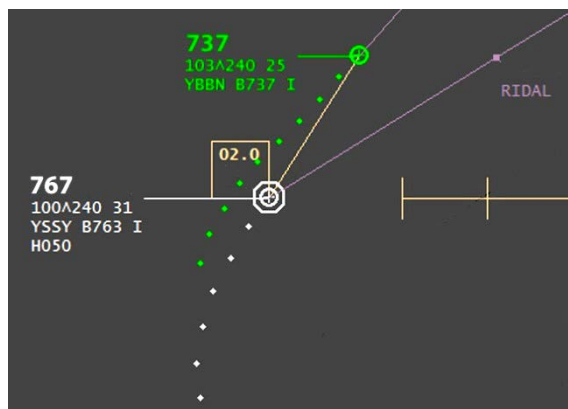
Figure 5: Proximity of the aircraft at 1422:07

At 1422:07, separation between the aircraft reduced to 2.0 NM (3.7 km) and 300 ft, with 60 kts closing groundspeed (Figure 5). At about that time, the Australian Advanced Air Traffic System (TAAATS) Short Term Conflict Alert (STCA) activated, and the Departures North controller acknowledged the alert.

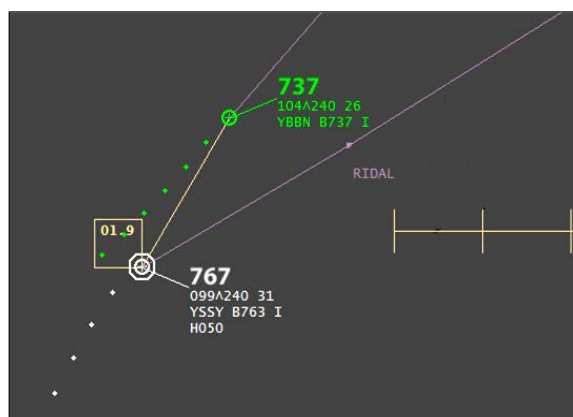
Figure 6: Proximity of the aircraft at 1422:12

Five seconds later, at 1422.12, separation between the aircraft was 1.9 NM (3.5 km) and 500 ft, with 50 kts closing groundspeed (Figure 6). A separation standard of 1,000 ft was re-established 19 seconds later (1422:31) with the distance between the aircraft increasing to 2 NM (3.7 km).

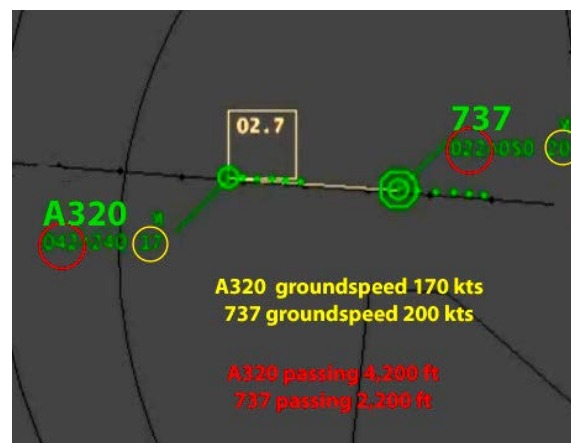
Figure 8: Proximity of the aircraft at 1042:49

At 1042:49, the ADC transferred the 737 to Departures North, as that ATC position had control jurisdiction for the airspace containing the NONIX NINE SID. At that time, the radar data indicated that there was 2.7 NM (5.0 km) and 2,000 ft between the A320 and the 737, with a closing groundspeed of 30 kts (Figure 8).

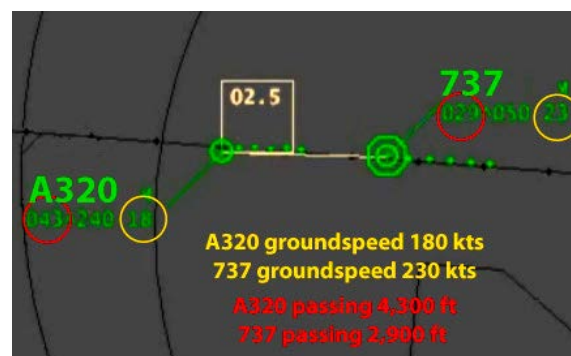
Figure 9: Proximity of the aircraft at 1043:02

At 1043:02, after the A320 had commenced the left turn at HOPLA, there was 2.5 NM (4.6 km) and 1,400 ft between the A320 and 737, with 50 kts closing groundspeed (Figure 9).

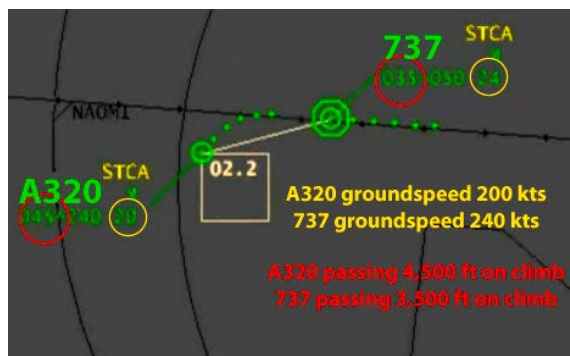
Figure 10: Proximity of the aircraft at 1043:15

At around 1043:15, a STCA activated on the air situation displays of the Departures North and South controllers. At that time there was 2.2 NM (4 km) and 1,000 ft between the aircraft, with 40 kts difference in groundspeed (Figure 10).

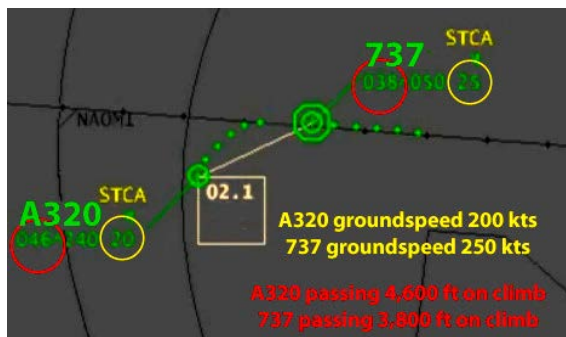
Figure 11: Proximity of the aircraft at 1043:22

At 1043:22, a breakdown of separation occurred between the A320 and the 737, as radar separation reduced to 2.1 NM (3.9 km) and vertical separation to 800 ft, with 50 kts difference in groundspeed (Figure 11).
