# Aviation Short Investigation Bulletin

Issue 9

Aviation Short Investigations  
AB-2012-044  
Final

**Report No.** AB-2012-044

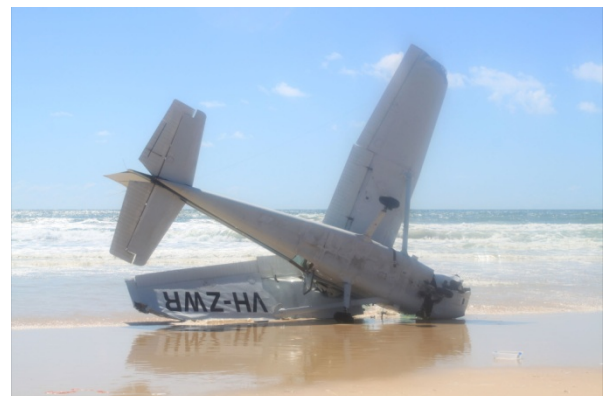
aircraft to a position above the high water mark, the aircraft was turned on its back by wave action.

**Figure 1: Aircraft shortly after the accident**
