Collision with terrain – PZL-Mielec M18A Turbine Dromader, VH-FOZ

23 km WSW of Dirranbandi, Queensland | 19 July 2011

Aviation Occurrence Investigation
AO-2011-082
Final

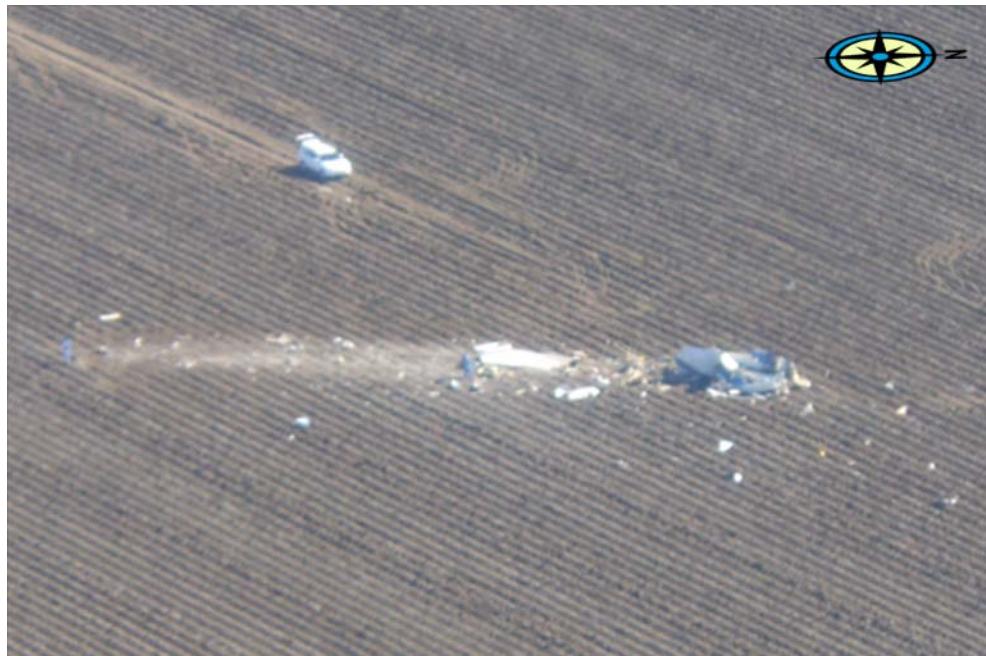
Figure 1: Aircraft wreckage

A search was initiated and the aircraft was located at about 1445 in a ploughed field on the station, 23 km WSW of Dirranbandi (Figure 1). The aircraft had impacted terrain. The pilot was fatally injured and the aircraft was destroyed by impact forces. There was no fire.

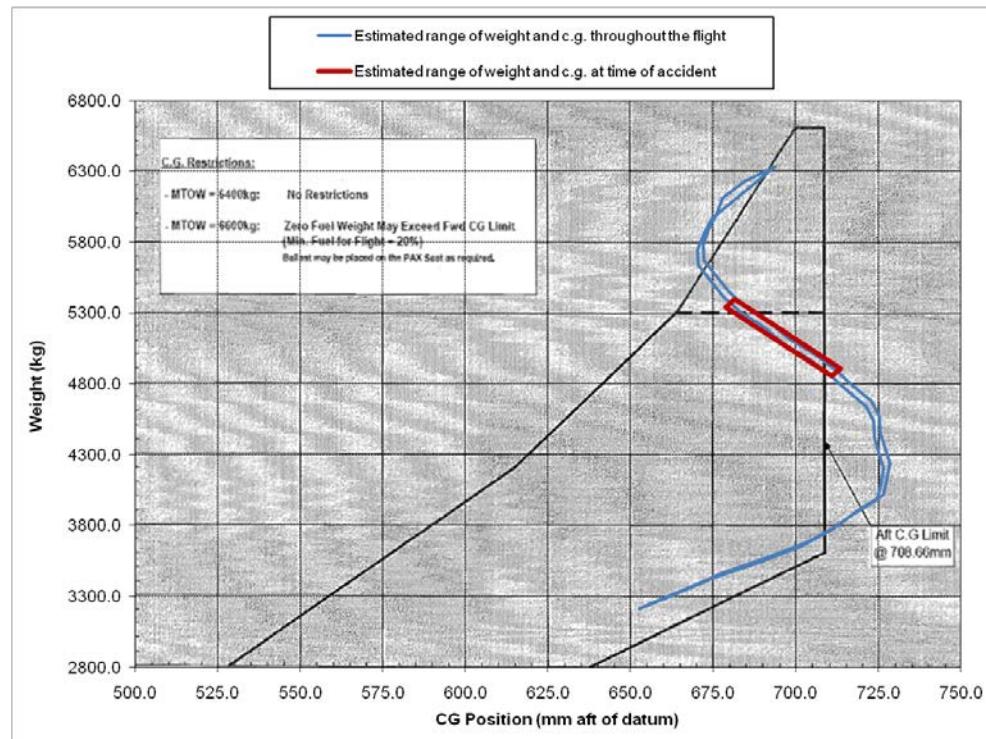
Figure 3: Weight and balance estimates

A chart showing the estimated variation of the aircraft's weight and c.g. throughout the flight, overlaid on the approved weight and balance envelope, is shown in Figure 3.

Based on those assumptions, the aircraft's weight was estimated to be between 5,945 kg and 6,367 kg at takeoff and between 4,853 kg and 5,397 kg at the time of the accident. Using that range of likely gross weights, it was estimated that the aircraft's weight and balance was most likely within or very close to the applicable weight and balance limits at the time of the accident (Figure 3, red plot).

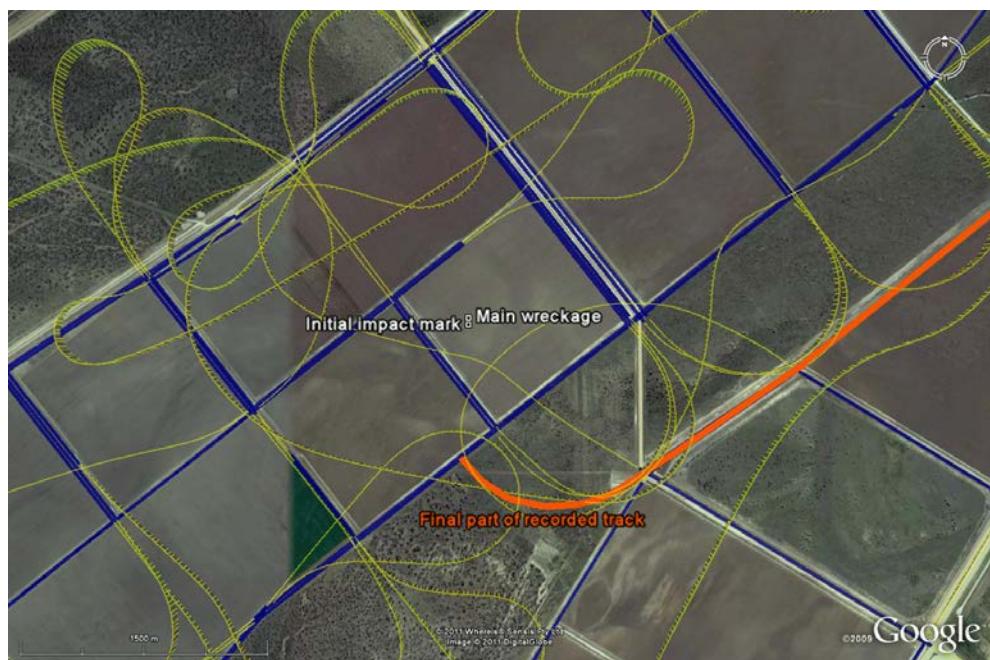
Figure 4: Accident site overview showing the recorded aircraft track (yellow), spray runs (blue) and the final part of the recorded track (orange)

The g-load then dropped sharply and remained below +1.0 g, indicating a downwards acceleration to impact.
