Aviation Short Investigation Bulletin

Issue 10

Report No. AB-2012-065

Publication date 25 June 2012

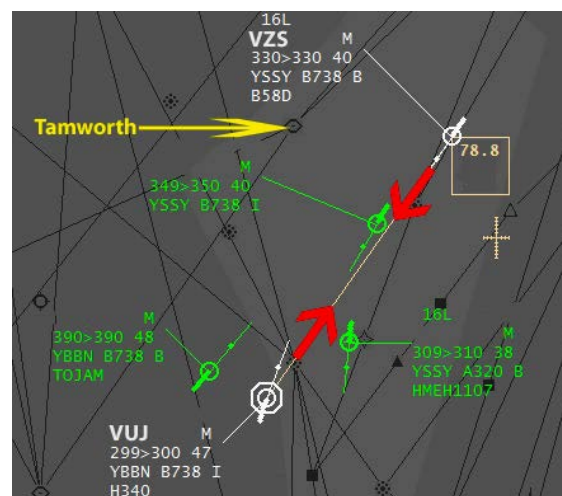
Figure 1: Position of the aircraft at 2137:47

The radar surveillance data indicated that as VUJ was cleared to track direct to TOJAM, there was 78.5 NM (145.4 km) between VZS and VUJ and the aircraft were vertically separated by 3,000 ft. As a

result of the weather diversions, however, the aircraft were now on reciprocal tracks (Figure 1).

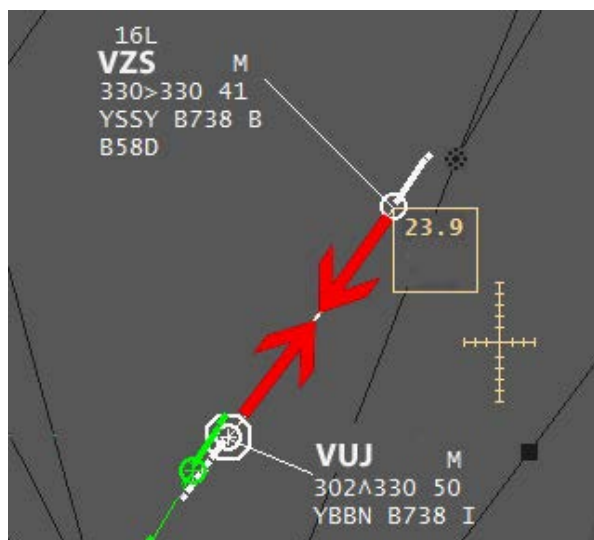
Figure 3: Proximity of the aircraft at 2141:30

At 2141:30, the flight crew of VUJ requested a heading of 040° for weather avoidance, which the controller approved, with an on-wards clearance of direct to TOJAM once the aircraft was clear of the weather. At that time, there was 23.9 NM (44.3 km) and 2,800 ft between the aircraft, as VUJ passed 30,200 ft on climb to FL 330 and VZS was maintaining FL 330 (Figure 3).

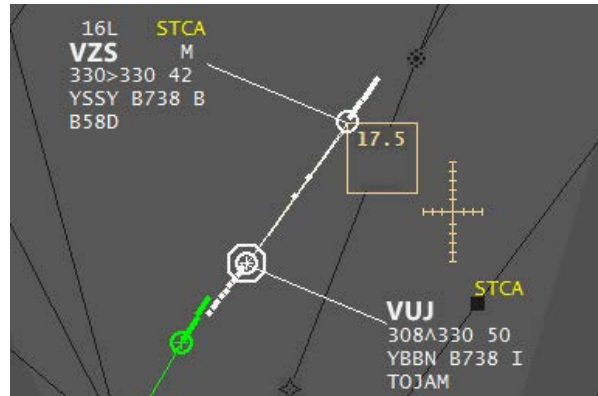
Figure 4: Proximity of the aircraft at 2141:51

At about 2141:51, as the controller was completing a transmission to the flight crew of VUJ, the Australian Advanced Air Traffic System (TAAATS) Short Term Conflict Alert (STCA)⁵ activated,

presenting the controller with both visual and aural alerts. At that time, there was 17.5 NM (32.4 km) and 2,200 ft between the aircraft, with a closing groundspeed of 920 kts (Figure 4).

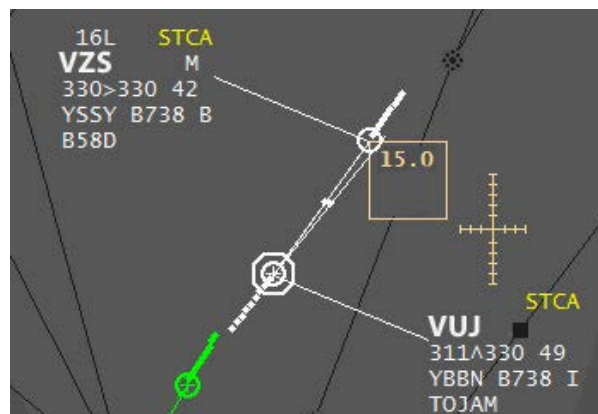
Figure 5: Proximity of the aircraft at 2142:04

Three seconds later, at 2141:54, the controller instructed the flight crew of VZS to turn right immediately by 30°, which they acknowledged. The controller then instructed the flight crew of VUJ to maintain FL 310 and turn further right onto a heading of 070°. That crew acknowledged the heading and reported descending to FL 310. At 2142:04, when the control instructions were issued for VUJ, that aircraft was passing FL 311 on climb, and there was 15 NM (27.8 km) and 1,900 ft between VUJ and VZS (Figure 5).

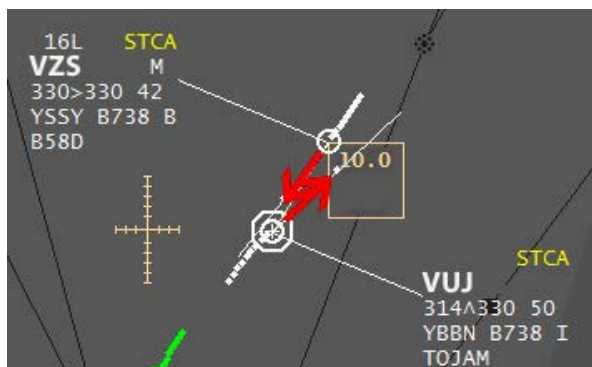
Figure 6: Proximity of the aircraft at 2142:21

At 2142:21, there was 10 NM (18.5 km) and 1,600 ft between the aircraft. As the flight crew of VUJ required time to arrest their aircraft's climb before being able to descend back to FL 310, the aircraft reached FL 314 before descending (Figure 6).

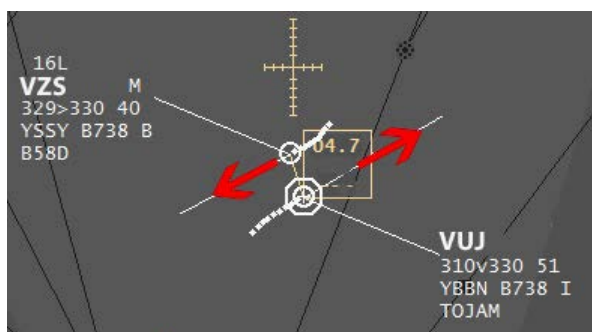
Figure 7: Proximity of the aircraft at 1042:55

At 2142:55, the aircraft passed abeam one another, 4.7 NM (8.7 km) and 1,900 ft apart. A breakdown of separation was avoided as the vertical separation standard of 1,000 ft had been maintained (Figure 7).

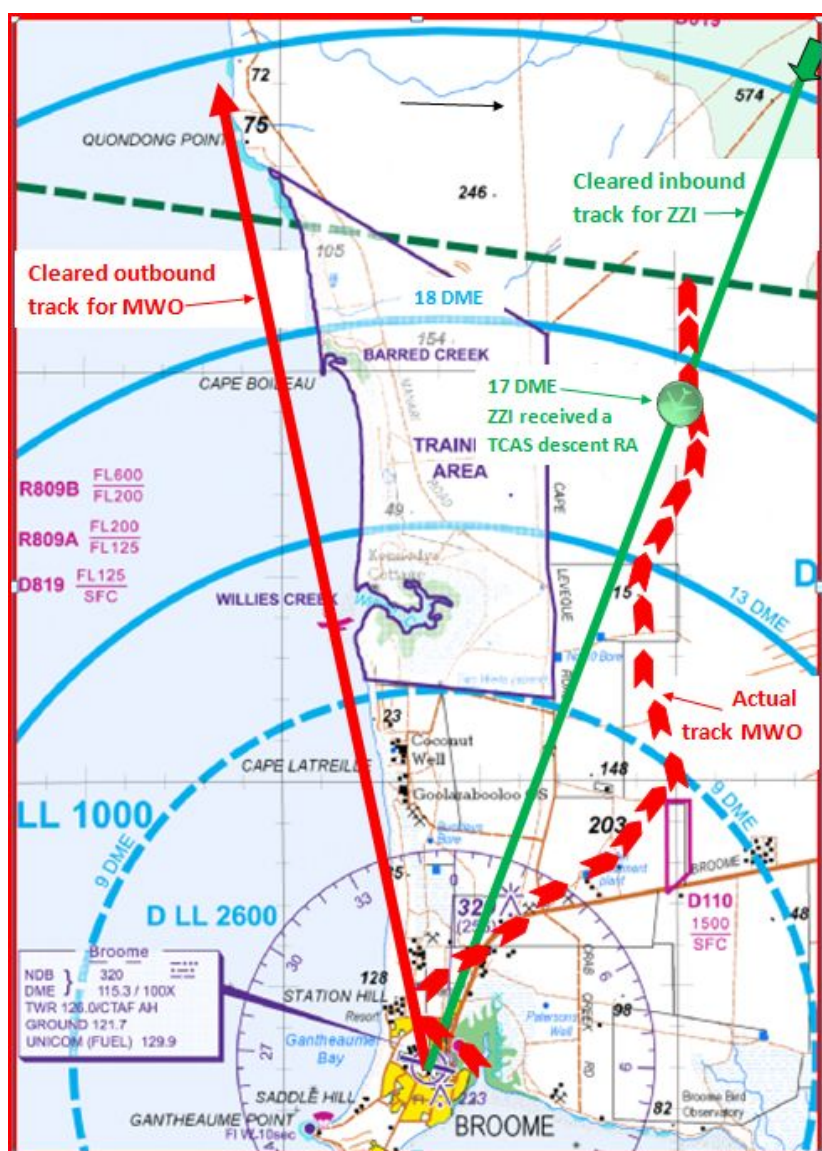
Figure 1: Cleared track inbound for ZZI (solid green line) and outbound for MWO (solid red line), and MWO's actual track (broken red line) derived from ADS-B data

Once airborne, the pilot realised that he had incorrectly planned his landing point as Lombadina, when it should have been One Arm Point (ALA), about 28 km east of Lombadina. While passing about 3,000 or 4,000 ft AMSL, the pilot programmed One Arm Point into the GPS. The pilot did not realise he had deviated from his cleared track until he observed ZZI on his TCAS display.

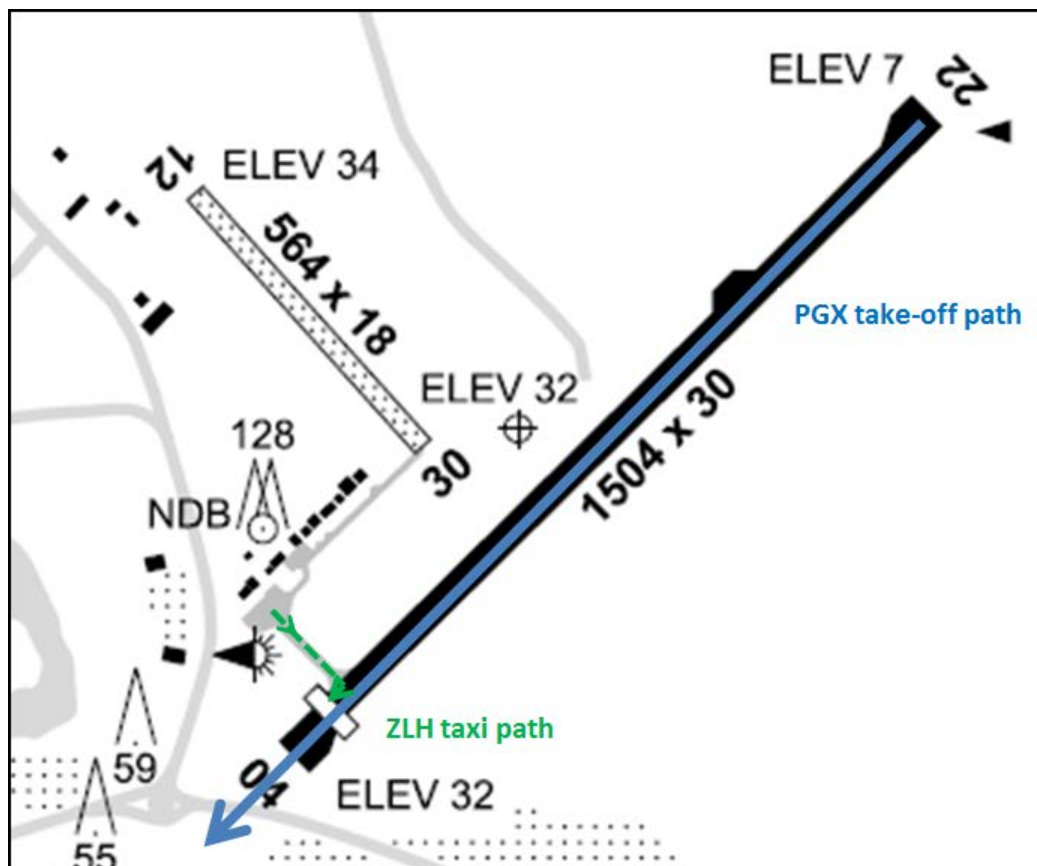
Figure 1: Take-off path of PGX (solid blue line) and taxi path of ZLH (broken green line)

As PGX became airborne at about 65 kts, the pilot observed the other aircraft enter the runway and turn right for the threshold of runway 04. The pilot reported that PGX became airborne between a quarter and a third of the way down the runway. As PGX was already airborne, the pilot decided the safest option was to continue the take-off. PGX passed directly overhead the other aircraft at about 300 ft.

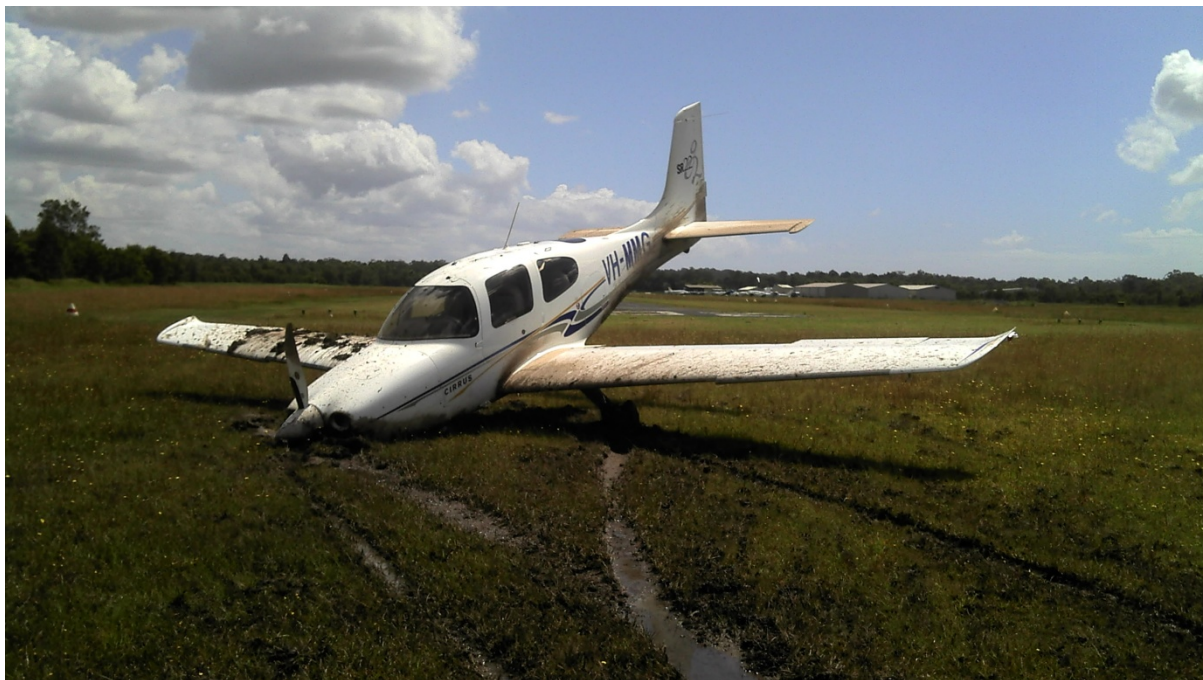
Figure 1: VH-MMG after landing at Warnervale Aerodrome

The aircraft sustained damage to the propeller, nose landing gear and lower engine cowl. All of the occupants exited the aircraft safely with no injuries reported. On exiting the aircraft, the pilot noticed that the windsock indicated gusting wind from zero to about 12 kts. The pilot reasoned the stall warning was the result of a sudden loss of headwind. He also realised that his approach had been too shallow, as if completing a short field landing.

This incident demonstrates the importance of establishing wind direction and strength using all available references, including those on the ground while on approach. Ground references, such as windsocks could better position the pilot to adjust the aircraft approach profile and airspeed to suit the weather conditions.

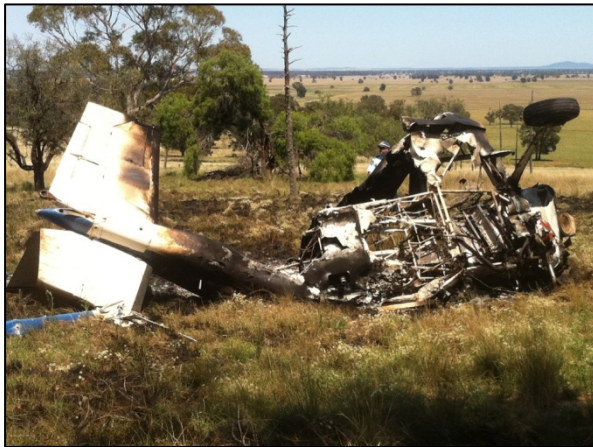
Figure 1: Photo of wreckage

The aircraft was seriously damaged with only sections of the right wing, right landing gear and tail surfaces remaining undamaged by the post-impact fire (Figure 1).

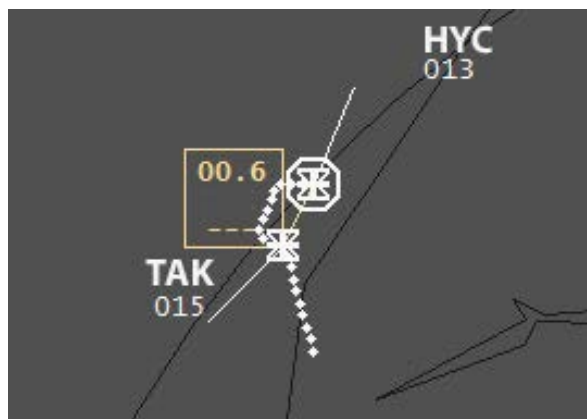
Figure 1: Proximity of the aircraft at 0959:01

A review of Airservices Australia radar surveillance data indicated that at 0959:01, the distance between HYC and TAK reduced to 0.6 NM (1.1 km) laterally and 200 ft vertically (Figure 1).

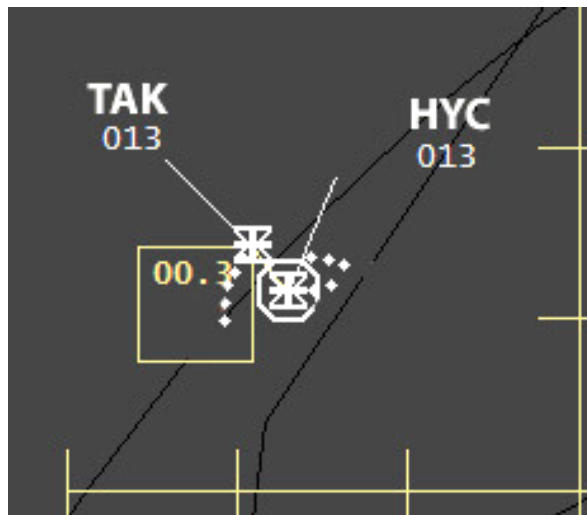
Figure 2: Proximity of the aircraft at 0959:37

At 0959:37, separation between the aircraft reduced further, when both aircraft were operating at the same altitude of 1,300 ft and there was 0.3 NM (560 m) between them (Figure 2).

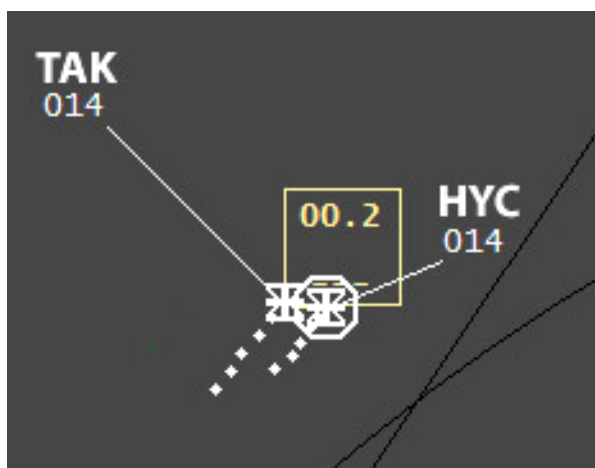
Figure 3: Proximity of the aircraft at 1001:30

Both aircraft then tracked in a north-easterly direction. At 1001:30, the aircraft were at their closest position, with both operating at 1,400 ft, 0.2 NM (370 m) apart (Figure 3).

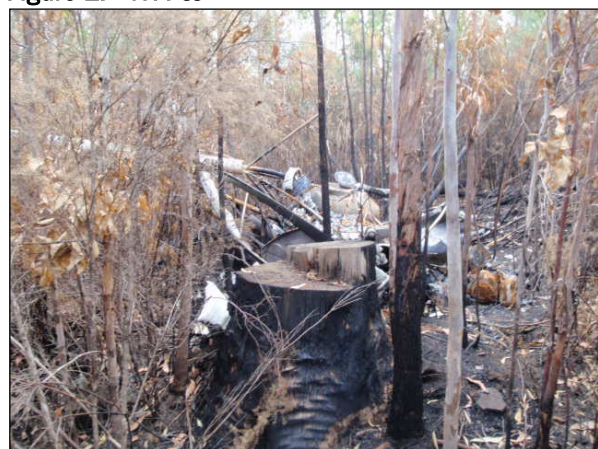
Figure 1: VH-FUJ

The helicopter was seriously damaged by the fire and the cause of the partial power loss was not determined.
