Derailment of train 1MP5

Goddards, Western Australia | 28 December 2010

ATSB Transport Safety Report
Rail Occurrence Investigation
RO-2010-015
Final

Report No. RO-2010-015

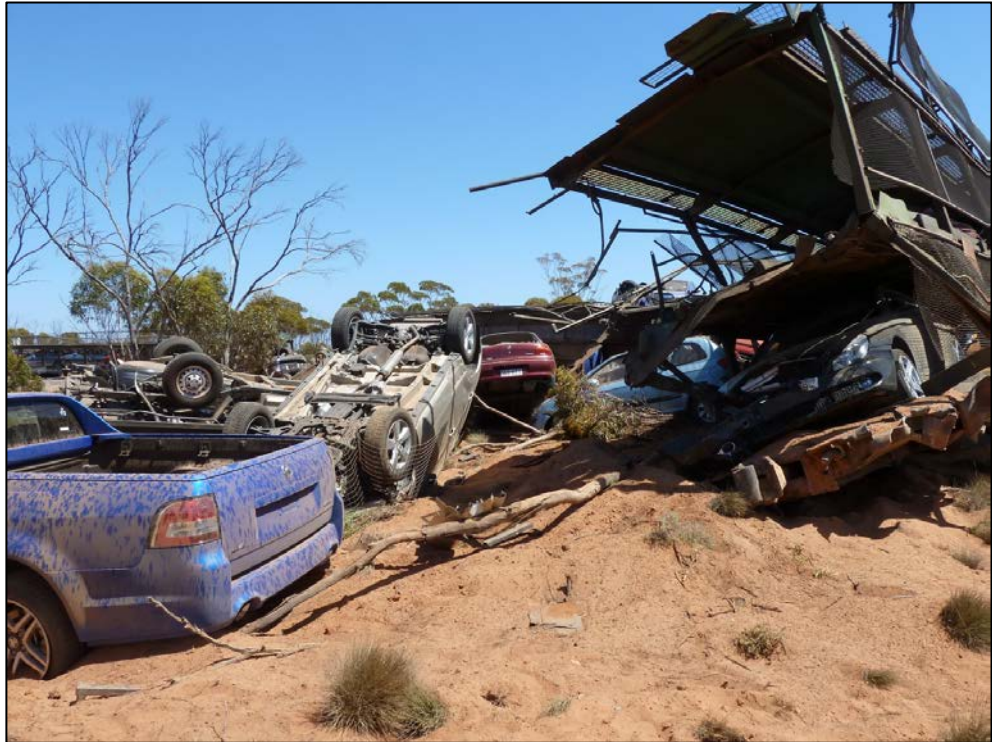
Figure 3: View looking north, mid train wreckage

A total of 23 freight wagons were derailed, with 14 sustaining significant damage. Six double-deck and four triple-deck car carrier wagons, and four container flat wagons sustained the majority of damage (Figure 3). About 550 m of mainline and 200 m of the crossing loop track was damaged in the derailment.

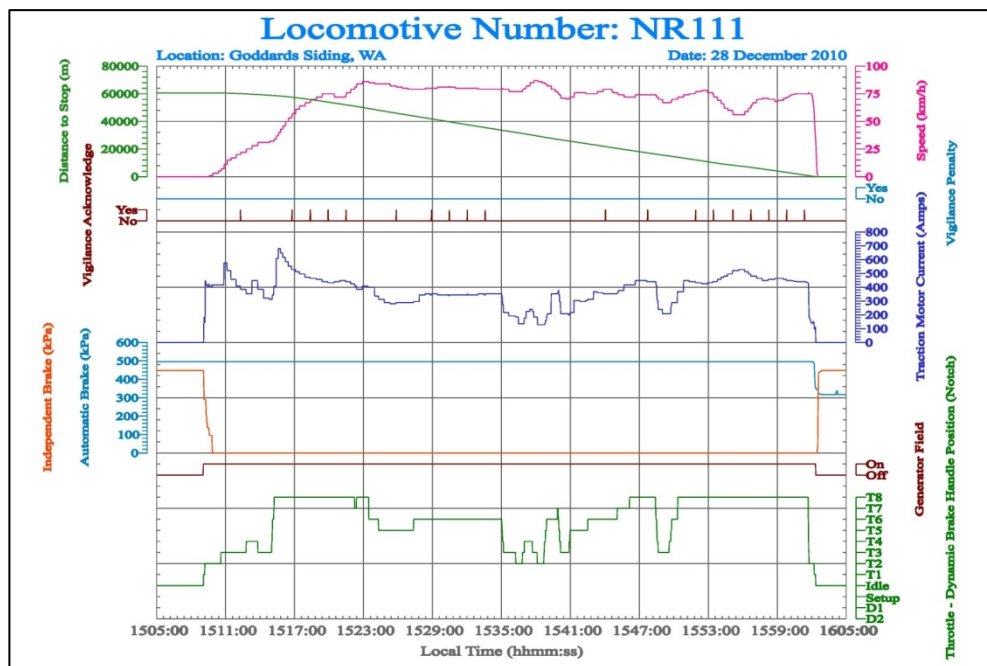
The extract from the locomotive data log corroborates the driver's recollection of events. The data clearly shows that train 1MP5 was travelling at a speed of 75 km/h, 35 km/h below the posted track speed of 110 km/h, as it approached and traversed the POD. It then shows that the driver responded to the misalignment by throttling off and allowing the train to slow, before making a final brake application, bringing the train to a stand about 791 m past the POD.

It was concluded that in-line train forces were not likely to have initiated the derailment, nor did the actions of the driver contribute to the derailment.

Figure 4: Extract from NR111 locomotive data log - Boonderoo to POD

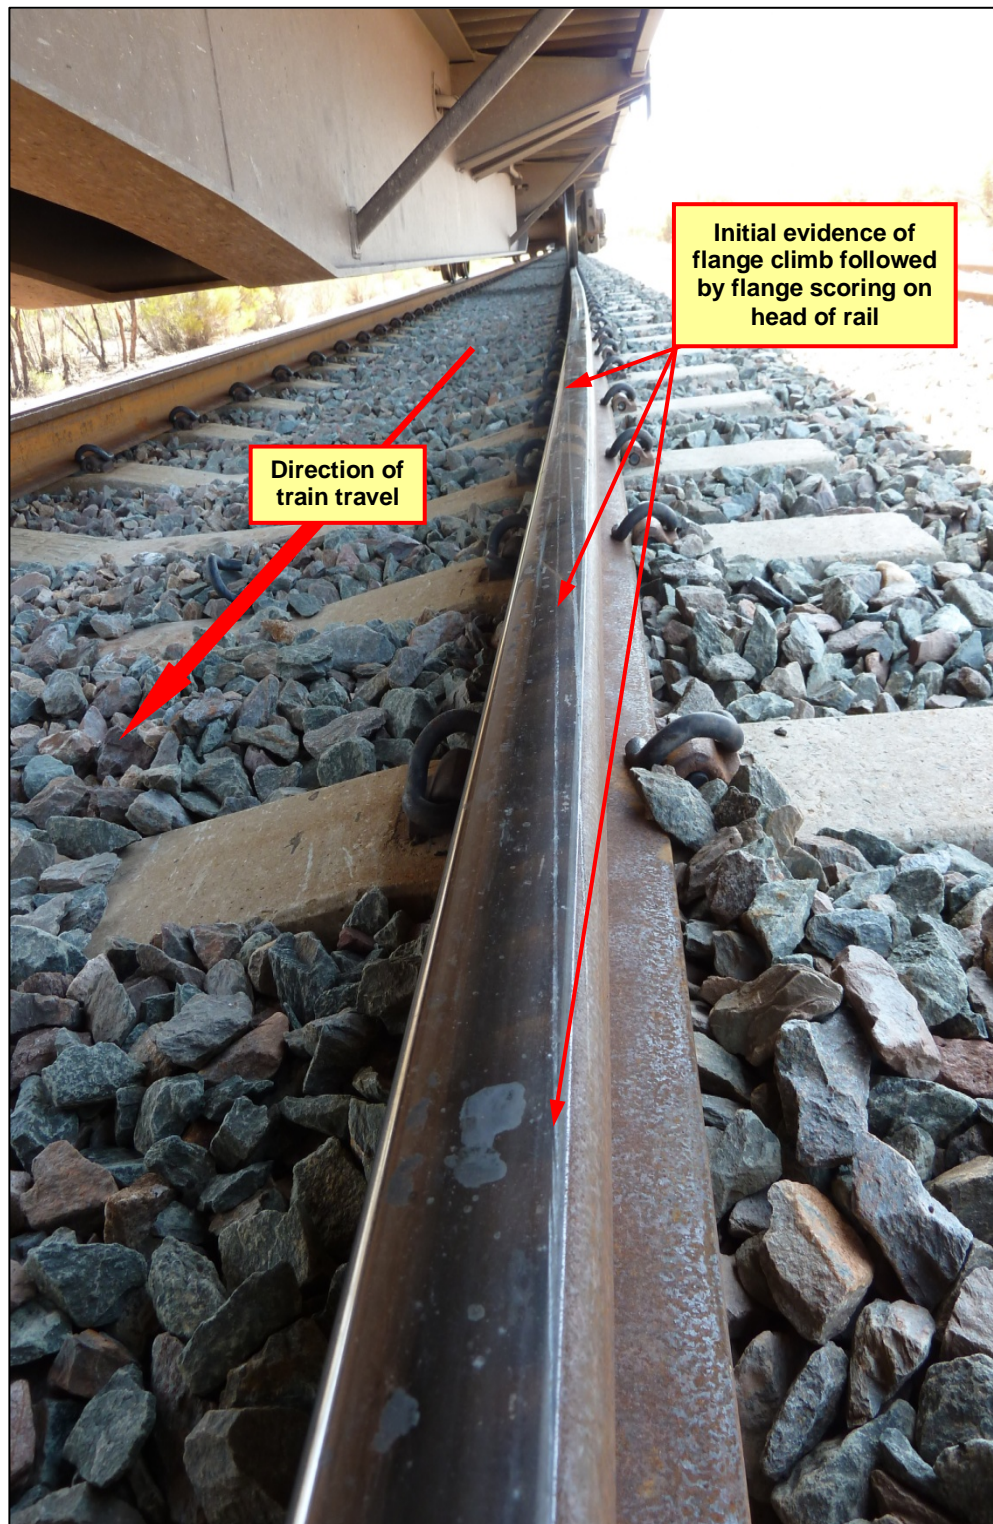
On arrival at Goddards and following inspection, the POD was determined to be at the 1544.411 km mark on the mainline and was a result of flange climb on the southern rail. Figure 5 shows the initial point of flange climb followed by two diagonal wheel contact marks, about 5 m in length, on the rail head just before the wheels dropped off into the six foot⁸. Signs of sleeper damage were observed past that point (Figure 6).

Figure 5: Photograph taken under wagon RRAY7176-R, shows evidence of initial flange climb and scoring on rail head

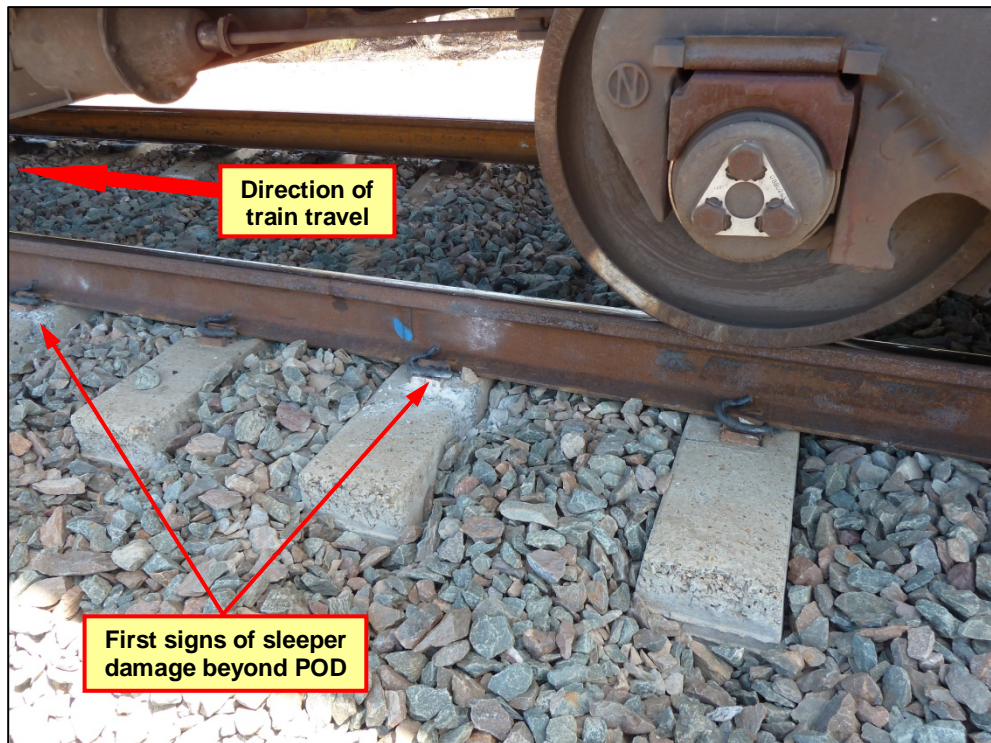
Figure 6: Photograph of track and wagon RRAY7176-R, shows evidence of initial sleeper damage

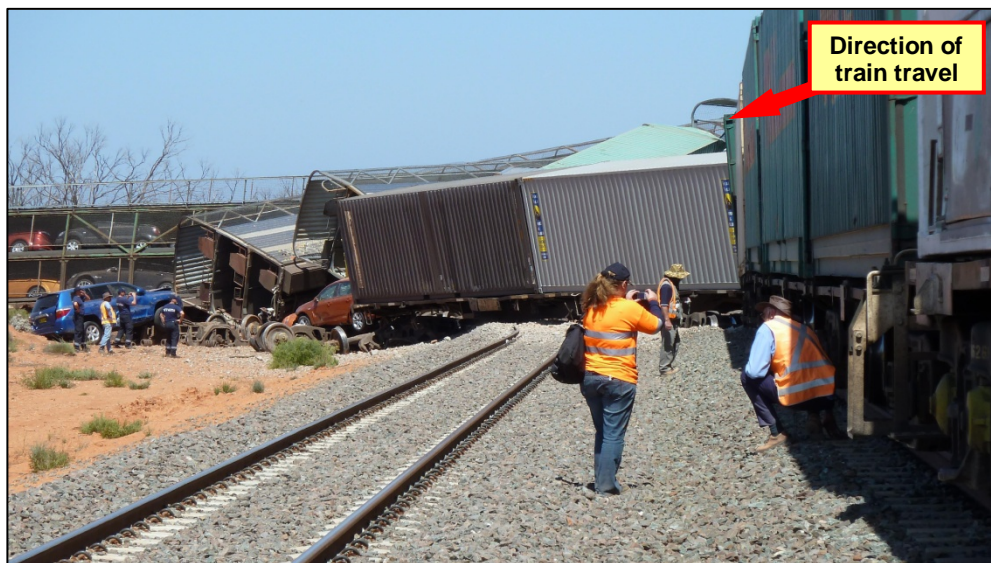
Beyond the POD, the wheels and bogies of derailed wagons advancing along the track progressively damaged the track structure, both within the four foot⁹ and the six foot, with ballast being ploughed into and along the track. This resulted in the loss of track structural integrity, with subsequent destruction of the track and the final multi-vehicle pile-up as seen at Figure 7.

Figure 7: Photograph shows multi wagon pile-up

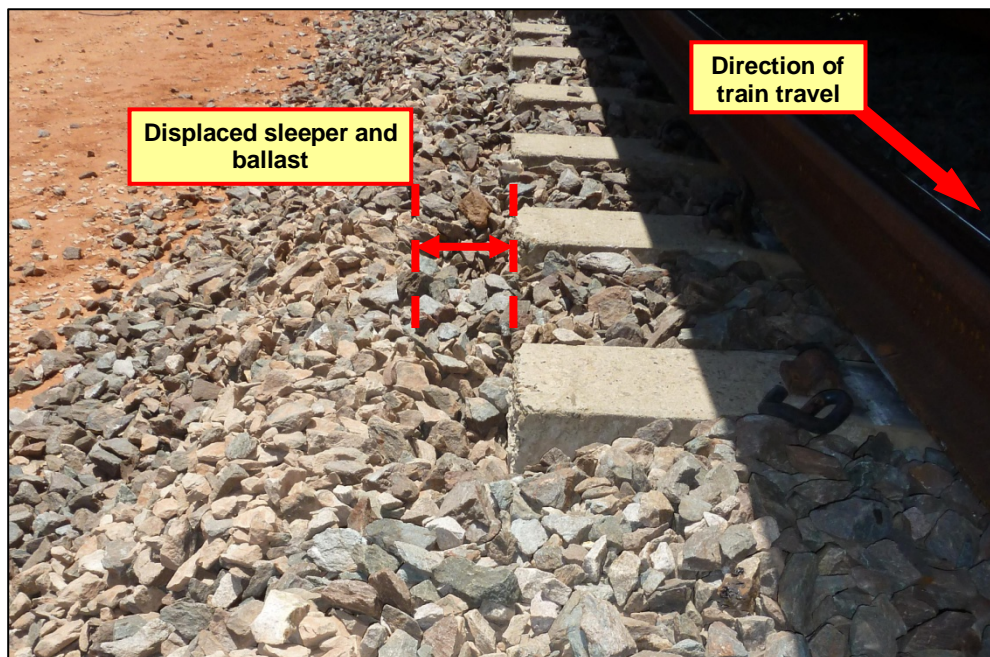
The photograph at Figure 8, taken on the northern side of the mainline near the POD, showed evidence of horizontal sleeper displacement of about 100 mm to the right, within the ballast bed. This suggested an initial misalignment to the left in the direction of train travel, which was corroborated by the train drivers.

However, site observations on 29 December 2010, the day after the derailment, show the track diverging to the right forward of the POD. It was concluded that the final position of the track forward of the POD was probably as a result of the track being kicked to the right by lateral train forces as the train traversed the misalignment, followed by longitudinal forces reflected back along the track as derailed wagons finally came to an abrupt halt ahead of the POD.

Figure 8: Photograph on northern side of mainline near the POD, shows evidence of horizontal sleeper displacement

- Track maintenance (disturbing the track) activities were discounted as a possible cause for the derailment.
- Evidence of lateral sleeper displacement (about 100 mm) on the northern side of the mainline near the POD supports the train driver's observations of a misalignment to the left, in the direction of train travel.

- The deflection of the track, to the right, forward of the POD was probably caused by the track being kicked by lateral train forces, as the train traversed the misalignment, followed by longitudinal forces reflected back along the track as derailed wagons came to an abrupt halt directly ahead of the POD.

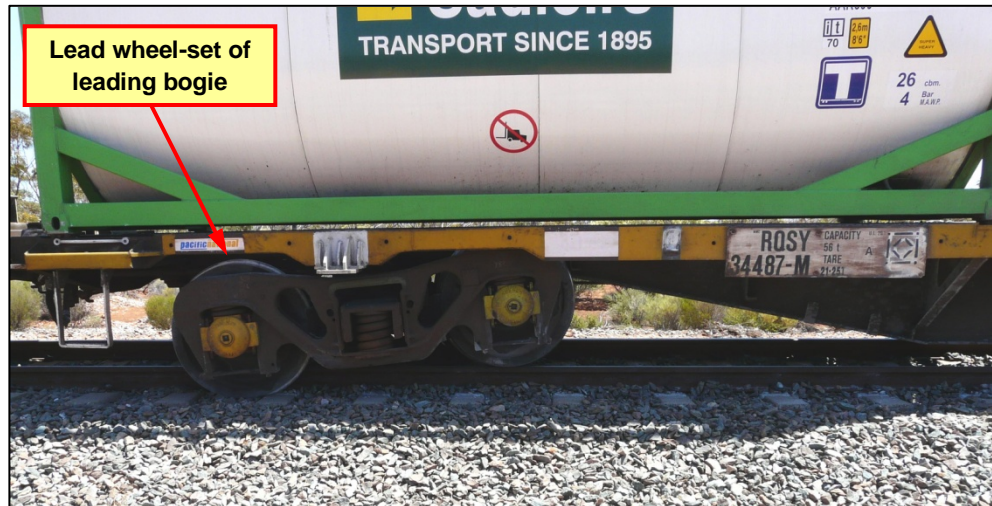
Examination of derailed wagons focused on RQSY34487-M, (Figure 9) the 11th wagon in the consist, a container flat, carrying two ISO containers¹⁰, one with bulk liquid. This wagon was identified as the first to have derailed, namely the leading wheel-set of the lead bogie. The POD was about 537 m to the rear of this wagon. Wagon RQSY34487-M was examined for mechanical condition, dragging equipment, etc and found to be operationally fit for purpose.

There was no indication of any mechanical deficiency with the train or the wagon so this was discounted as a possible cause for the derailment.

Figure 9: First of derailed wagons RQSY34487-M, note the lead wheel-set of the leading bogie

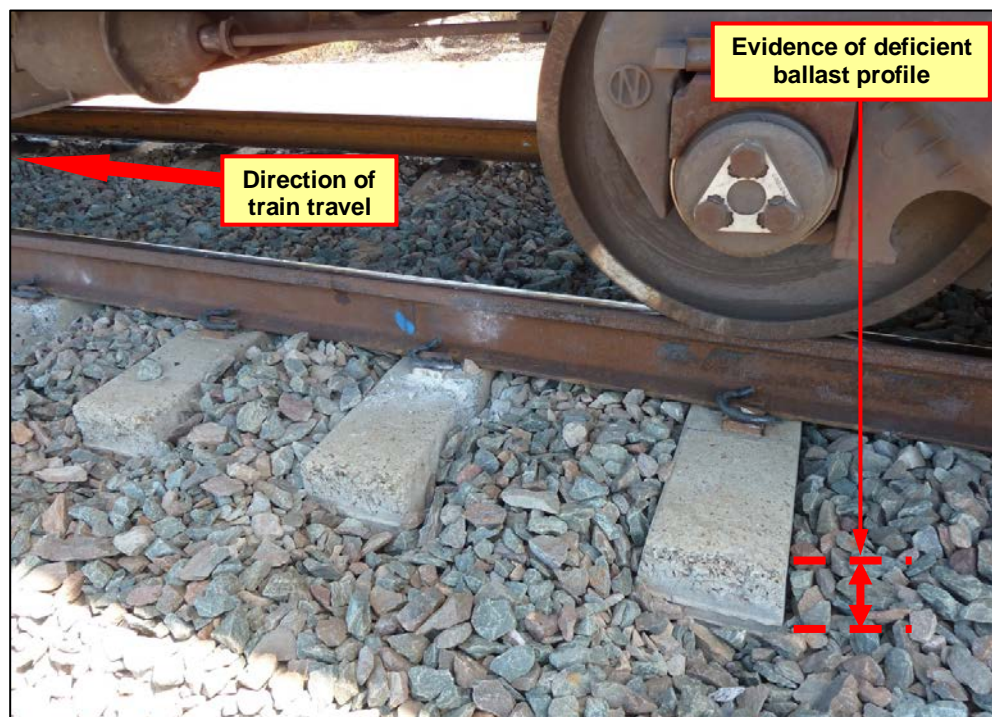
Track buckling is heavily influenced by the quality/quantity of ballast surrounding sleepers, particularly within the crib and surrounding the shoulder. Where ballast within the crib and/or shoulder is deficient or in poor condition, the track will be more susceptible to misalignment due to a lack of lateral track stability.

Figure 11: Photograph showing lack of shoulder ballast

During the site inspection it was noted that the ballast profile at the POD (Figure 11) and various locations throughout Goddards yard, as illustrated at Figure 12 (183 points), was ballast deficient and did not meet ARTC requirements.

It was concluded that the track structure at the POD probably had reduced resistance to lateral movement due to deficient shoulder ballast.

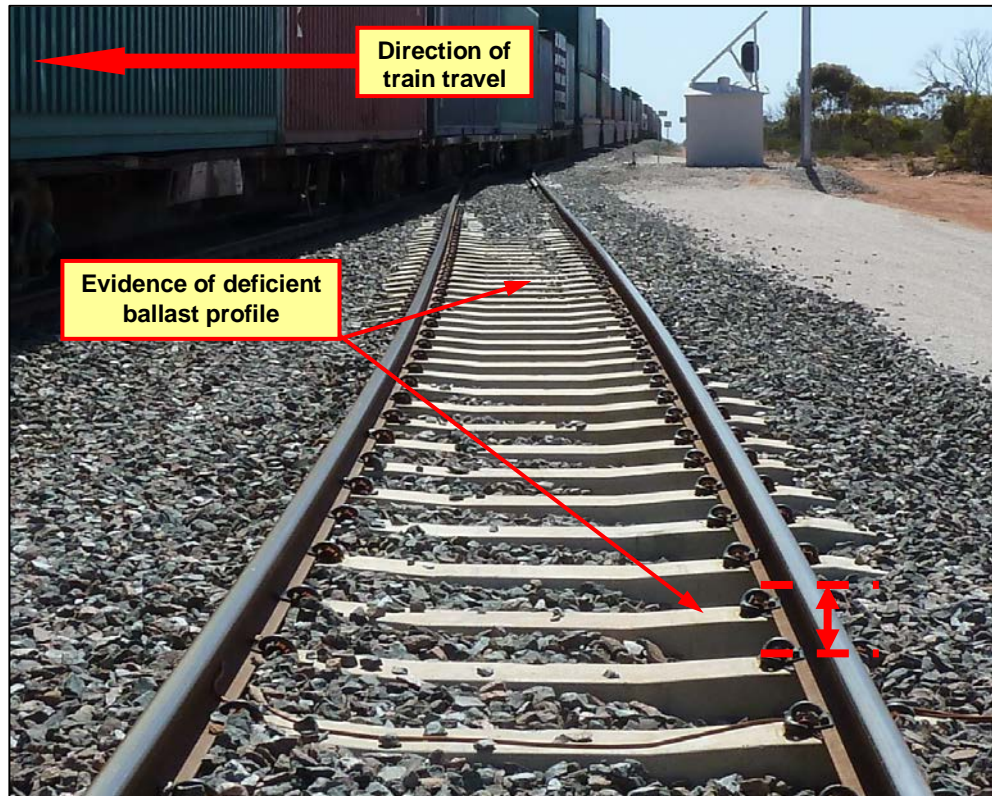
Figure 12: Photograph at 183 points showing lack of ballast within crib
