Australian Transport Safety Bureau

TECHNICAL ANALYSIS REPORT

Report No. 12/03

**Examination of an RB211-524G-T Turbofan Engine Compressor
Failure**

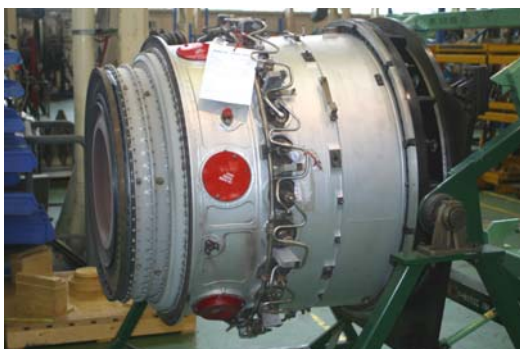
Fig. 2 (Top L) Module 41 assembly as examined. First-stage high-pressure compressor disk is at the left.

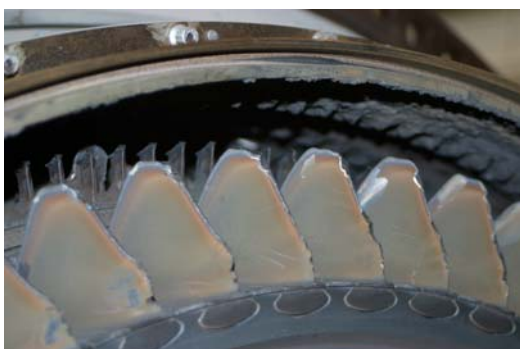
Fig. 3 (Top R) First-stage high-pressure compressor rotor, viewed looking aft. Missing blade is arrowed.

Fig. 4 (Above) Extensive metal loss as shown by the remaining HPC first-stage blades. The conical shape and extensive surface metallisation (splattering) is indicative of a titanium fire having occurred within the compressor.

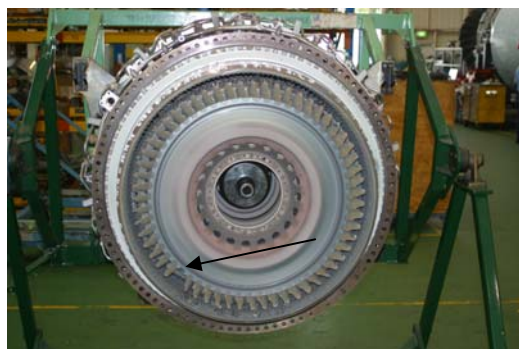
Fig. 5 (Left) Burn-through sustained by the HPC first-stage case as a result of the titanium fire.

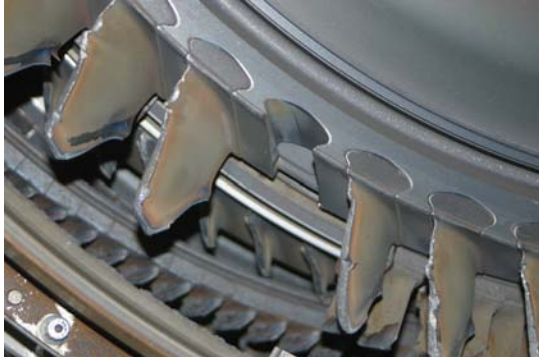
A single blade from the first-stage HPC rotor was missing from the disk, having completely liberated from its single-tier dovetail slot (figure 6). The trailing edge of the disk slot showed a prominent ridge of metal where the lost blade had evidently folded over in the slot before being released (figure 7).

Fig. 6 HPC 1 disk with missing blade.

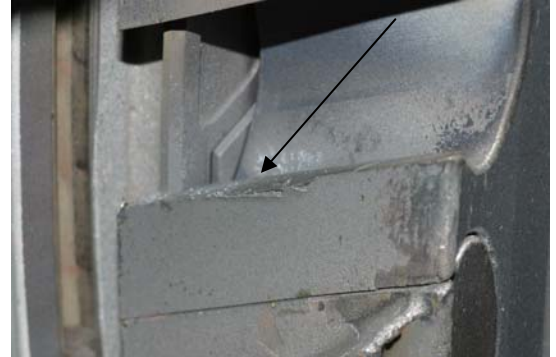
Fig. 7 Metal deformation and burring found on the slot edge.

The liberation of the HPC first-stage blade was attributed to the development of high-cycle fatigue (HCF) cracking across the forward corner of the blade dovetail block. Eventual loss of this material allowed the operational centrifugal and bending loads to fold the blade forward, breaking it free from the slot and producing the mechanical slot-edge burr as noted.

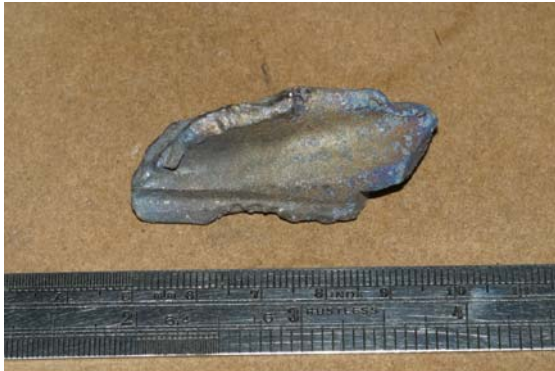
The root stub of the released HPC first-stage blade (figure 8) was recovered amongst the debris removed from the engine intermediate case (module 33) upon disassembly. While extensively battered and abraded, the stub clearly originated from the HPC first-stage rotor (figure 9). Close inspection of the stub showed evidence of the cracking and loss of the forward trailing edge corner of the blade dovetail root block (figure 10). The relatively smooth, even nature of the fracture surface was consistent with a fatigue cracking mechanism, originating from the edge of bedding area at the top of the dovetail (figure 11). None of the other 58 blades within the HPC first-stage assembly showed any visible evidence of cracking when inspected with the unaided eye.

Fig. 8 HPC first-stage blade stub as-recovered.

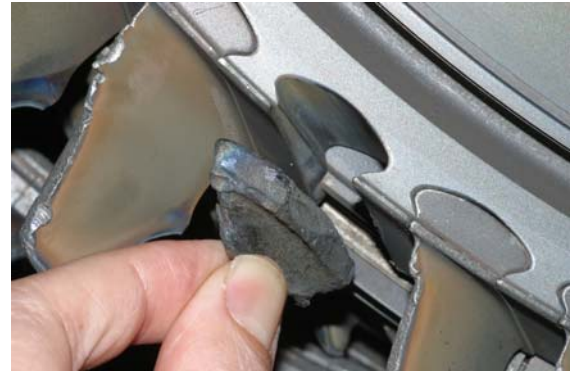
Fig. 9 Orientation of the blade stub with respect to the HPC first-stage disk.

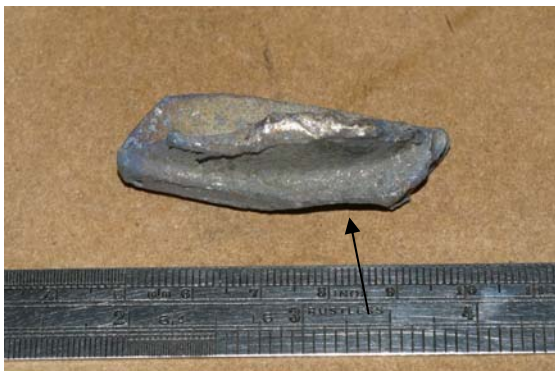
Fig. 10 HPC first-stage blade stub, showing missing forward corner (arrowed).

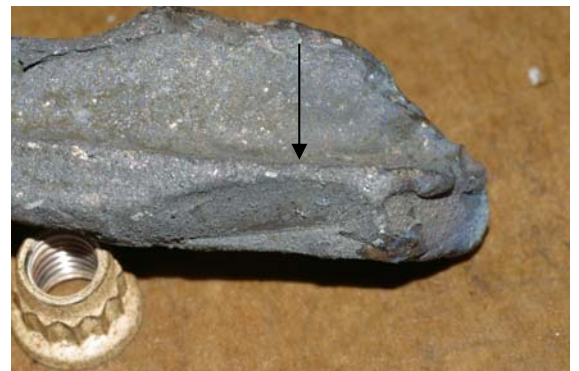
Fig. 11 HPC first-stage blade stub corner fracture with suspected fatigue crack initiation region shown.

The engine manufacturer was aware of a mechanism whereby high cycle fatigue cracking developed from uneven load distribution across the bedding surfaces of the blade dovetail. 'Patchy friction' between the contact surfaces resulting from a breakdown of the dry lubricant within the joint has been considered to be a significant factor, however evidence also exists to suggest that a stress-raising influence such as possible root flank mechanical damage is also contributory. Analysis by the manufacturer has shown the fundamental blade root direct centrifugal stresses to be low.

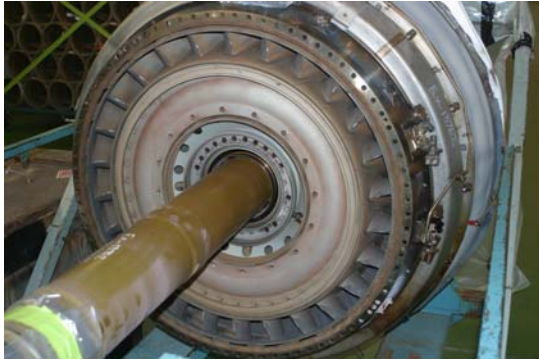
The inlet of the module 51 turbine assembly (figure 12) showed only minor, low level abrasion to the leading edges of the first stage intermediate pressure (IP) turbine inlet guide vanes (figure 13). Light metallisation and unusual gas flow patterns were evident through the nozzle guide vane (NGV) unit, however gross overheating or metal loss from the NGV leading edges had not occurred.

Fig. 12 Inlet to IP/LP turbine (module 51)

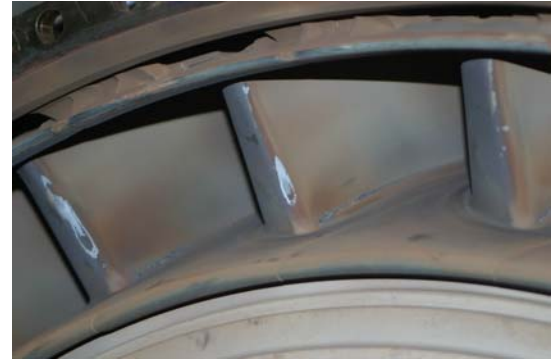
Fig. 13 Minor damage to the leading edges of the IP turbine inlet guide vanes.

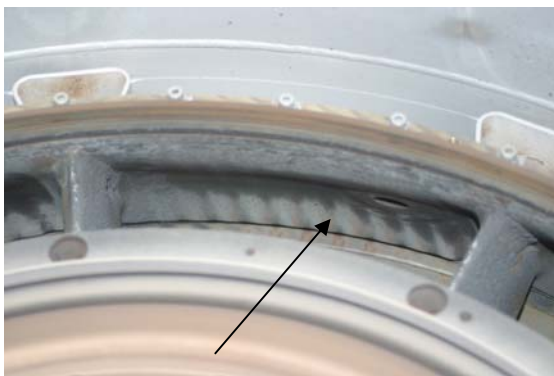
The surfaces of the intermediate case immediately forward of the HPC inlet showed heavy metallisation and evidence of forward gas flow (figure 14), typical of a compressor stall/surge event. Where the HPC first-stage case had perforated, the inside walls of the intermediate case were sprayed with oxidised metal and exhibited a degree of overheating effects (figure 15). A single case strut showed localised perforation at the juncture to the outer case, with the puncture subsequently being oversprayed with the oxidised metal from the HPC (figure 16). Indentation marks adjacent to the puncture suggested the perforation might have resulted from the released HPC first-stage blade impacting the strut base.

Fig. 14 (Top L) Module 33 intermediate case looking forward. Evidence of forward gas flow and combustion.

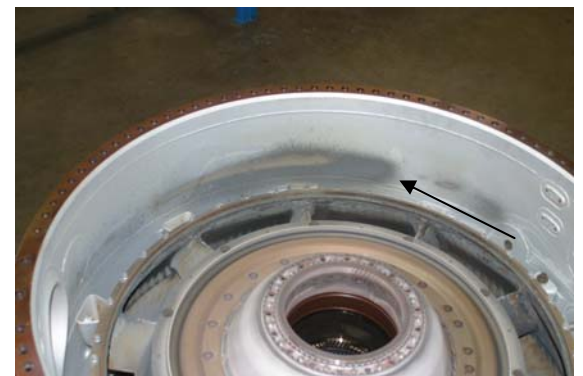
Fig 15 (Top R) Intermediate case with metallisation spray on the internal walls from the burn-through of the HPC first-stage casing.

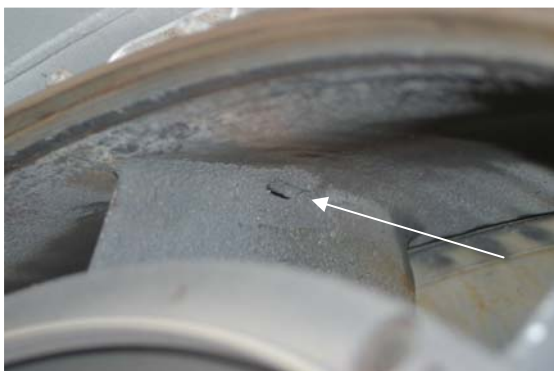
Fig 16 (L) Intermediate case strut showing puncture and metallisation overspray.
