ATSB TRANSPORT SAFETY REPORT

MO-2010-002

Independent investigation into the stevedore fatality on board the
Antigua and Barbuda registered container ship

Vega Gotland

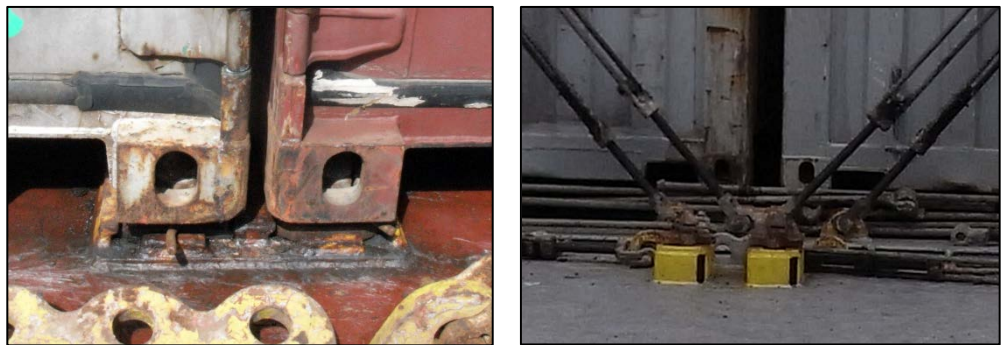
The positioning of the twistlock foundations on *Vega Gotland* differ from this in that the foundations do not sit directly next to each other. There is a gap of about 150 mm between each foundation (Figure 4b) to allow for the carriage of over-width cargo in flat rack containers.

Figure 4a & b: Containers positioned directly next to each other and *Vega Gotland*’s containers positioned apart

This spacing generally requires the container being loaded to be manoeuvred into position, either manually or by the portainer driver, as the container cannot be ‘butted’ up against an already loaded container. Consequently, loading of containers on board *Vega Gotland*’s hatch covers can take longer than other container ships and more manual intervention is required during the loading process.

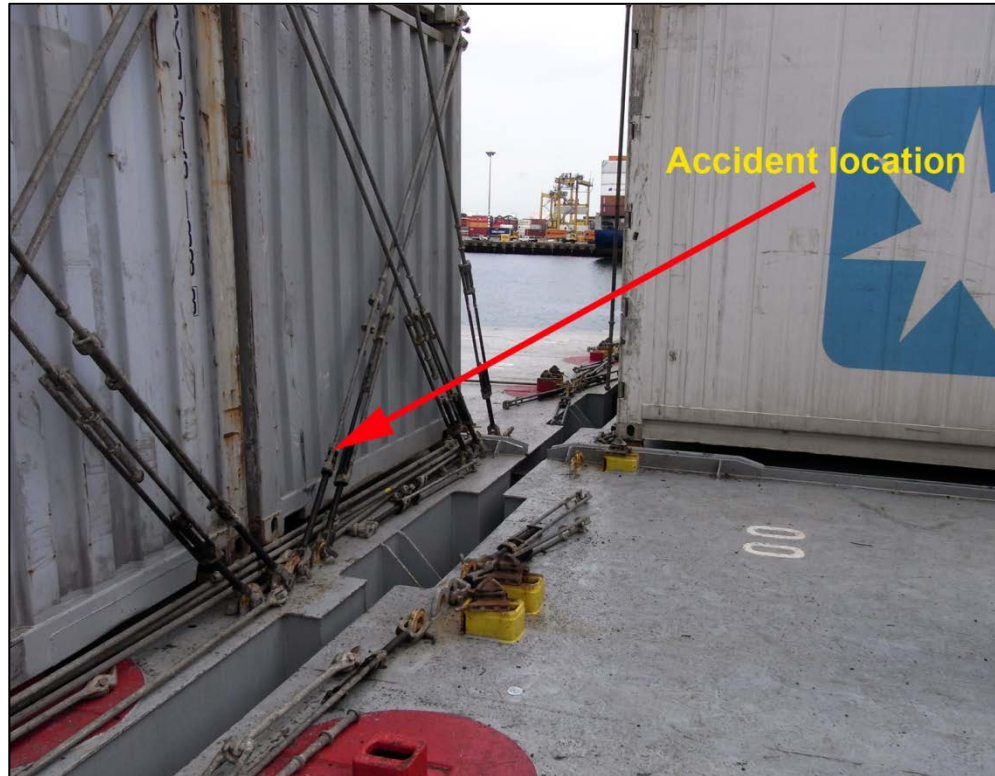
Figure 8: Accident location between Bays 20 and 24

However, while he was doing so, the top of the twistlock foundation⁴ separated from its base and the container swung aft. The lashing team leader was standing at the after end of the container. Before he had the chance to move clear, he was crushed between the swinging container and a loaded container on deck in Bay 24. He was killed instantly.

When the portainer driver lifted the container slightly, the deck team leader felt the starboard hatch cover lift. He immediately shouted to the portainer driver, via his hand-held radio, to stop lifting. However, just as he did so, the inboard foundation holding the locked twistlock failed and container swung.

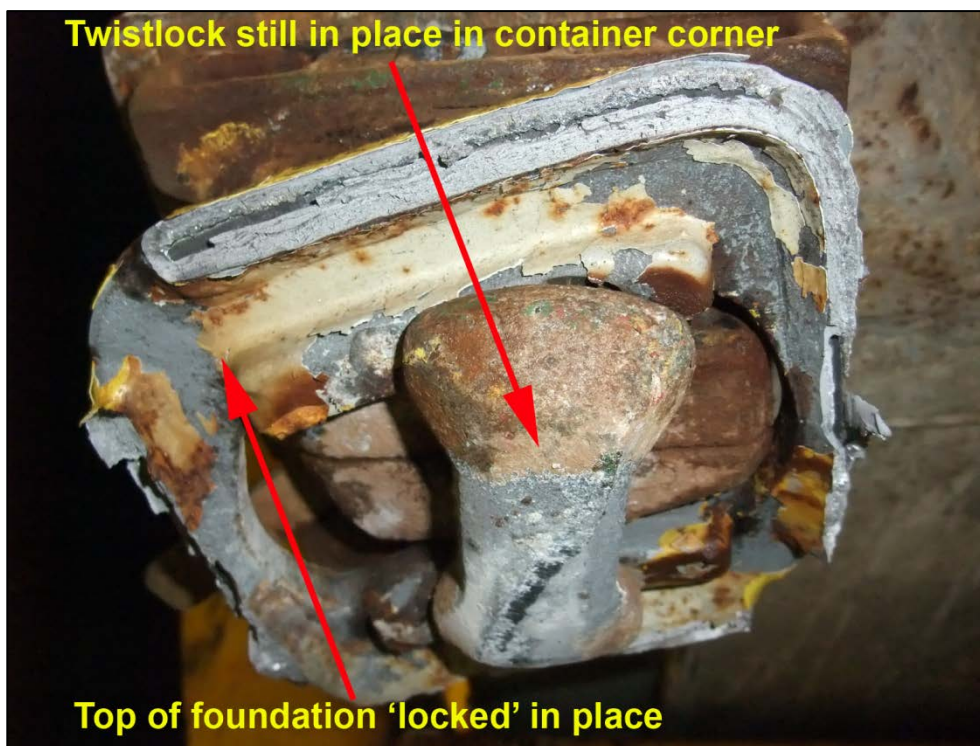
Figure 9: Top of the twistlock foundation that parted

The container which swung aft was secured to *Vega Gotland*'s hatch cover by a twistlock which had been locked into a single twistlock foundation (Figure 9). At the time of the accident, the ship was 5 years old. The ship and the container fittings on its hatch covers were well maintained and in good condition. Consequently, the strength and effectiveness of the foundation that separated was not affected by corrosion. The twistlock foundations had been welded in place during the construction of the hatch covers and had not been modified or replaced since the ship entered service.

The technical examination determined that the failure of *Vega Gotland*'s twistlock foundation assembly was consistent with its exposure to gross overstress conditions. The weld fractures and deformation of the hardware (the twistlock and the twistlock foundation top) were found to be consistent with a combination of tensile, bending and shear loads generated during the reported asymmetric lifting of the partly secured container and the unsecured hatch cover. The angle of the hatch cover, due to the ship's stern trim, applied a magnified leverage to the foundation and this contributed significantly to the failure of the welds.

While the ATSB's technical examination found that the welds between the top plate and the side plates of the twistlock foundation were not in compliance with MacGregor's engineering and design specifications, the deficiencies were not at a level likely to have had a major detrimental effect on the overall strength of the assembly.

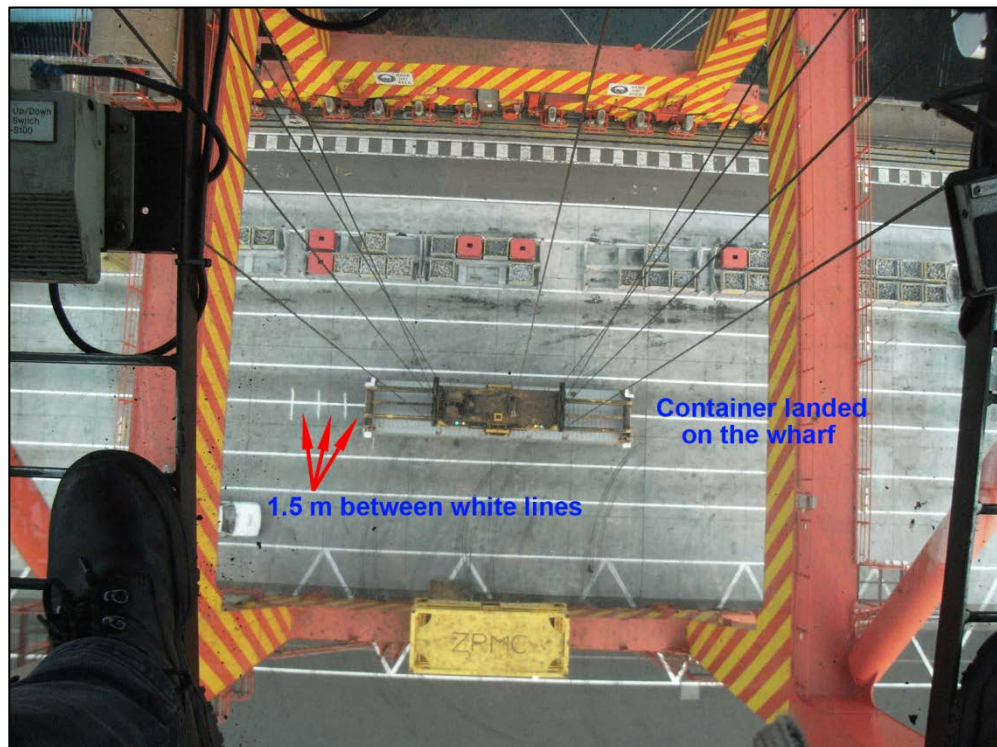
Visibility of *Vega Gotland*'s hatch covers from the portainer cabin was restricted. With a container suspended under the spreader, due to perspective (or field of view) the portainer driver had virtually no visibility of the forward and aft twistlock foundations while he was lowering the container into position. He was able to see the forward and after ends of the hatchcover/walkways only when the container was landed in position (Figure 10). Therefore, he relied on the directions provided by the deck team leader for container positioning.

Figure 10: View from the portainer cabin with a 40 foot container attached to the spreader

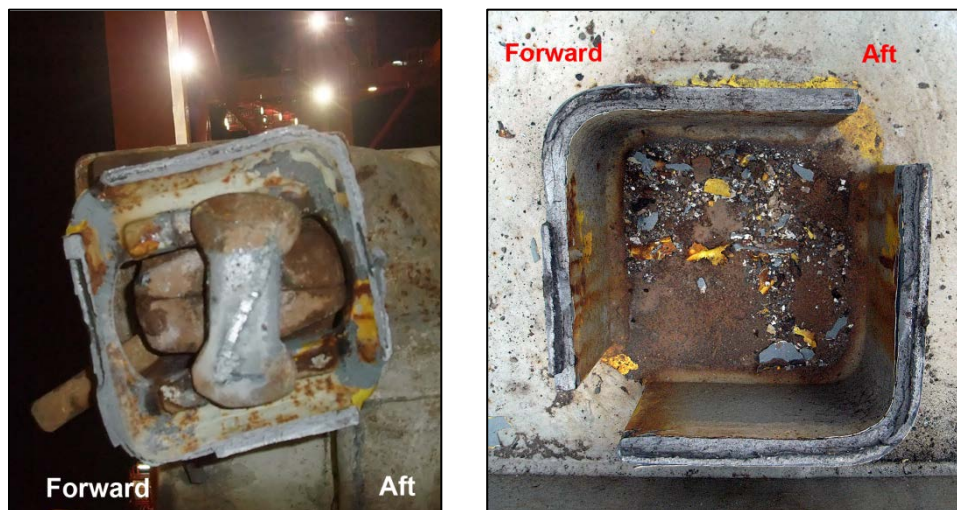
Figure A1a & b: Twistlock assembly and top plate, as made fast to the container, and the two side plates, as made fast to the hatch cover.

Apart from the tearing of the steel side plates from the top plate (Figures A1a & b), notable bending of the top plate occurred (Figure A2) where it made contact with the lower locking cone (Figure A1a) of the twistlock, thereby inducing reverse bending of adjacent sides (Figure A3a). As well, the lower cone indented the two undersides of the top plate (Figure A3b) where it had made contact.

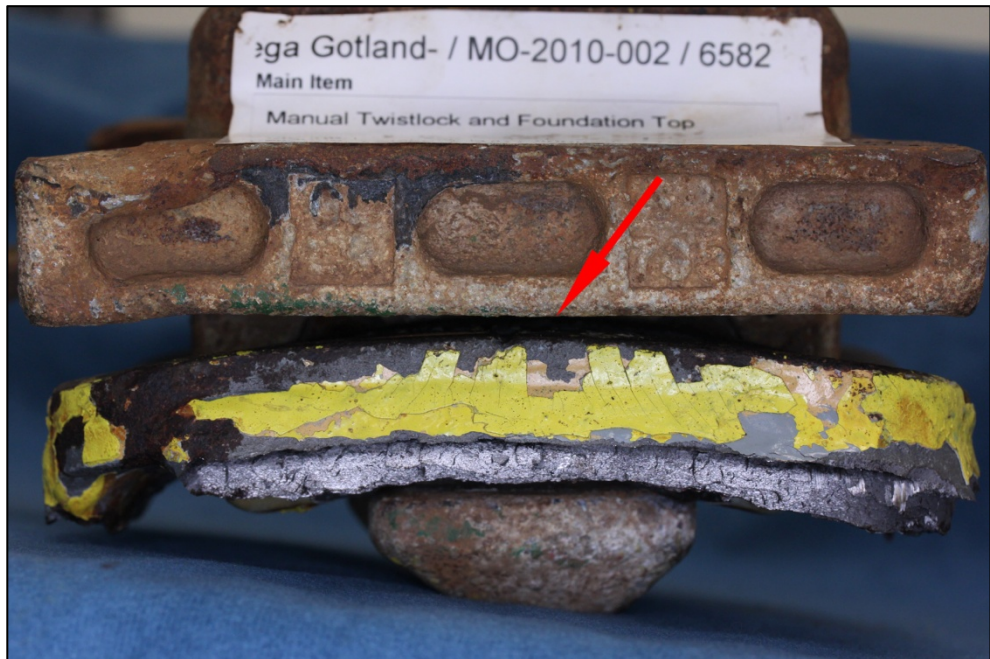
inclination angle between the twistlock housing and the foundation top plate. Such bending reduced the clearance between the foundation top plate and twistlock housing on the port side to 4 mm (Figure A2) and increased it to 17 mm on the starboard side.

Figure A2: Port view of the assembly; note the 4 mm clearance (arrowed) and the curvature of the foundation top plate

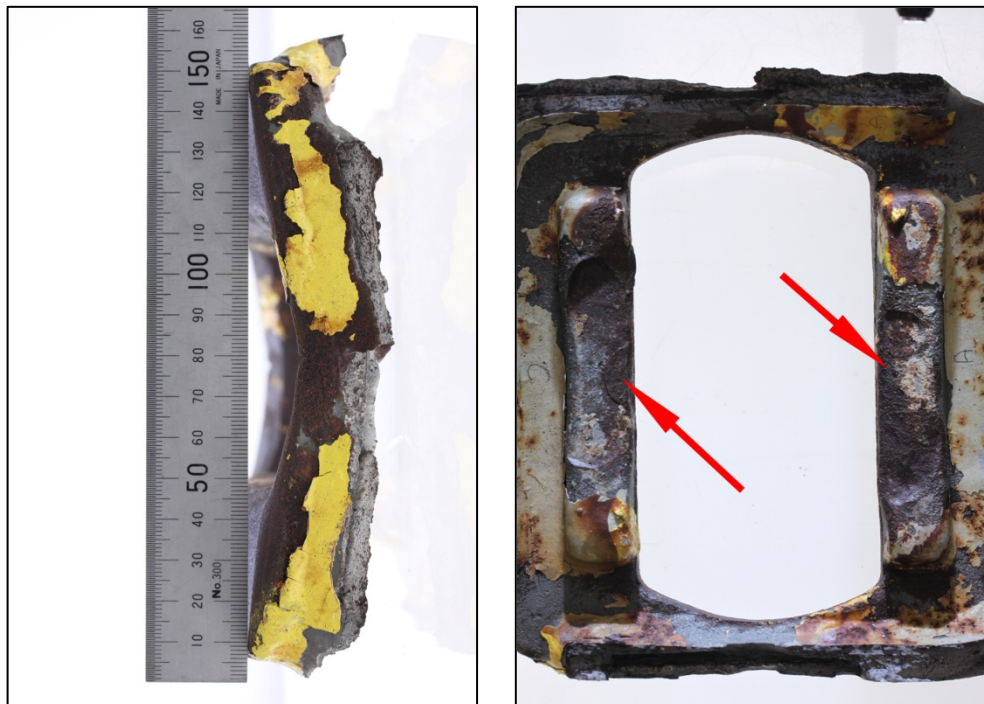
Figure A3a & b: Deformed foundation top plate with two indentations on the underside (arrowed)

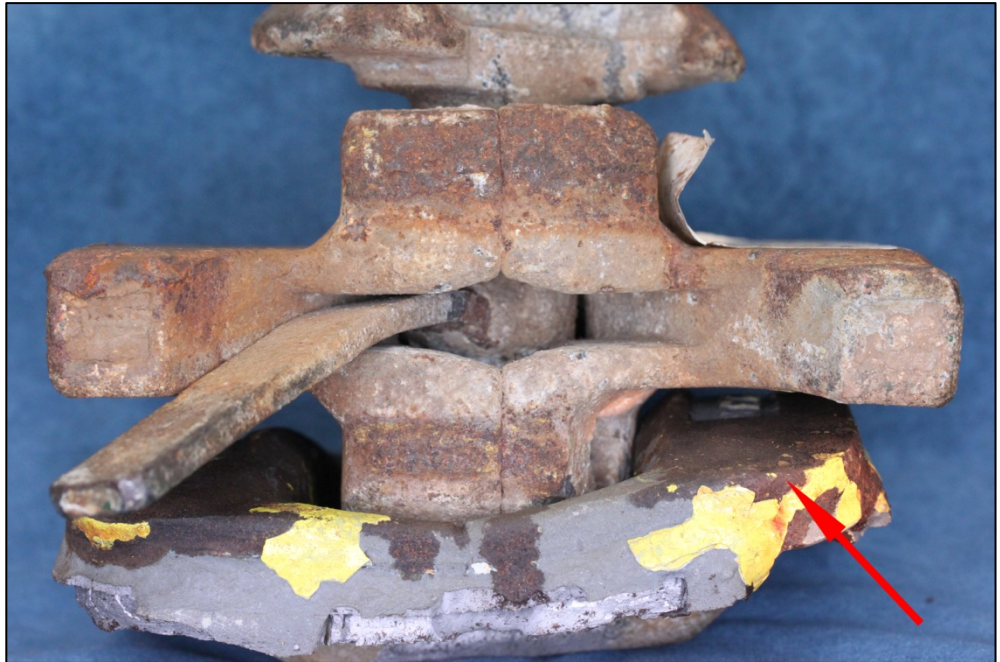
Figure A4: Forward view of the twistlock and top plate; note the angle between them, the bent upper cone plus the flattened facet on the port/forward corner of the foundation top (arrowed)

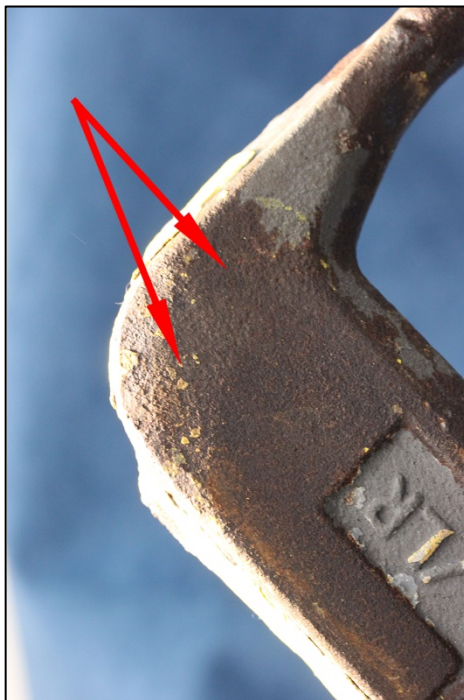
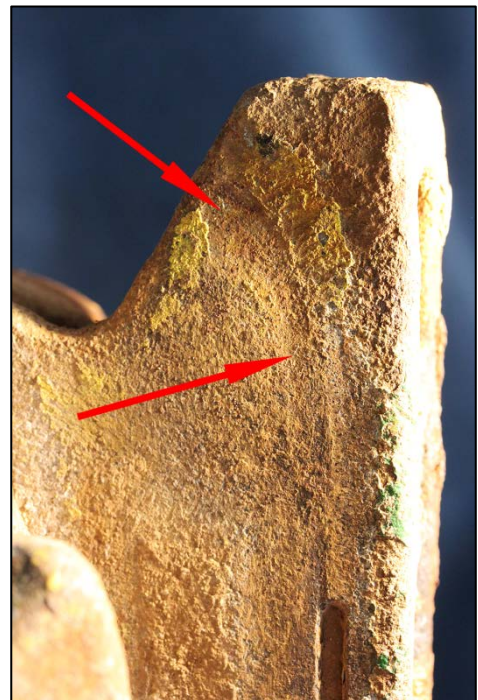
The flat facet indicated in Figure A4 was observed on the port/forward corner of the top plate (Figure A5a). A closer examination revealed that this witness mark also contained two rubbing marks, due to contact with the underside of the twistlock body (Figure A5b).

Figure A5a & b: Flat (arrowed) on the port/forward corner of the top plate and witness mark/paint (arrowed) on the port/forward corner of the twistlock's underside

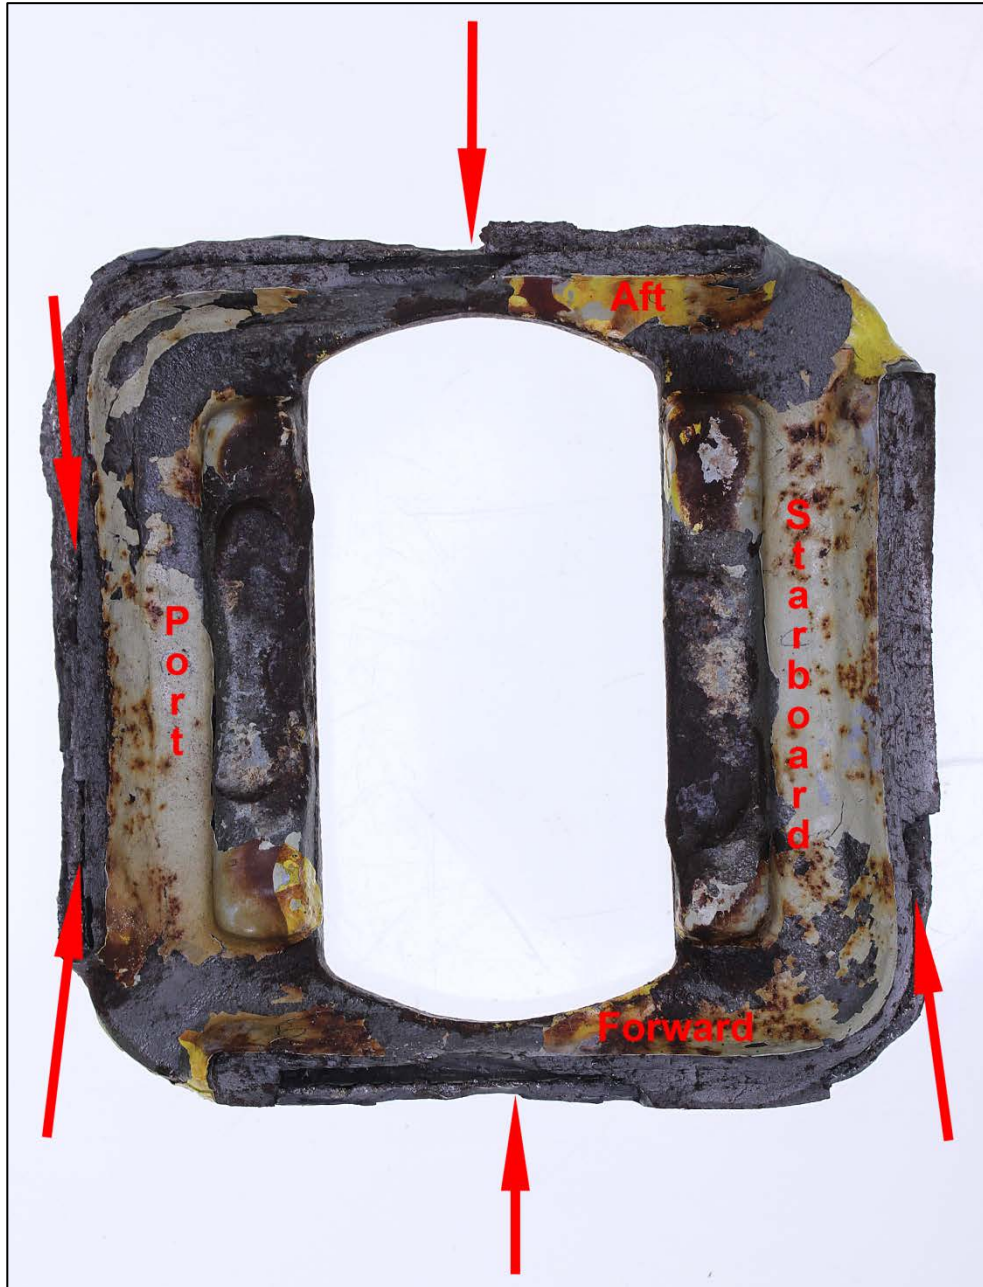
Various fracture zones at the welded junction of the top plate and the two side plates can be seen in Figure A6. Of note are the numerous dark zones adjacent to the grey fracture surfaces. These fracture surfaces contained two modes of failure: overload (via lamellar tearing) and crystalline (brittle) fracturing (Figure A7a).

Figure A6: Grey fracture zones on the top plate; note the numerous adjacent dark zones (arrowed)

Fracturing occurred in a plane that was approximately 5 mm from the junction of the side plate to the top plate, i.e. through the parent metal. The aforementioned dark zones (Figure A7b) at the junction of the external butt weld to the top plate consisted of the original surface of the top plate where welding has not occurred (known as lack-of-penetration) and areas adjacent to them where the butt weld metal has not joined to the parent metal (known as lack-of-fusion). During microscopic examination, these latter areas were found to contain porosity, oxides, inclusions, fisheyes, slag and weld spatter.

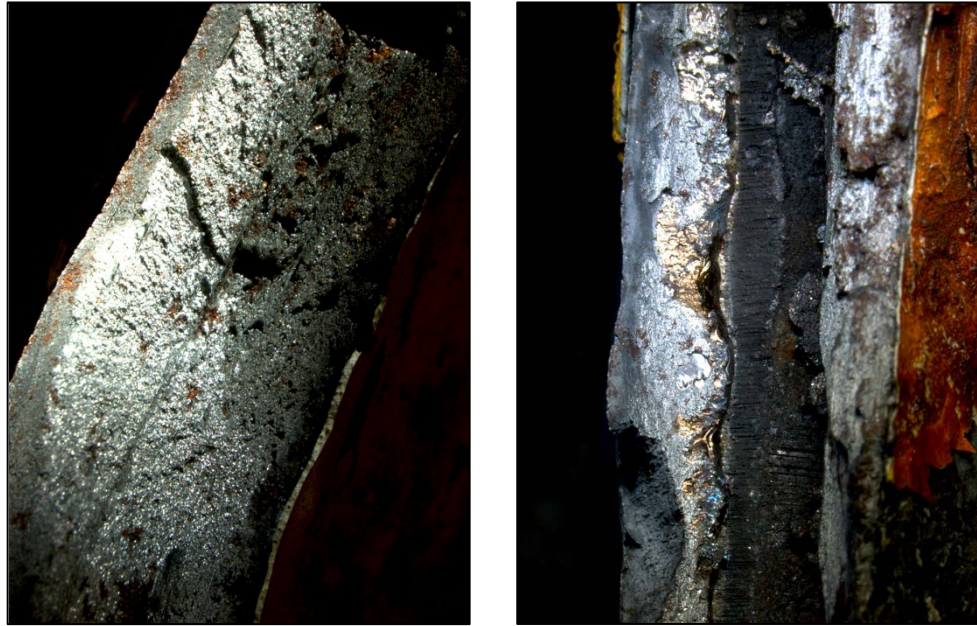
Figure A7a & b: Crystalline (bright) and overload (grey) fractures in the left photo; lack-of-fusion (gold) and lack-of-penetration (dark grey striations) areas are in the right photo

Given the proportion of the lack-of-penetration zones compared with the total, and that these zones, along with the lack-of-fusion zones, cannot carry any load, it was decided to determine the total area of them plus that of the load-carrying areas (crystalline and overload).

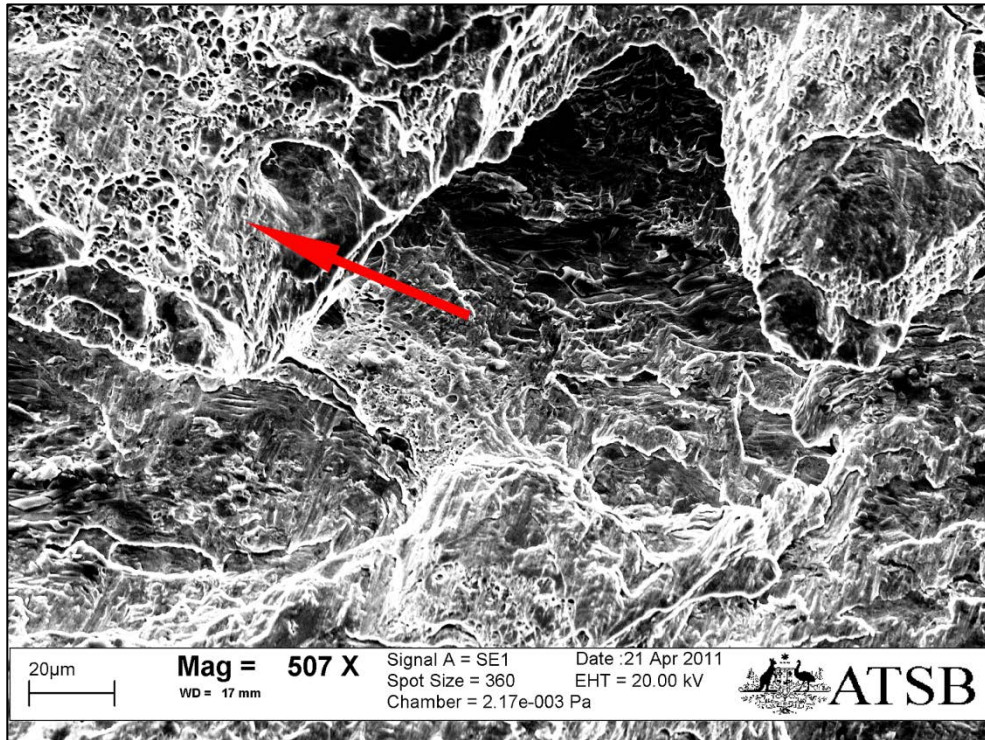
A semi-attached piece of fracture surface near the centre of the port side in Figure A6 was removed and examined using a scanning electron microscope (SEM). At higher magnifications, the surface was found to contain both elongated dimples and shear zones (Figure A8).

Figure A8: SEM fractograph showing elongated dimples (arrowed) and shear zones
