Grounding of the Panama registered bulk carrier *Dumun*

Gladstone, Queensland | 29 April 2011

ATSB Transport Safety Report
Marine Occurrence Investigation
285-MO-2011-004
Final

Report No. MO-2011-004

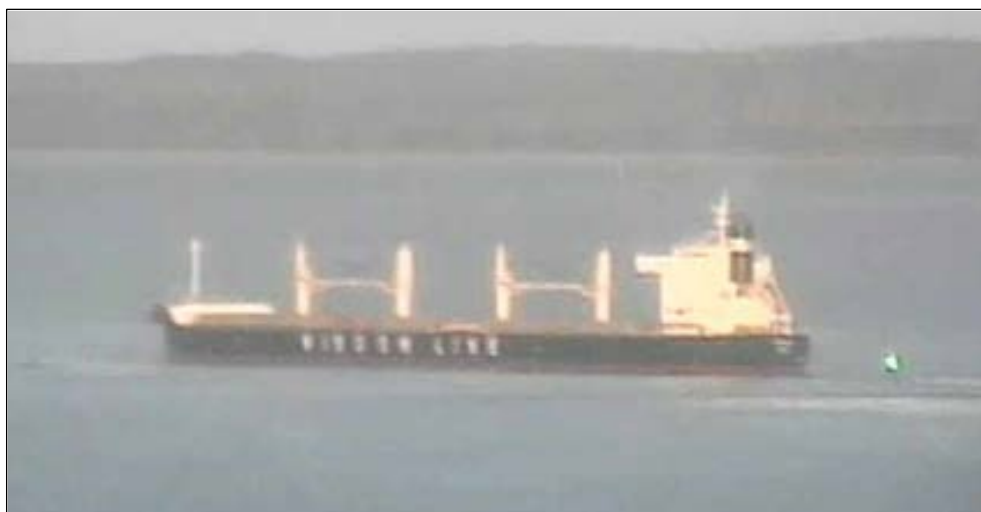
Figure 8: VTS image of *Dumun* aground, with A1 beacon astern

At 1706, the ship came to a stop on a heading of 066° (T) in position 23°50.723S 151°18.473E, with A1 beacon about 40 m off the port quarter (Figure 8).

On 2 May, a complete underwater examination was carried out to the satisfaction of the attending LR surveyor. No structural damage was found but the hull coating was scored and abraded with exposed metal in some areas. The ship's condition was considered suitable to allow it to continue normal operations.

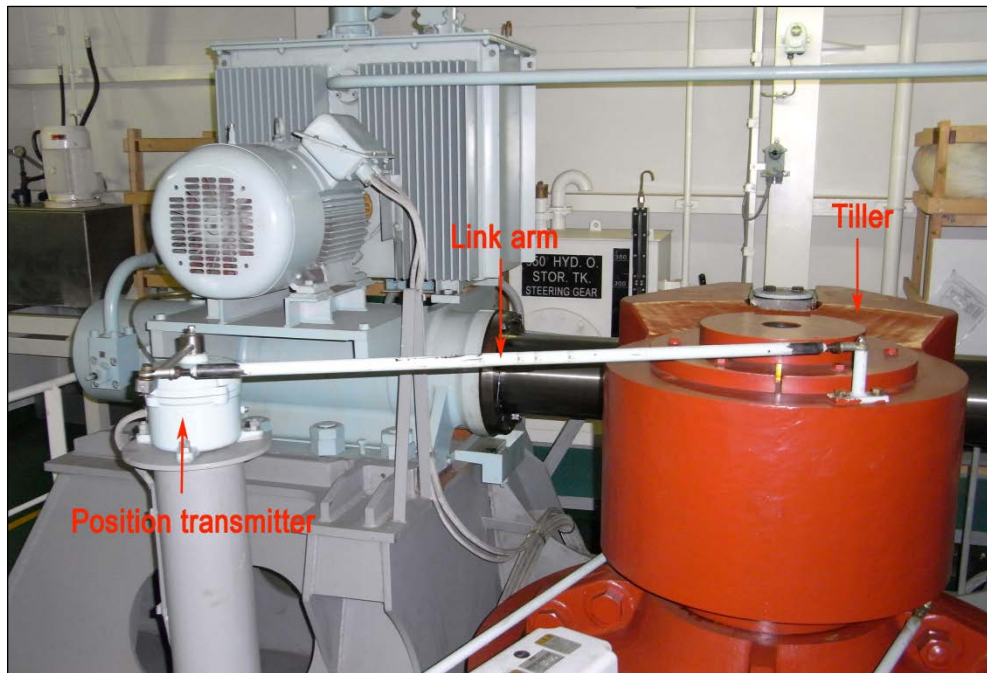
Figure 9: Rudder position transmitter link arm

The chief engineer finished re-fitting the link-arm and then, at 1709, telephoned the bridge to report that the steering had been repaired. However, he was told that the ship had already grounded.

When the engineers arrived at the steering compartment, they saw that the rudder angle indicator transmitter link-arm was not connected to the tiller. The threaded link-arm/rod-end connection (Figure 10) had come loose and the link-arm had fallen out of the rod-end. With this inter-connection lost, the transmitter was not getting an input signal. As a result, the bridge mounted rudder angle indicator was not showing the actual position of the rudder.

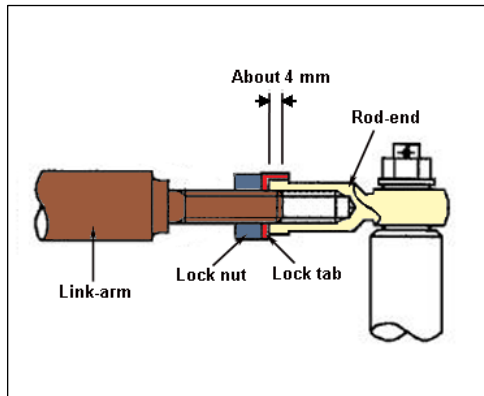
Figure 10: The link arm/end piece joint as it was fitted on board *Dumun*

probably only about one or two circumferences of thread holding the link-arm in place in each rod-end. With only this small amount of thread in place, an appropriate amount of tension could not have been applied to the threaded shaft with the lock nut. As a result, insufficient friction would have been generated to ensure that the connection would not come loose.

The connection should have been prevented from coming loose by the fitted lock tabs. However, an inspection of the lock tabs after the incident indicated that they were probably not fastened tightly and, hence, allowed enough play for the lock nuts to slacken off and for the link-arm to 'drop out' of the tiller mounted rod-end.

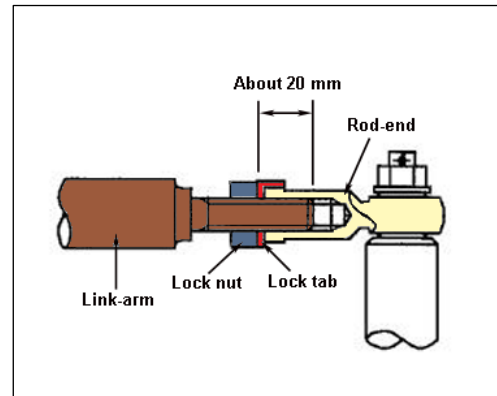
Figure 11: The link arm/end piece joint as it should have been fitted

When correctly fitted, there should have been about 20 mm of thread in each of the two rod-ends (Figure 11). With this amount of thread in place, an appropriate amount of tension could have been applied to the threaded shaft and, as a result, sufficient friction would have been generated to ensure that the connection would not loosen. Furthermore, correctly fitted locking tabs would have provided a further protection against loosening.

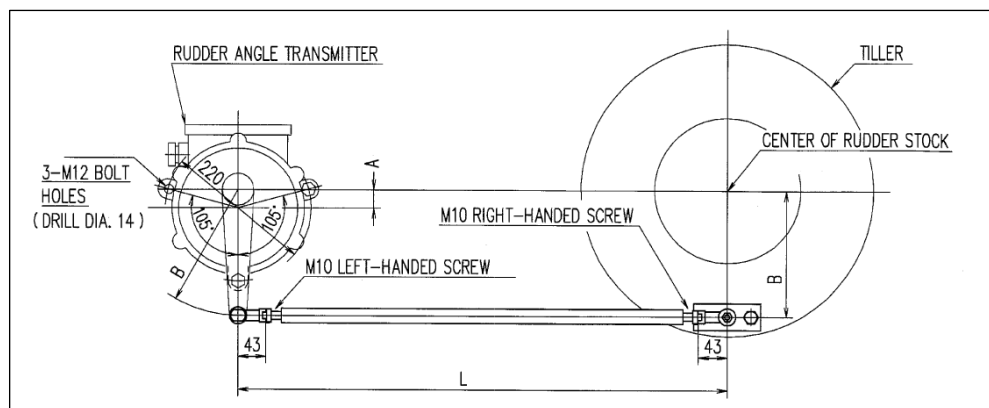
Figure 13: Section of the installation drawing for the rudder angle indicator transmitter

The manufacturer's installation instructions and drawings provided clear guidance regarding the positioning and installation of the rudder angle indicator transmitter and its associated components. The drawings showed where the mounting post for the transmitter should be located relative to the centre of the rudder stock. They also showed where the mounting bolt holes should be drilled in the mounting post top plate (Figure 13).

The drawings showed that, when fitted correctly, the distance between the pivot point of the transmitter and the centre of the rudder stock should be the same as the adjusted length of the link-arm and rod-ends. The drawing also indicated that this dimension (L in Figure 13) should be 1180 mm.

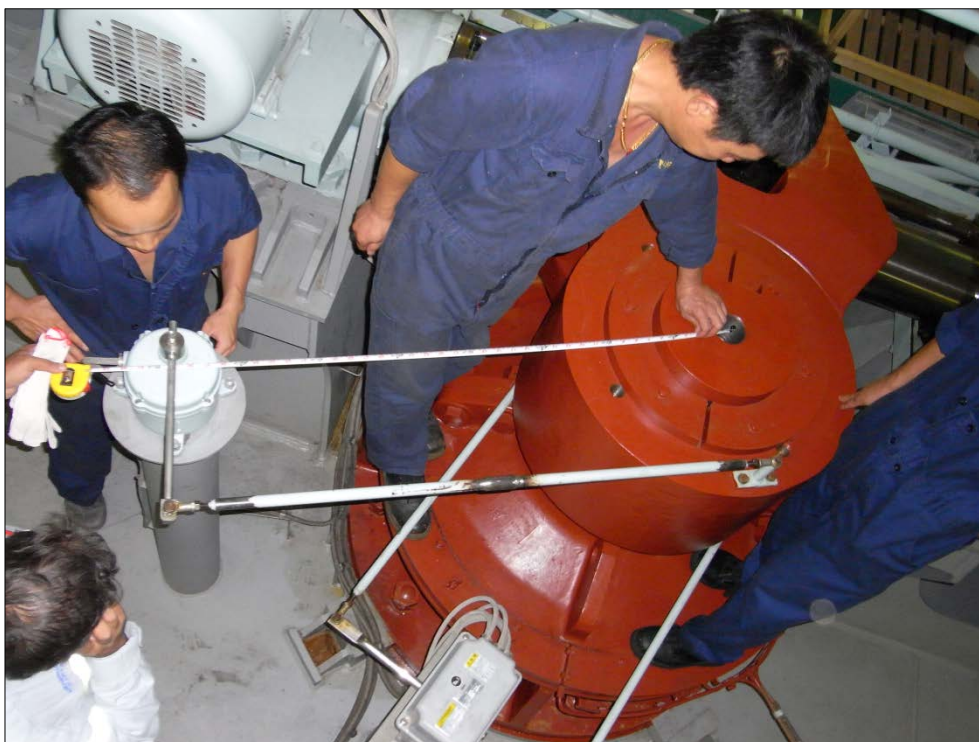
Figure 14: Ship's engineers checking the transmitter/rudder stock dimension

Inspections carried out on board *Dumun* after the grounding, showed that the distance between the pivot point of the transmitter and the centre of the rudder stock was not the same as the adjusted length of the link-arm and rod-ends. The adjusted length of the link-arm and rod-ends was about 25 mm longer (Figure 14).

The inspections determined that the mounting post was in the correct position, but the transmitter had been mounted slightly out of alignment on the mounting post. As a result, the link arm had to be adjusted to its extreme length so that the rudder angle indicator would display the correct rudder position.

The manufacturer's drawings supplied to the ship clearly showed the correct installation arrangement and the critical dimensions. However, the shipyard did not have a commissioning process in place to ensure that the installation and each of the critical dimensions was checked. As a result, *Dumun* left the shipyard with a defect that would inevitably lead to a steering system malfunction.
