Derailment of Ballast Train 8M24N near Broken Hill NSW 11 April 2012

Decisions regarding whether to conduct an investigation, and the scope of an investigation, are based on many factors, including the level of safety benefit likely to be obtained from an investigation. For this occurrence, a limited-scope, fact-gathering investigation was conducted in order to produce a short summary report, and allow for greater industry awareness of potential safety issues and possible safety actions.

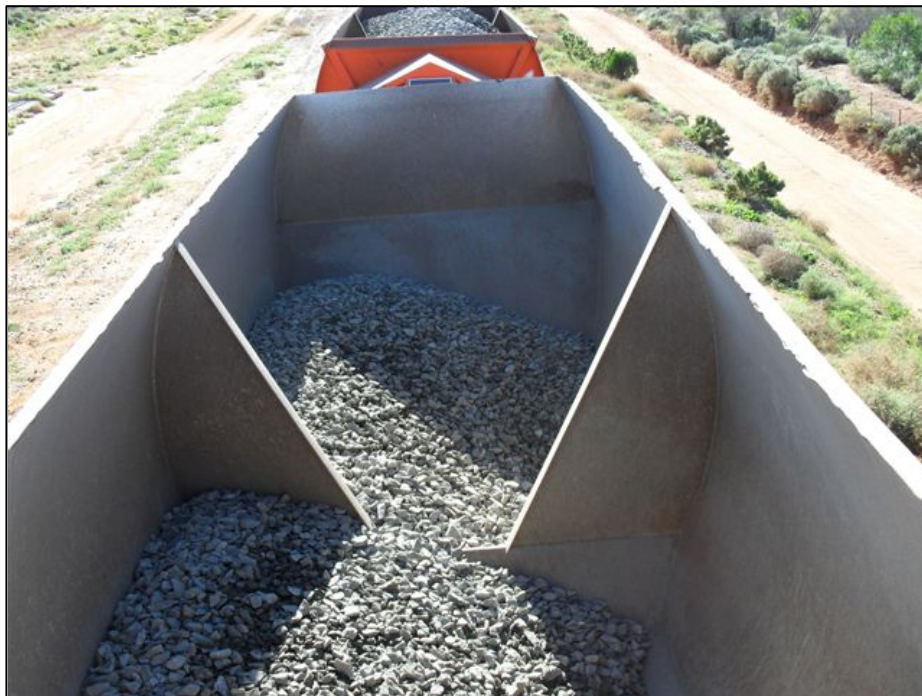
Subsequent to the derailment, there was considerable track damage over a 4 km length. The derailed wagon sustained minor damage and was able to be re-railed. An inspection of the wagon after the derailment found that the load was uneven (Figure 1).

Figure1: Wagon AHBY0001R post derailment showing uneven load

The load in wagon AHBY001R had partially discharged from one door, which resulted in an uneven load. The wagon was therefore unbalanced and, when the train negotiated a curve, the wagon derailed.

To ensure wagons are evenly loaded, the rail operator's procedures for checking the load distribution need to be followed and carried out to the required standard.

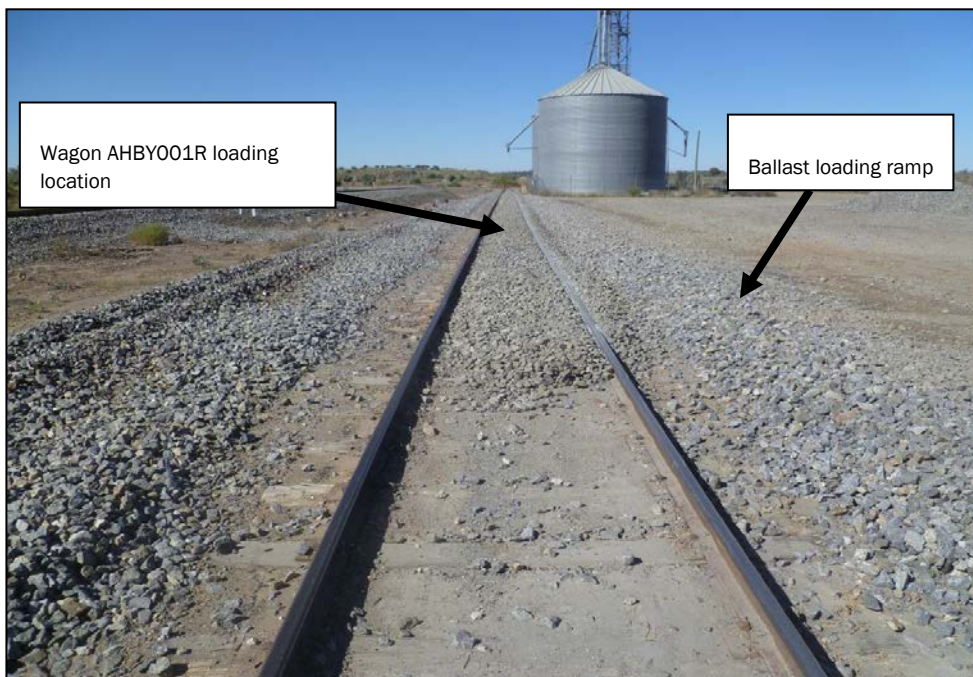
An ARTC investigation into the loading of the ballast train suggested that the front-end loader operator would not have seen if the middle door on AHBY001R wagon was open, due to the loading ramp obscuring his view. The report concluded that the wagon had discharged ballast until there was no more room underneath for it to discharge, as seen by the amount of ballast in the 4 foot² (Figure 2). Once the train was shunted for the final wagons to be loaded, the ballast continued to discharge.

Figure 2: Ballast siding showing ballast in 4 foot and ballast ramp
