## **Appendix A: Technical Analysis Report**

# **Examination of failed landing gear struts MD Helicopters, Model MD520N VH-MPI 21 June 2004**

Report No. 35/04

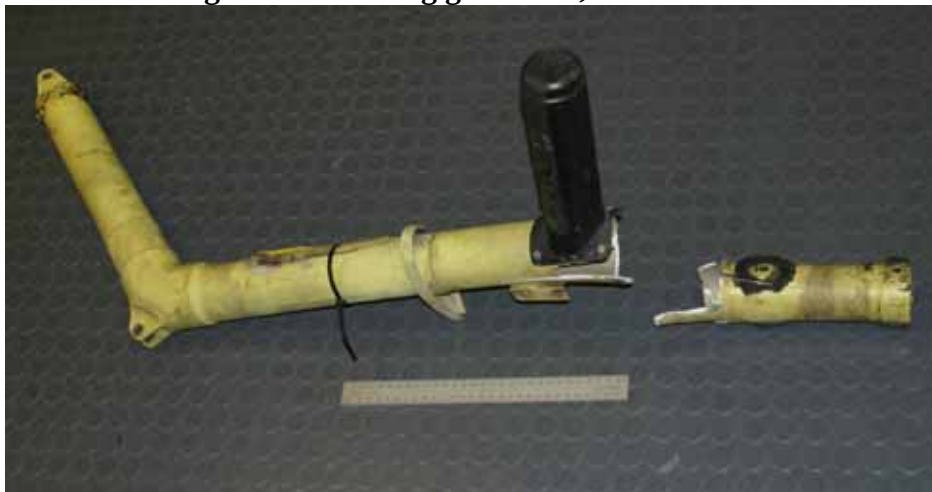
The front landing gear strut had fractured approximately mid-way along its external length at a location coincident with the lower riveted attachment point of the cabin step (see Figure 1). Fracture was predominantly transverse in nature, although the tubular strut section had cracked axially in two locations for approximately 170 mm above the primary fracture plane (see Figure 2). All fracture surfaces were typical of tensile or shear overload failure of the strut material, with no visible evidence of prior cracking or other pre-existing defects. The strut had sustained a degree of bending deformation about the point of fracture, consistent with the outward movement of the strut as the landing gear collapsed.

**FIGURE 1: Right front landing gear strut, as received**

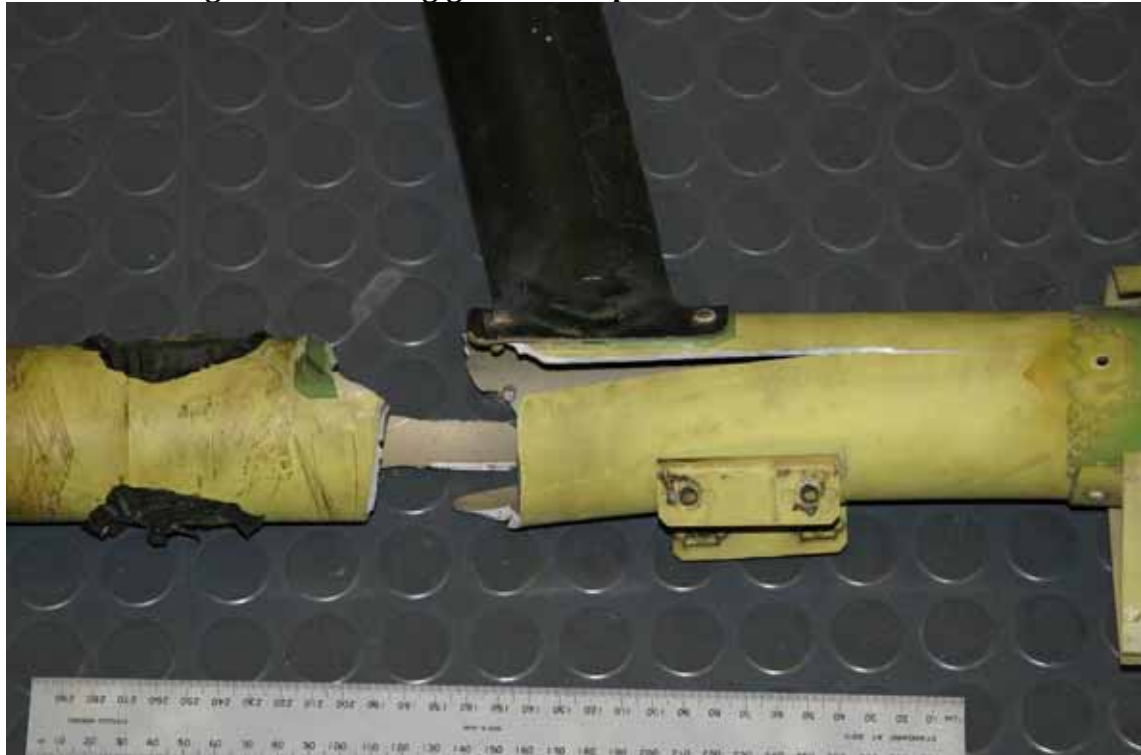
**FIGURE 2: Right front landing gear strut – point of fracture**

**Note the extension of fracture axially and the bending deformation of the associated tube section.**

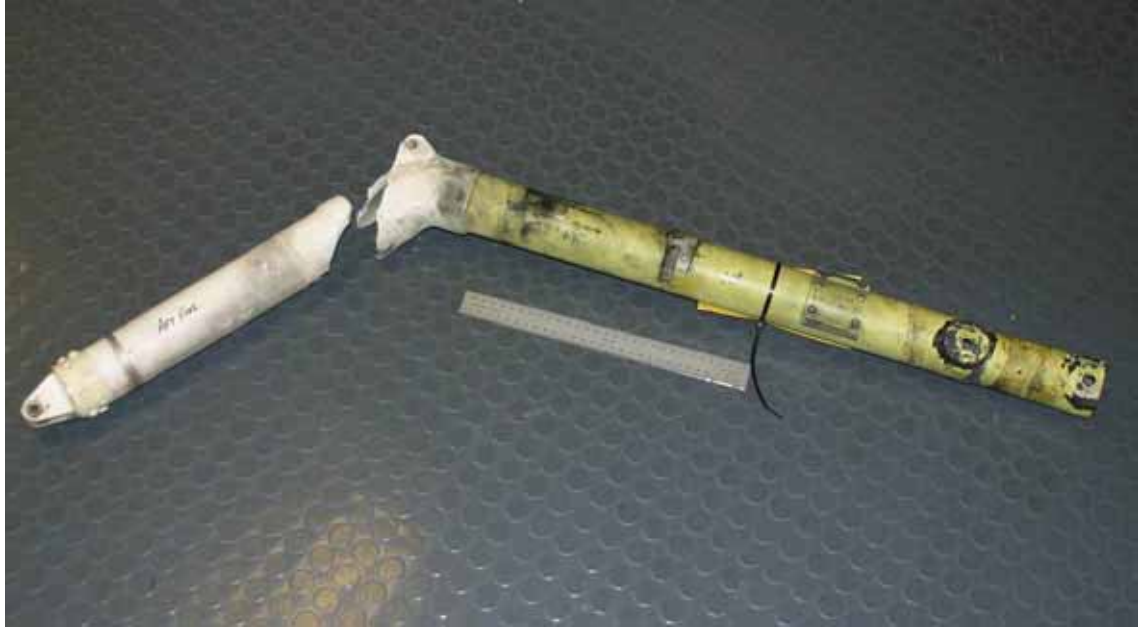
The rear strut had fractured in an irregular, diagonal fashion through the inner end of the reinforced elbow (see Figure 3). The fracture coincided with the lower hole of the skid to drag brace attachment point (see Figure 4). Evidence of a small area of pre-existing cracking was found at the point the fracture intersected the hole bore (see Figure 5) and on closer study, a second area of cracking was noted extending radially from the same hole (see Figures 6 & 7). The main cracked area was triangular in shape and extended radially into the parent strut tube for approximately 0.25" and transversely for almost the full thickness of the tubular strut wall. From external measurement, the second cracked area appeared similar in size.

**FIGURE 3: Right rear landing gear strut, as received**

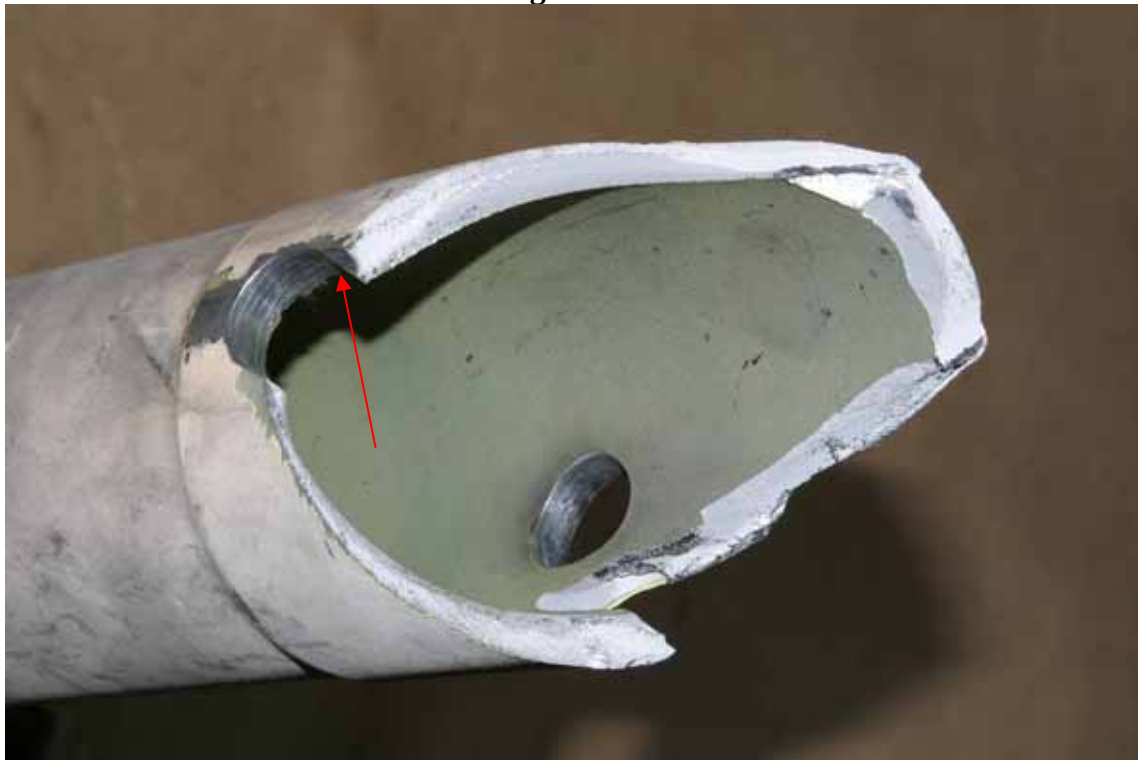
**FIGURE 4: Fracture surfaces of the right rear strut**

**Pre-existing cracking within the drag brace lower connection hole is arrowed**

Both front and rear right landing gear strut legs had failed in gross outward bending overload, in a manner consistent with the loads imposed during the helicopter landing. The strut fracture features pointed to the initiation of failure at an area of pre-existing fatigue cracking within rear strut drag brace lower connection hole. That cracking originated at the roughly machined inner surface of the hole and showed evidence of propagation under high-cycle (vibratory) loading conditions. A second crack of similar dimensions to the first showed a similar orientation and was also suspected as having initiated from the hole surface.

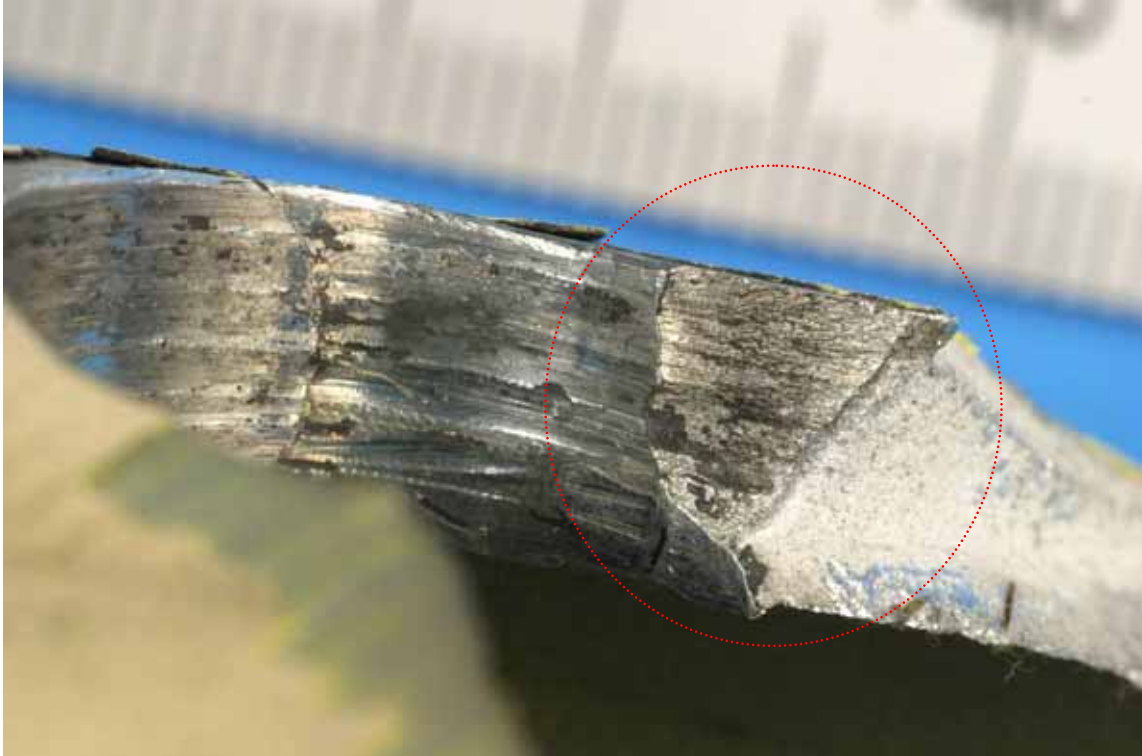
**FIGURE 5: Closer view of the pre-existing cracking (circled)**

**Note the surface oxide products**

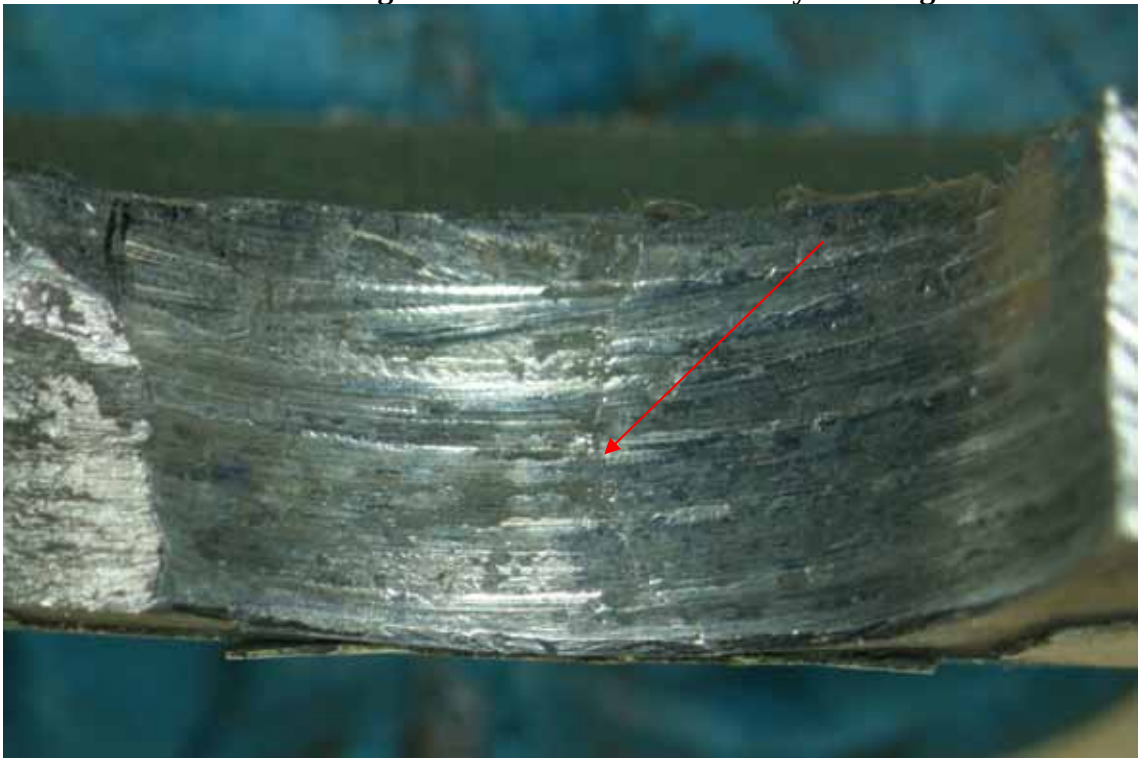
**FIGURE 6: Bore of the drag brace hole with the secondary cracking indicated**

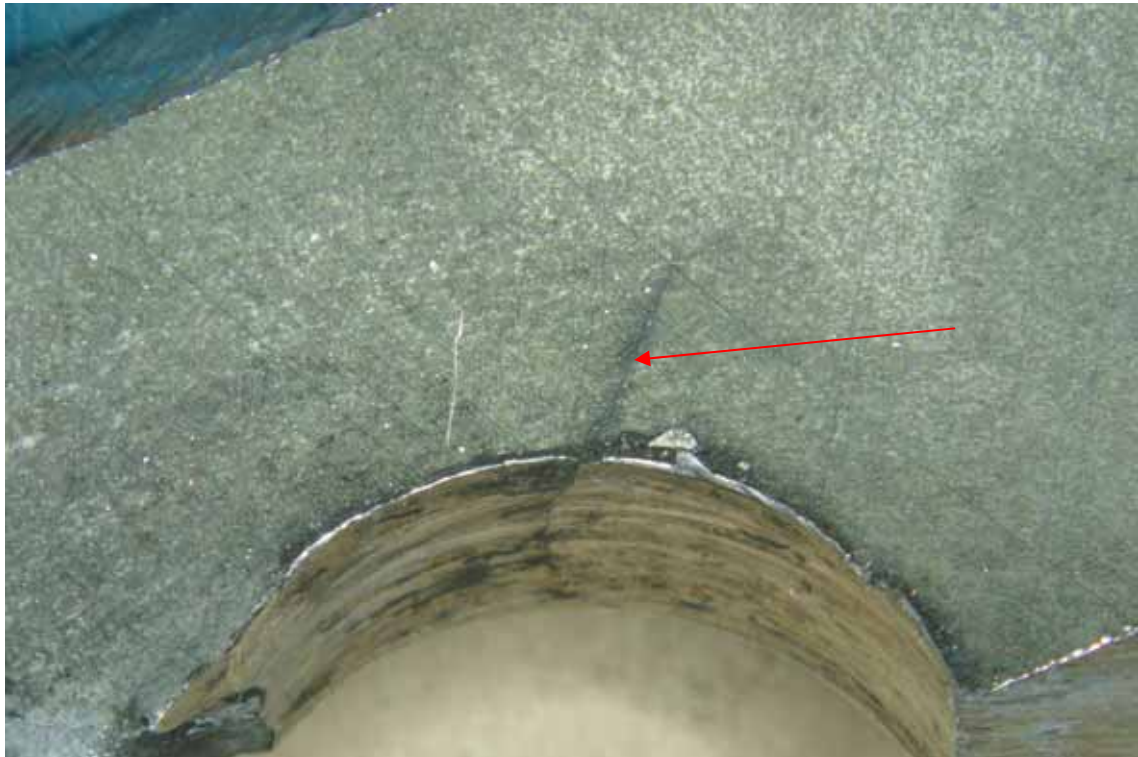
**FIGURE 7: Secondary cracking visible from the inside surface of the strut tubular section**

**Note also the rough machining and flash around the hole periphery**

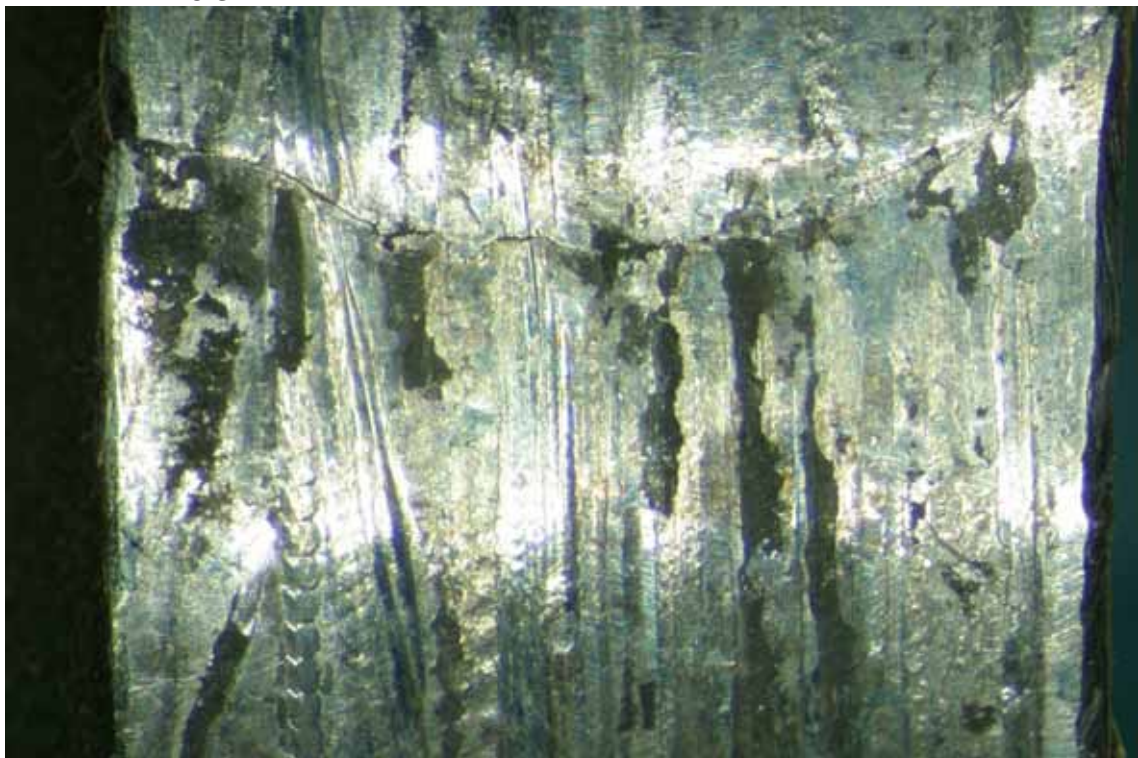
The bore of the hole itself was roughly machined and contained a distinct lip of metal (typical of machining flash) around the inside edges. Irregular areas of dark, oxide like compound were apparent within in the hole bore (see Figure 8) and also extended onto the crack surfaces. There was no evidence of paint or other protective coating material having been applied to the bore surfaces. The bulk of the rear strut fracture resembled that of the front strut and exhibited similar ductile overload morphology.

**FIGURE 8: Oxide (corrosion product) evident within the cracked drag brace hole**

Energy-dispersive x-ray spectroscopy (EDS) was used to qualitatively characterise the dark product observed on the rear strut hole bore and crack surfaces. As such, the material was identified as a mixed aluminium oxide corrosion product, with traces of chloride, sulphide and silicate compounds (see Figure 14). The marine operating environment of the helicopter was a rich source of chloride products.

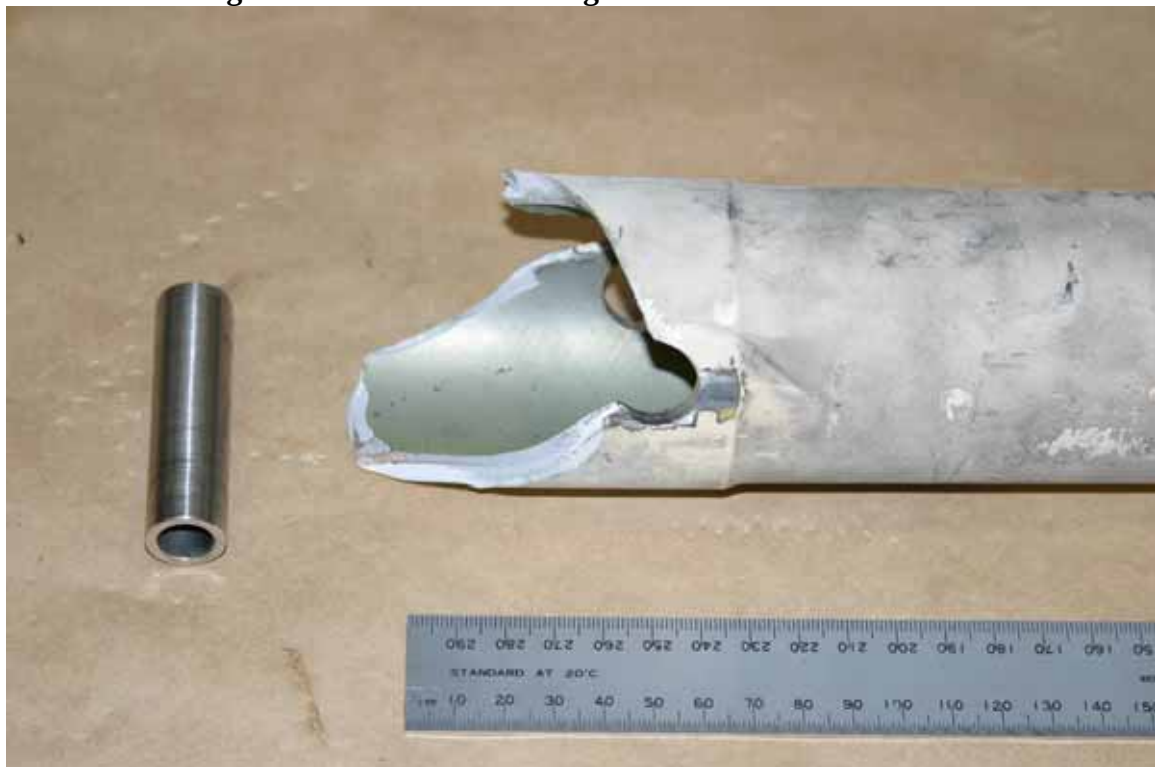
A cylindrical steel bushing had been fitted to the rear strut drag brace attachment point (through which fracture occurred) and served to transmit forward and aft landing gear loads into the drag link (see Figure 9).

**FIGURE 9: Drag brace connection bushing and fractured rear strut**

The bushing component installed at the connection of the drag brace to the rear strut leg was a non-standard item that did not resemble any of the approved parts for the application. The use of an oversize bushing implies the need to ream out or otherwise enlarge the strut hole to suit, with this activity having produced a rough, poorly finished hole surface. The stress raising influence of the rough machining, in combination with the elevated hoop stresses from the (prescribed) interference fit bushing installation were suspected as being prime factors contributing to the initiation of fatigue cracking. The synergistic action of a corrosion mechanism must also be considered, given the presence of a chloride bearing product within the crack confines.

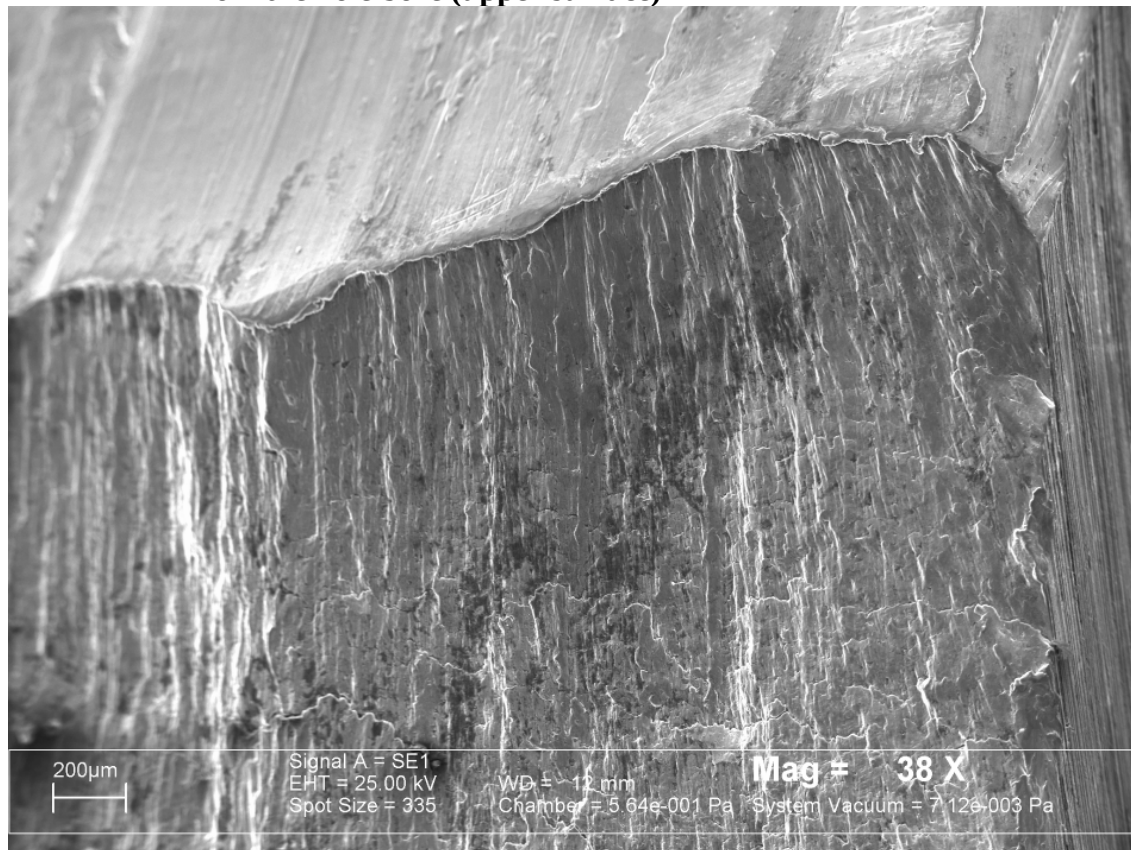
The small area of prior cracking identified within the rear strut drag link hole was cleaned and studied under the scanning electron microscope (SEM). That work identified features typical of progressive fatigue cracking, initiated at multiple locations within the hole bore (see Figure 11). Regular crack progression markings characterised the fracture path to the limit of the prior cracking (see Figure 12), before the morphology changed to the typical dimpled appearance of ductile tensile overload (see Figure 13).

**FIGURE 11: Scanning electron fractograph showing the extension of cracking from the hole bore (upper surface)**

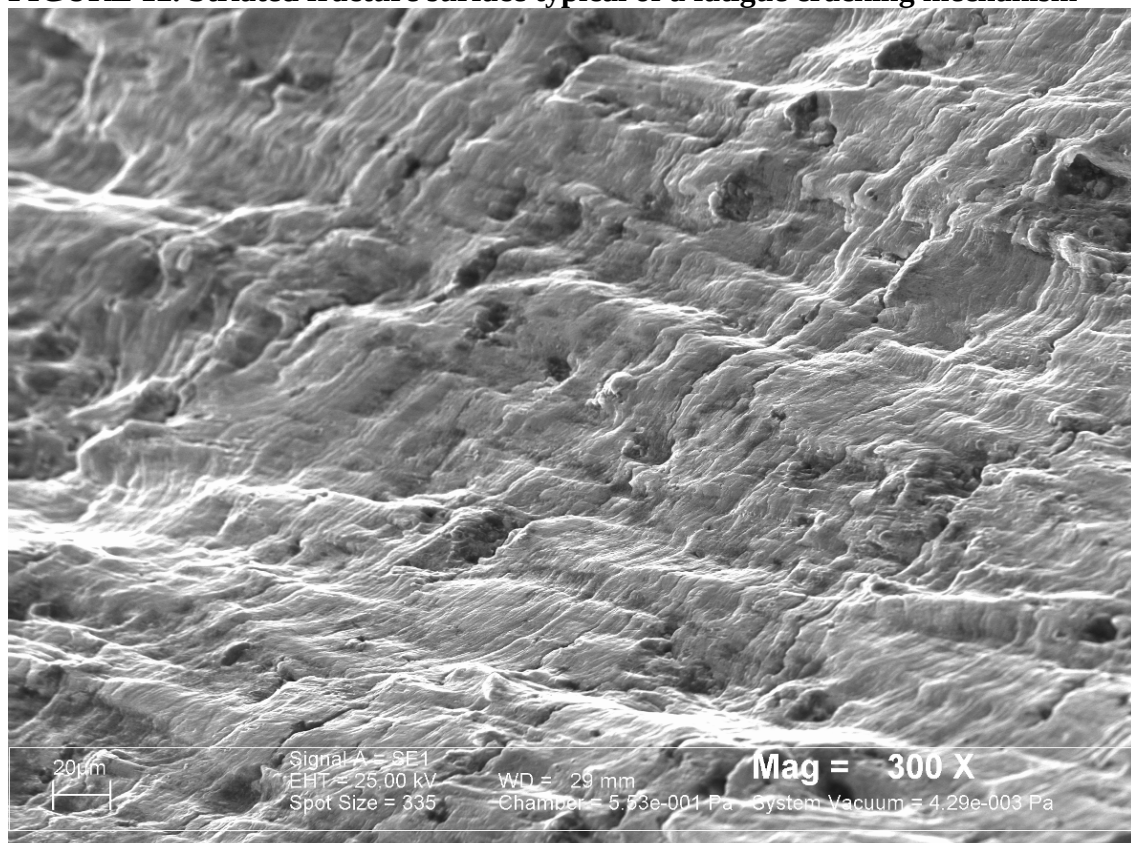
**FIGURE 12. Striated fracture surface typical of a fatigue cracking mechanism**

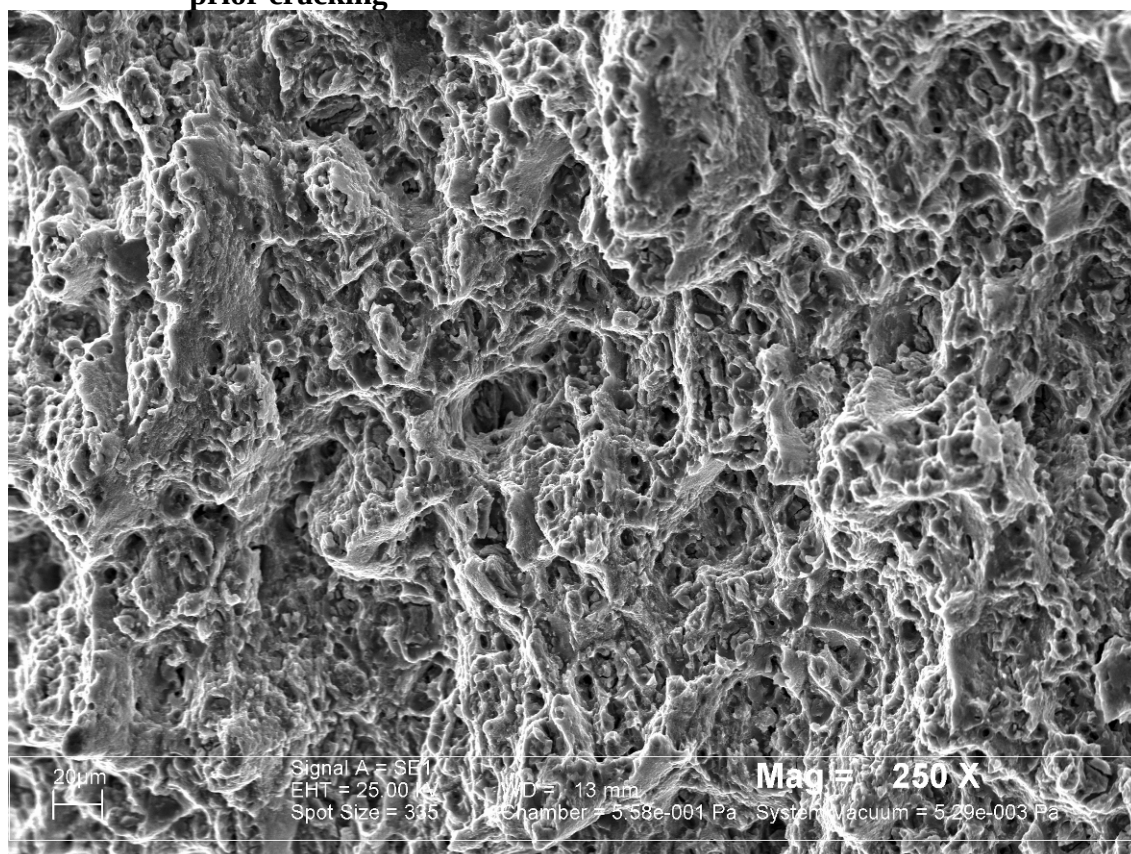
**FIGURE 13: Ductile fracture morphology as evident away from the areas of prior cracking**

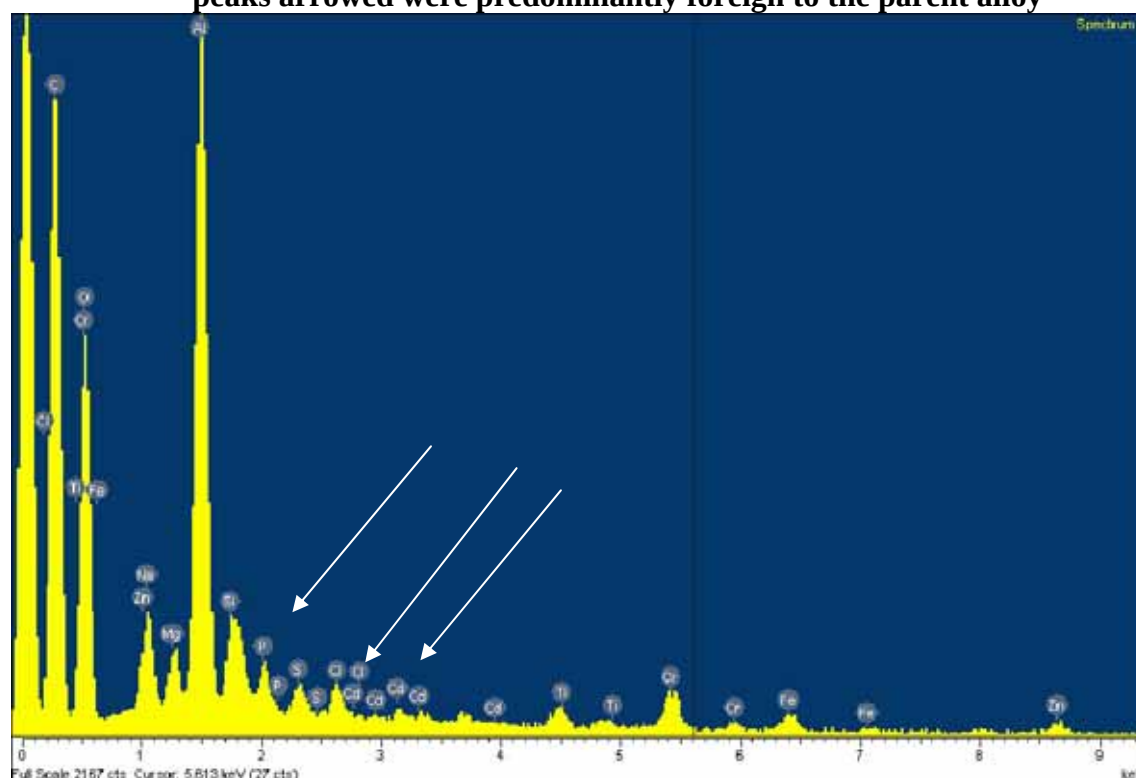
**FIGURE 14: EDS spectrum taken from the crack surface product. Elemental peaks arrowed were predominantly foreign to the parent alloy**
