# Loss of control Robinson Helicopter Company R44 Astro, VH-HFH

Cessnock Aerodrome, New South Wales | 4 February 2011

AO-2011-016

**Report No. AO-2011-016**

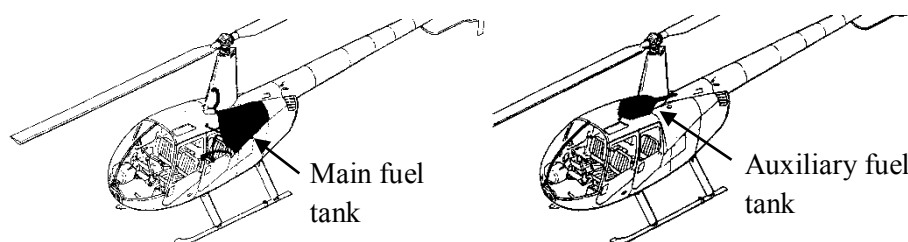
**Figure 6: Fuel tanks**

The R44 was originally manufactured with two all-aluminium fuel tanks that were installed above the engine firewall, either side of the main transmission (Figure 6).

Examination of the wreckage and aircraft documentation confirmed that the helicopter was fitted with all-aluminium fuel tanks.

On 20 December 2010, the manufacturer issued R44 Service Bulletin 78 (SB-78) requiring that R44 helicopters with all-aluminium fuel tanks be retrofitted with bladder-type tanks as soon as practical, but no later than 31 December 2014. The background information to the service bulletin stated:

On 21 February 2012, the helicopter manufacturer released Service Bulletin 78A (SB-78A) that brought forward the date of compliance in SB 78 from 31 December 2014 to 31 December 2013.<sup>5</sup> The manufacturer also released SB-82 that day, requiring the replacement of the rotor brake switch to reduce the chance of a possible ignition source in the event of a fuel leak.<sup>6</sup> The stated time of compliance was 'within the next 150 flight hours or by 31 May 2012, whichever occurs first'.

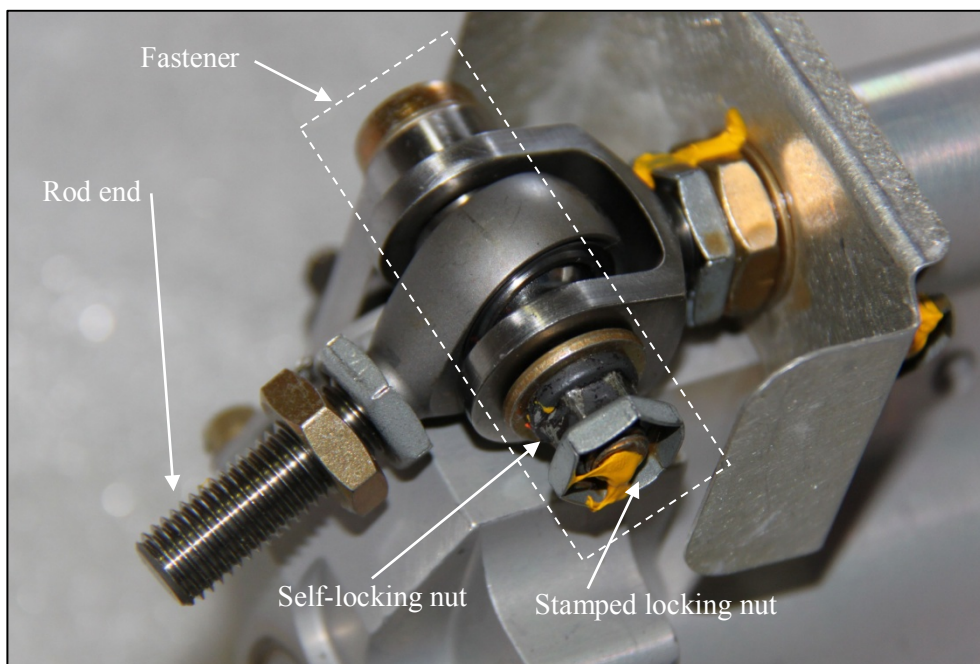
**Figure 8: Lower flight control push-pull tube rod end**

| Date | Event |
|---|---|
| 25 February 2009 | Repair and functional testing of the servo was completed by the manufacturer. The repair required the disassembly of the lower flight control push-pull tube rod end securing fastener (Figures 8 and 9). The repair documentation indicated that, with the exception of the components associated with the leak, all of the original parts of the servo were re-used, <sup>11</sup> and that the servo was repaired and tested in accordance with established procedures. That included duplicate inspections where required. |

The securing fastener consisted of seven individual components, including a self-locking nut and a secondary stamped locking nut (Figures 8 and 9). The assembly of the fastener only permitted detachment of the spacers if the bolt moved free of the rod end. The washer that was located under the bolt head could only detach if the bolt completely separated from the servo. In order to discourage removal of this fastener, the bolt head had an uncommon tri-slot recess that required a specific tool to disassemble/assemble the fastener (Figures 3 and 14).

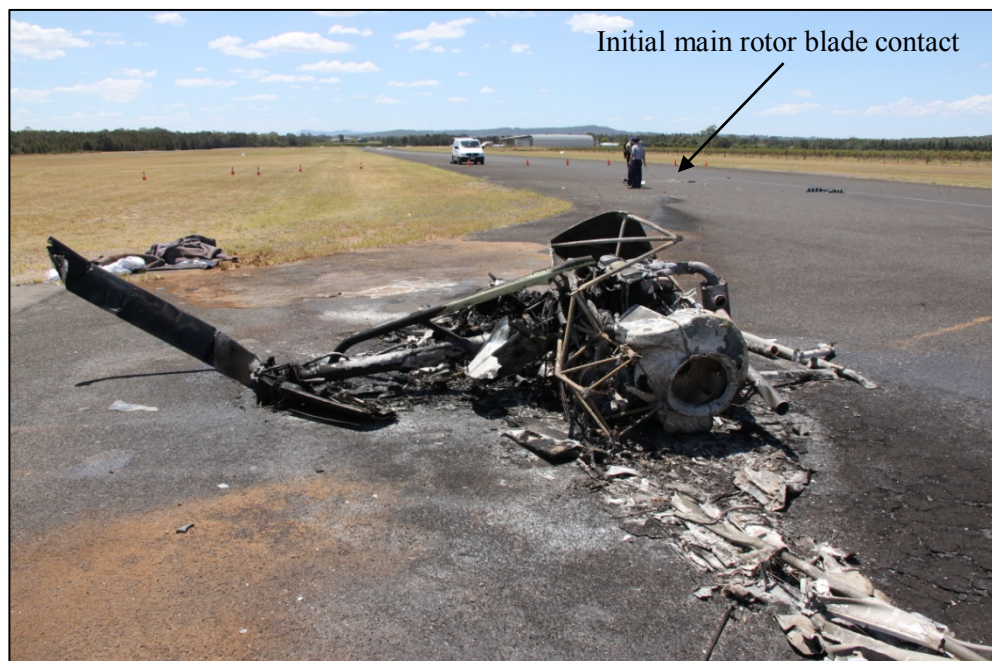
**Figure 10: Accident site**

Examination of the main rotor blades showed that they contacted the runway with significant rotational energy. This was consistent with the pilot's recollection that the engine was operating normally prior to the accident.

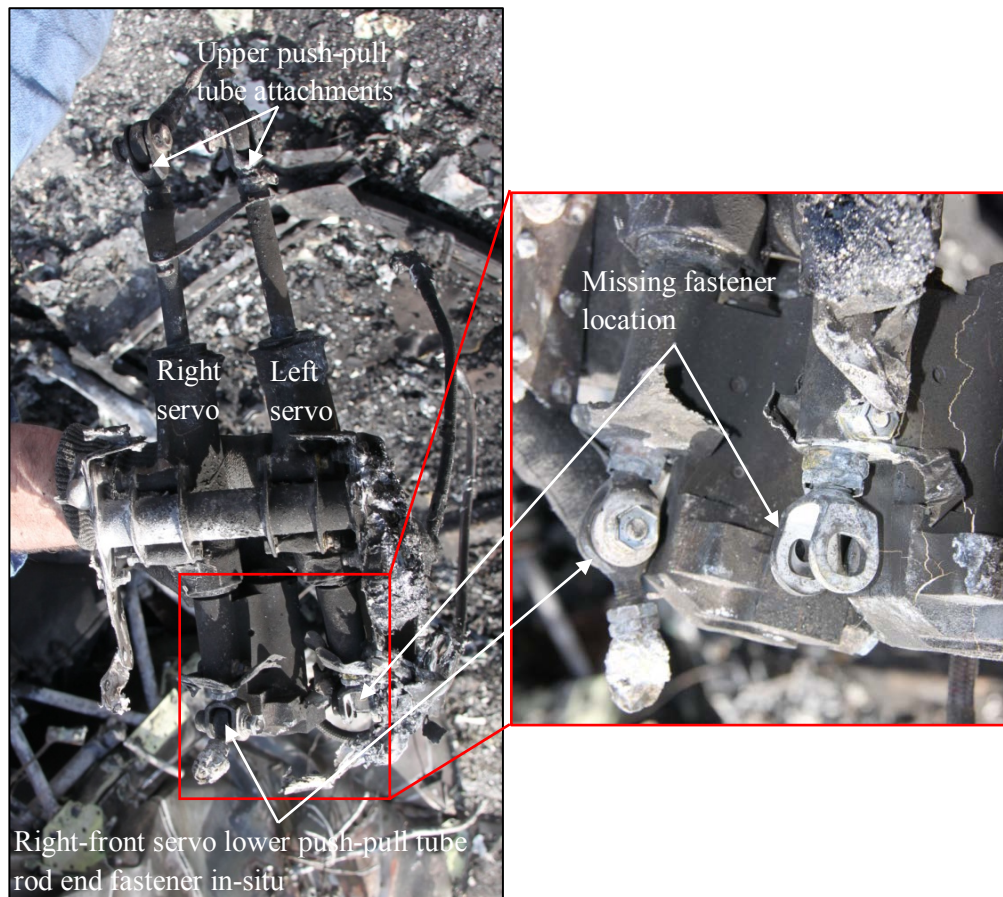
**Figure 11: Front hydraulic-boost servos**

On-site wreckage examination identified that the securing fastener that retained the lower flight control push-pull tube rod end to the left-front hydraulic-boost servo was missing (Figures 11 and 13).

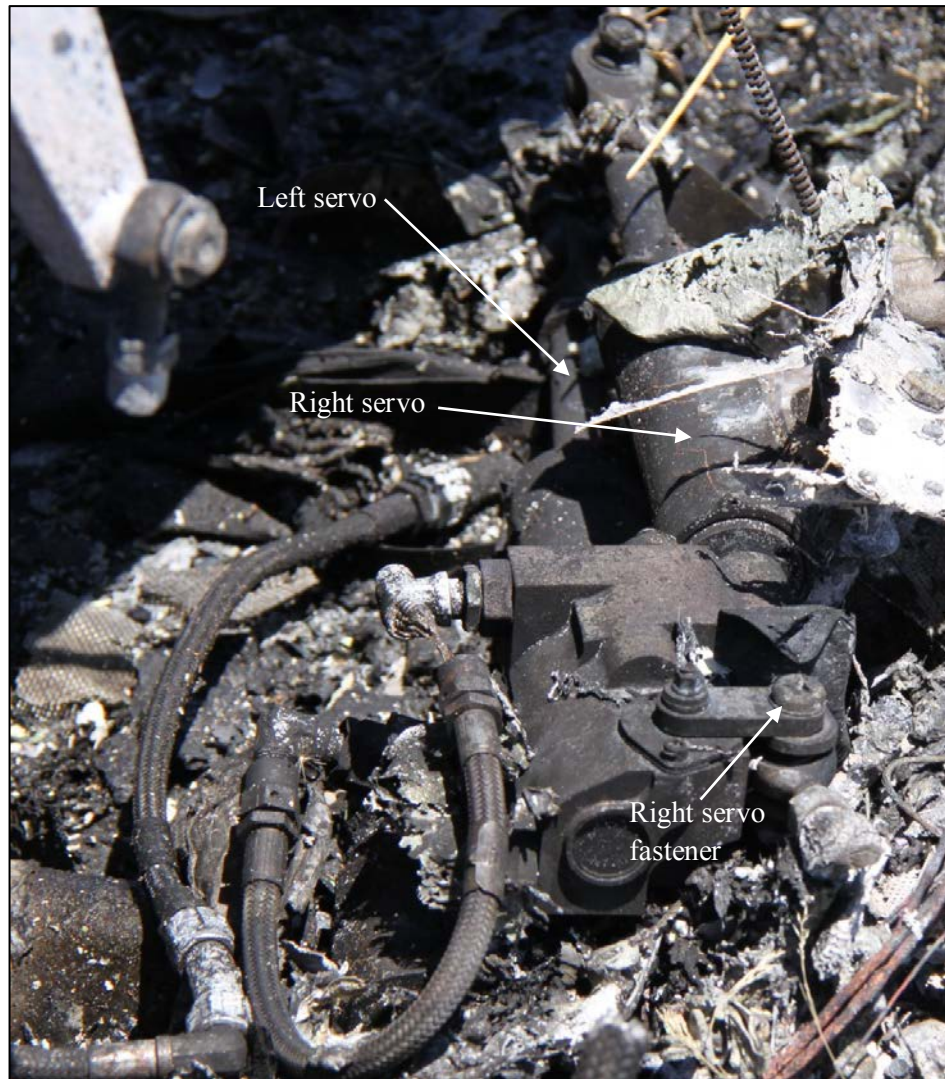
Figure 12: Position of the front hydraulic-boost servos in the wreckage

The lower push-pull tube rod end was subsequently found in the vicinity of the front servos (Figure 13). The bolt was also located within the wreckage close to the cabin floor (Figures 13 and 14) and about 1 m from the installed position of the front servos.

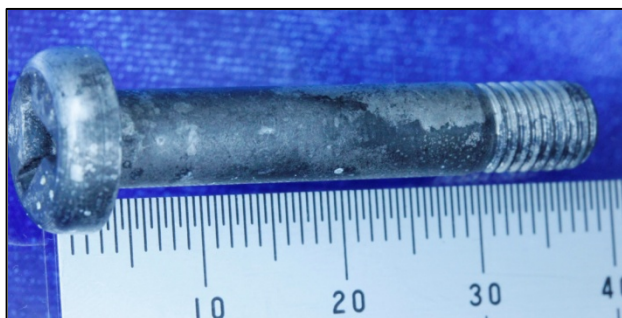
**Figure 14: Detached bolt**

The hardness of the bolt was found to be less than that specified; however, this may have been due to the post-impact fire as the bolts from the right-front and aft servos were similarly affected. There was no evidence of damage to the bolt head that might suggest tampering (see the section titled *Testing conducted by the ATSB*). Some of the witness marks on the bolt's thread and tri-slot head indicated that a self-locking nut had previously been fitted to the bolt and that the fastener had previously been disassembled. This was consistent with the documented repair history of the left-front servo.

The absence of physical damage or defect on the detached bolt, combined with the testing conducted by the Australian Transport Safety Bureau (ATSB), identified that the fastener likely failed as a result of its incorrect assembly, or a material defect that affected the serviceability of the retaining nuts, or a combination of both.

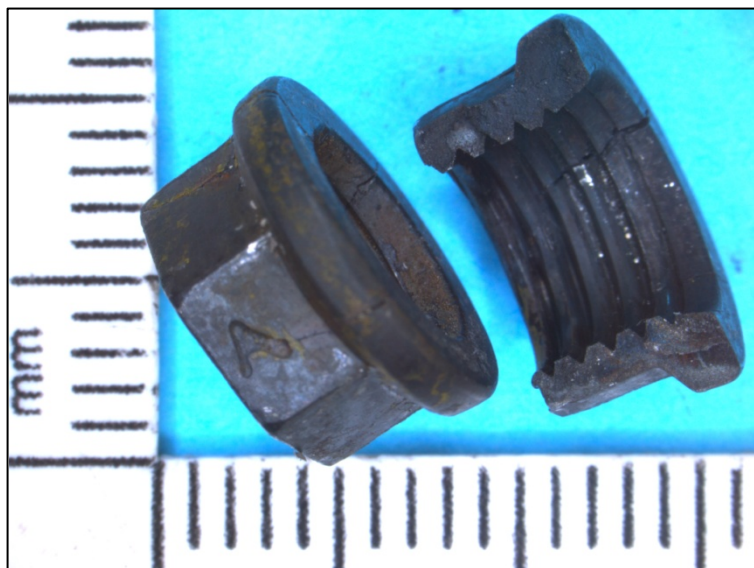
**Figure 15: Cracked self-locking nuts**

During the examination of the hydraulic-boost servos, a number of cracked self-locking nuts that secured the servos to the helicopter were identified (Figure 15). These nuts were of the same type as those fitted to the detached fastener. Detailed analyses of these nuts identified that they had failed due to the effect of the post-impact fire and not a pre-existing defect (see the section titled *Liquid-metal embrittlement*). No cracks were identified in any of the stamped locking nuts.

Liquid-metal embrittlement is a sudden, brittle failure that occurs when a normally ductile metal is coated with a thin film of liquid metal while sufficiently stressed. An examination of the fracture surface of one of the self-locking nuts from VH-HFH identified a pattern that was characteristic of liquid metal embrittlement. In a cross-section of another of the nuts, cadmium was detected remote from the originally-plated surface, indicating that it had flowed in the liquid form. The source of the liquid metal was the cadmium plating that normally plated the nuts, but had melted during the post-impact fire.

The presence of cracked self-locking nuts, which were identified to have failed due to liquid metal embrittlement, introduced the possibility that the fastener failed during the post-impact fire. Assuming that the fastener was correctly assembled, a failure mechanism would have been required that enabled both nuts to separate from the bolt. While cracked self-locking nuts were identified in the wreckage, no cracked stamped locking nuts were identified. In any event, given the orientation and relative position of the front servos, it was unlikely that the bolt could have fallen free of the servo, even if both the nuts were absent. Finally, the distance that the bolt was found from the virtually co-located front servos and lower push-pull tube rod end was not consistent with it having detached during the post-impact fire.

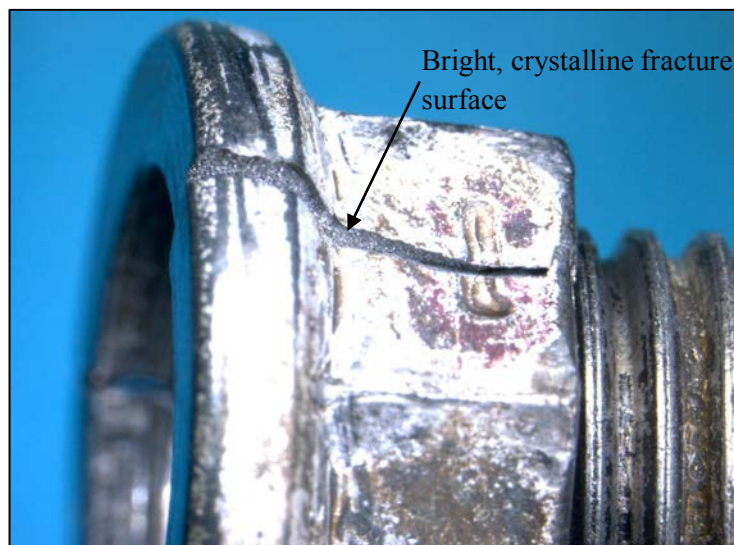
**Figure 19: Cracked self-locking nut following paint removal**

During the course of this investigation, three cracked self-locking nuts (Figure 19) from R22 helicopters, of the same specification as that fitted to the detached fastener, were subjected to detailed examination. This examination identified that they had cracked due to hydrogen-induced delayed cracking.

When high-strength steel, which has been exposed to hydrogen is sufficiently stressed, it can fail prematurely in a sudden, brittle manner. In the case of the examined self-locking nuts, the source of hydrogen was likely to have been from the cadmium plating process that was specified during manufacture for corrosion resistance. Under conditions of sustained stress, such as that associated with an assembled fastener, plus any residual tensile stresses from manufacturing, the presence of hydrogen can result in brittle cracking, typically less than 1 week from the time of application of the sustained stress.

The helicopter manufacturer advised that two of the self-locking nuts that were examined were from a different lot number to that of the locknut that was fitted to the detached servo fastener. The origin of the third cracked self-locking nut could not be established.
