# Aviation Short Investigation Bulletin

Issue 11

**Report No.** AB-2012-088

**Publication date** 3 August 2012

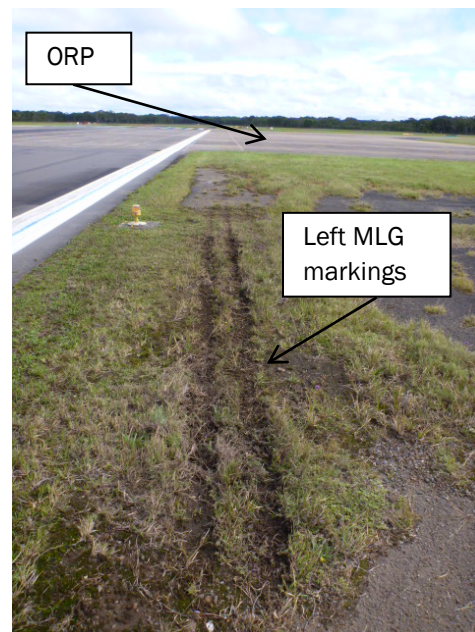
An inspection of the wheel markings showed that the left main landing gear departed the ORP adjacent to runway 12, 145 metres from the threshold, tracking straight (Figure 1).

**Figure 1: Wheel markings (looking back in direction of threshold runway 12)**

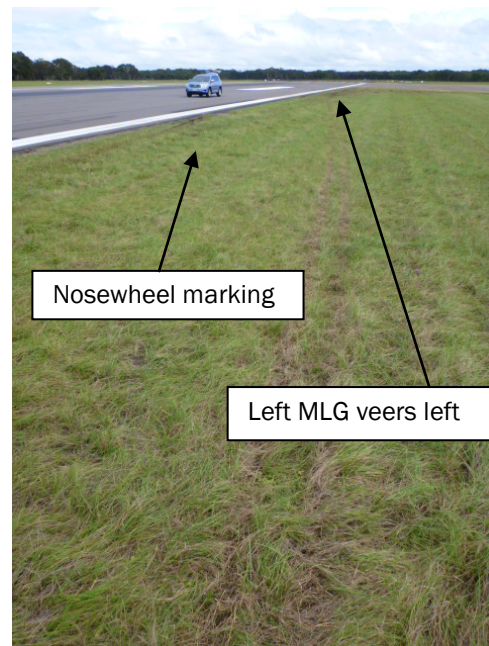
The aircraft then veered left and the nosewheel entered the grass at about 180 metres (Figure 2).

**Figure 2: Wheel markings, left MLG and nosewheel**

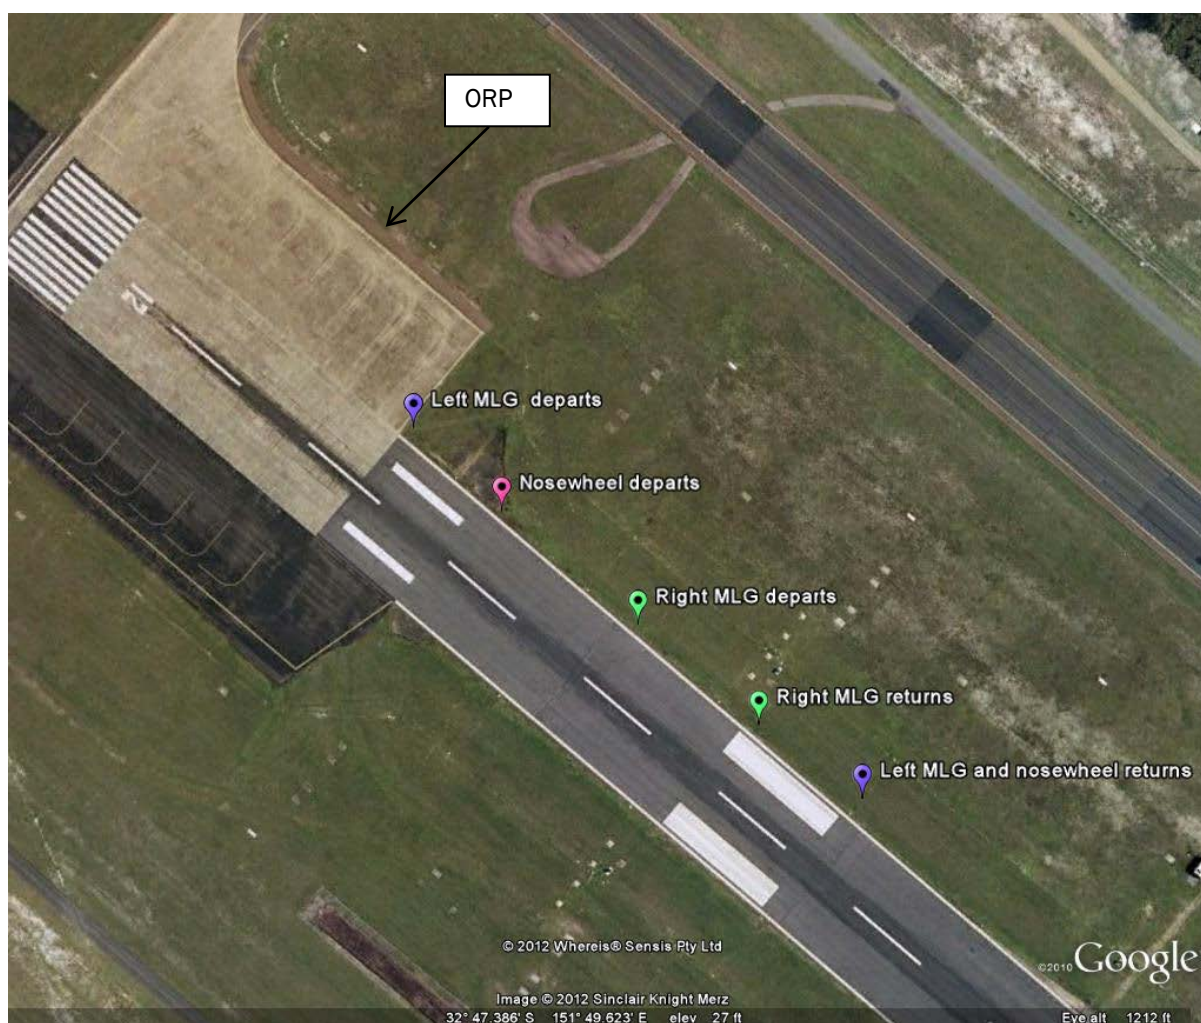
The right main landing gear contacted the grass at about 240 metres after impacting a runway edge light. The right main landing gear re-entered the runway at about 300 metres, with the nose wheel and left main landing returning to the sealed runway surface at about 330 metres (Figure 3).

Figure 3: ORP and approximate location of runway excursion wheel markings

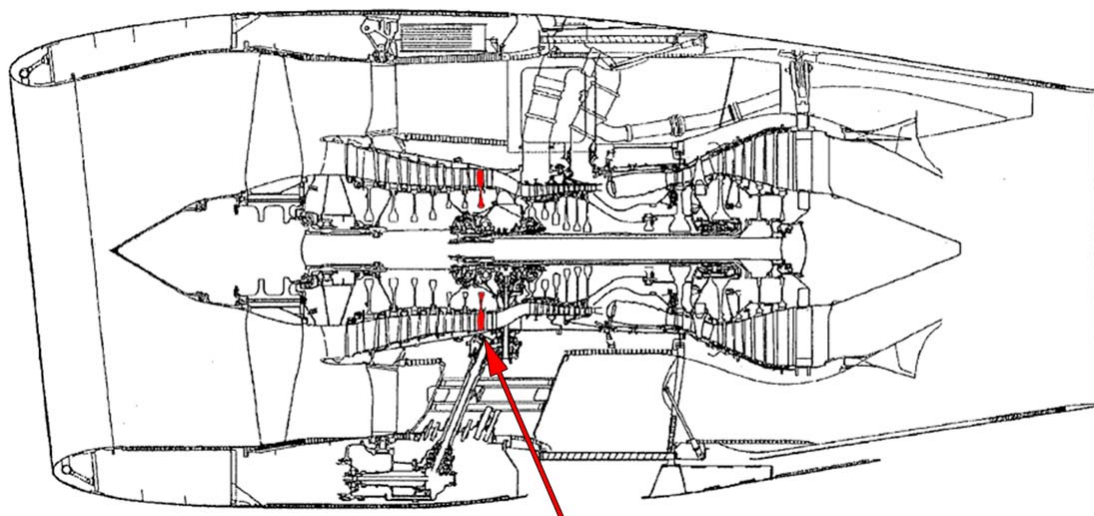
The initial inspection showed that a single, stage 7 intermediate pressure compressor (IPC) blade had separated from its slot in the compressor disc (Figure 1). Disassembly of the engine confirmed the blade release and revealed significant damage to the remaining IPC blades as well as to the surrounding components.

The released blade was destroyed as a result of its passage through the engine. The condition of the recovered blade fragments was such that identification and physical analysis of the blade release mechanism was not possible.

**Figure 1: RB211-524 engine with stage 7 IPC rotor highlighted**

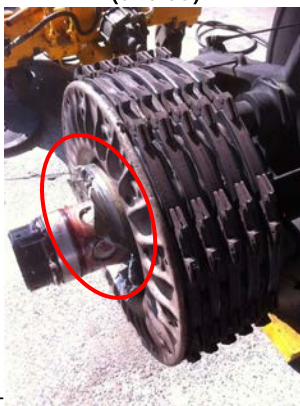
On 8 November 2011, a Virgin Australia Boeing 737-8FE aircraft, registered VH-VUF (VUF), was being operated on a scheduled flight from Melbourne, Victoria to Sydney, New South Wales. At approximately 0820 Eastern Daylight-saving Time (EDT)<sup>1</sup>, after landing at Sydney Airport, the crew experienced difficulty in taxiing to the gate, reporting that excessive engine thrust was required during the taxi and that the aircraft was difficult to steer. A subsequent inspection found the No. 4<sup>2</sup> main wheel had failed at the radius of its hub (Figure 1). Relevant identification details on its rim were the part number (2615480-1) and serial number (B8645).

**Figure 1: No. 4 axle with remnants of wheel hub (circled).**

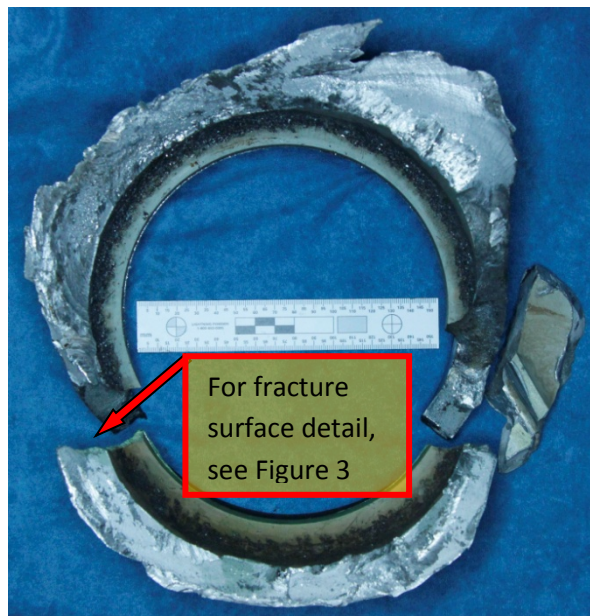
The wheel's hub had separated from its rim and had broken into three principal (Figure 2) and three sub-60mm pieces.

**Figure 2: Principal pieces of the wheel hub**

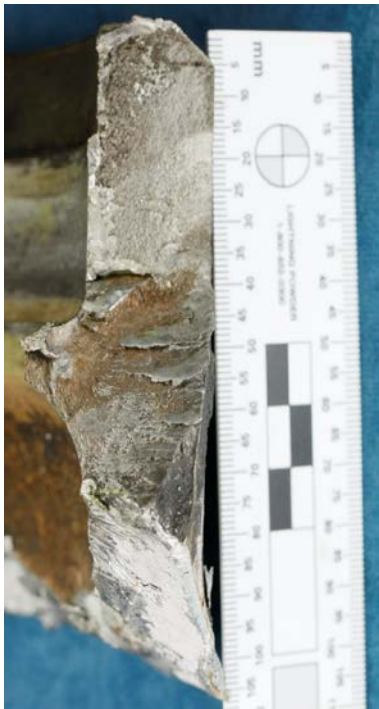
Examination of the fracture surfaces showed two zones: a discoloured zone concentrated around the bearing shoulder and the remaining, bright, metallic-grey zone (Figure 3).

**Figure 3: Discoloured and grey fracture zones**

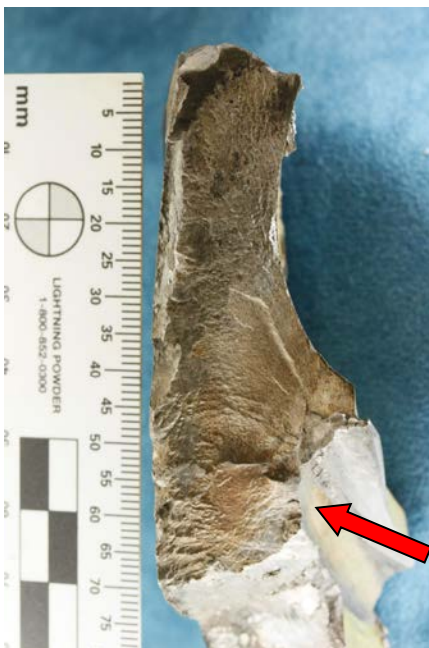
Oblique lighting showed chevrons emanating from the bearing shoulder radius (Figure 4). Microscopic examinations of the radius showed fatigue cracks adjacent to the shot-peened area (Figure 5). Their presence was confirmed with fluorescent dye penetrant.

**Figure 4: Fracture surface of the small piece; note the chevron origin at the bearing shoulder radius (arrowed).**

The wheel manufacturer made a change to the design of new production wheel components, incorporating shot peening of the entire bearing bore area to help prevent the fatigue cracks from developing. This change was introduced at wheel assembly serial number B15419. The improved wheels were intended for delivery on new aircraft at line number 3099; scheduled for November 2009 (extract from AO-2009-062).

Virgin Australia issued Technical Advisory B737-TA-32-005 on 28 November 2011. It specified that, if abnormal ultrasonic indications were detected in the hub-bearing bore of the wheel inner-half, then an eddy current inspection is required. If that inspection detects cracks, the wheel half shall be quarantined, awaiting disposition.

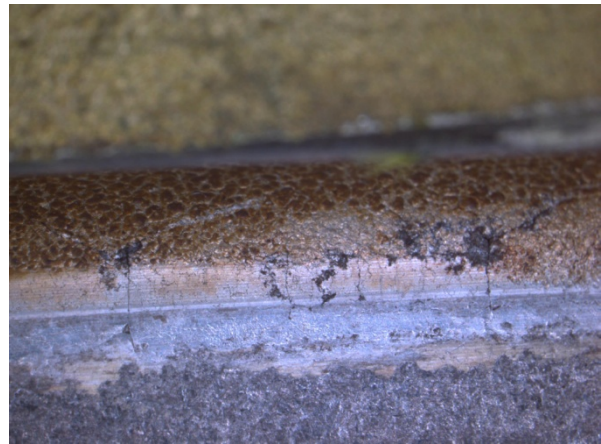
**Figure 5: Axial cracks adjacent to the peened radius**

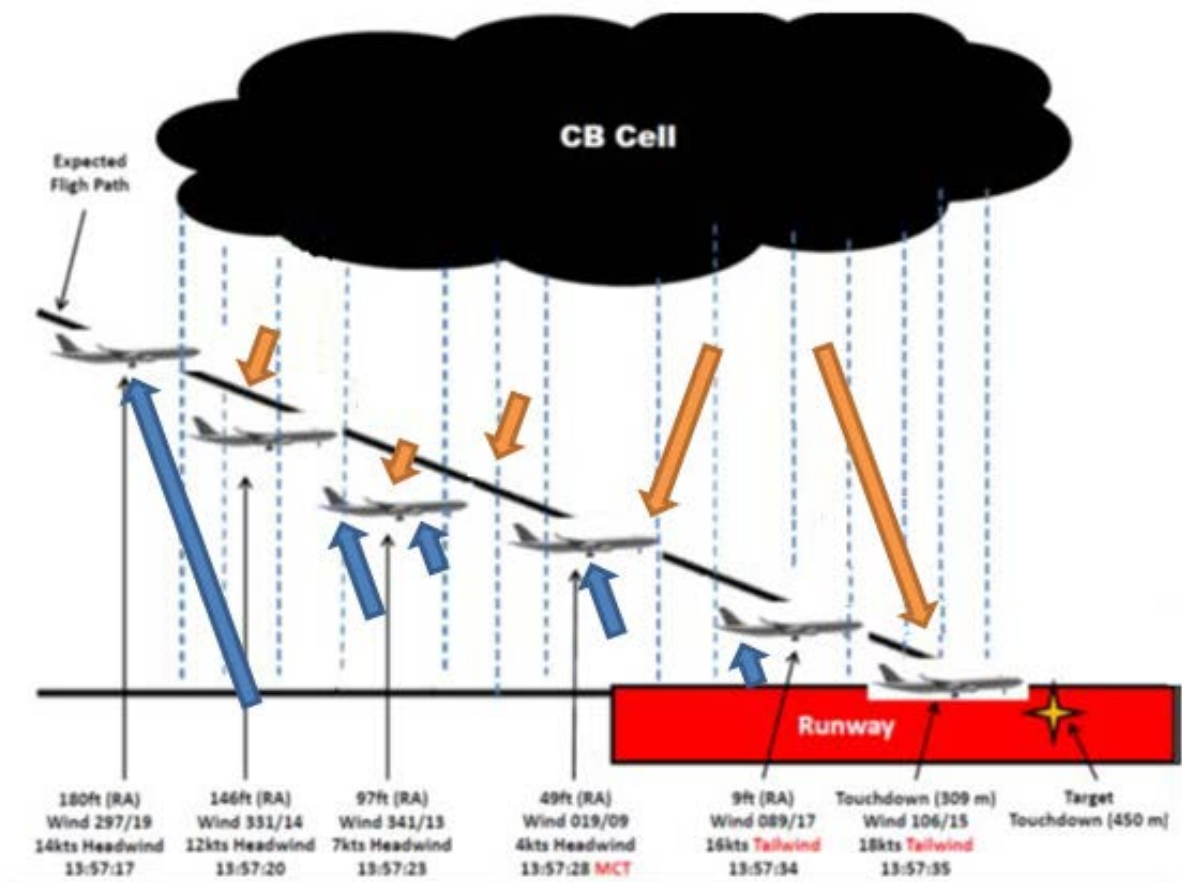
The Bureau of Meteorology (BOM) issued a report detailing weather conditions at Darwin Airport at the time of the incident. The report noted that there were no obvious dry slots in the atmosphere that would be typically present in a microburst. The report could not rule out the presence of a microburst forming under rain showers (Figure 1).

Figure 1: Flight path diagram with wind component

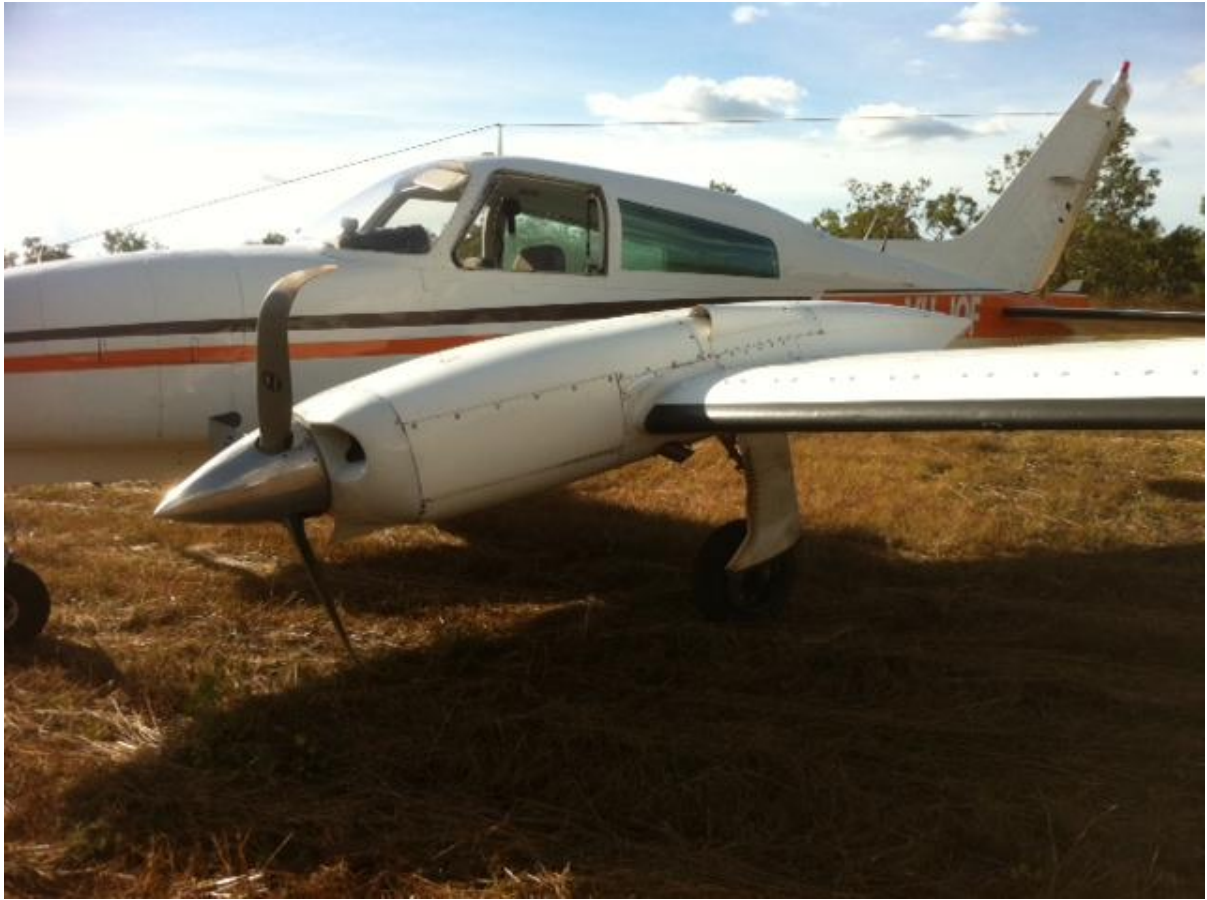
One passenger reported some minor whiplash injuries. The remaining passenger and pilot were uninjured. The aircraft was seriously damaged (Figure 3) including:

Figure 3: VH-JOF
