# VFR into IMC – Bell 206L Helicopter, VH-CIV

South Turramurra, New South Wales | 22 July 2011

**ATSB Transport Safety Report**  
Aviation Occurrence Investigation  
AO-2011-085  
Final

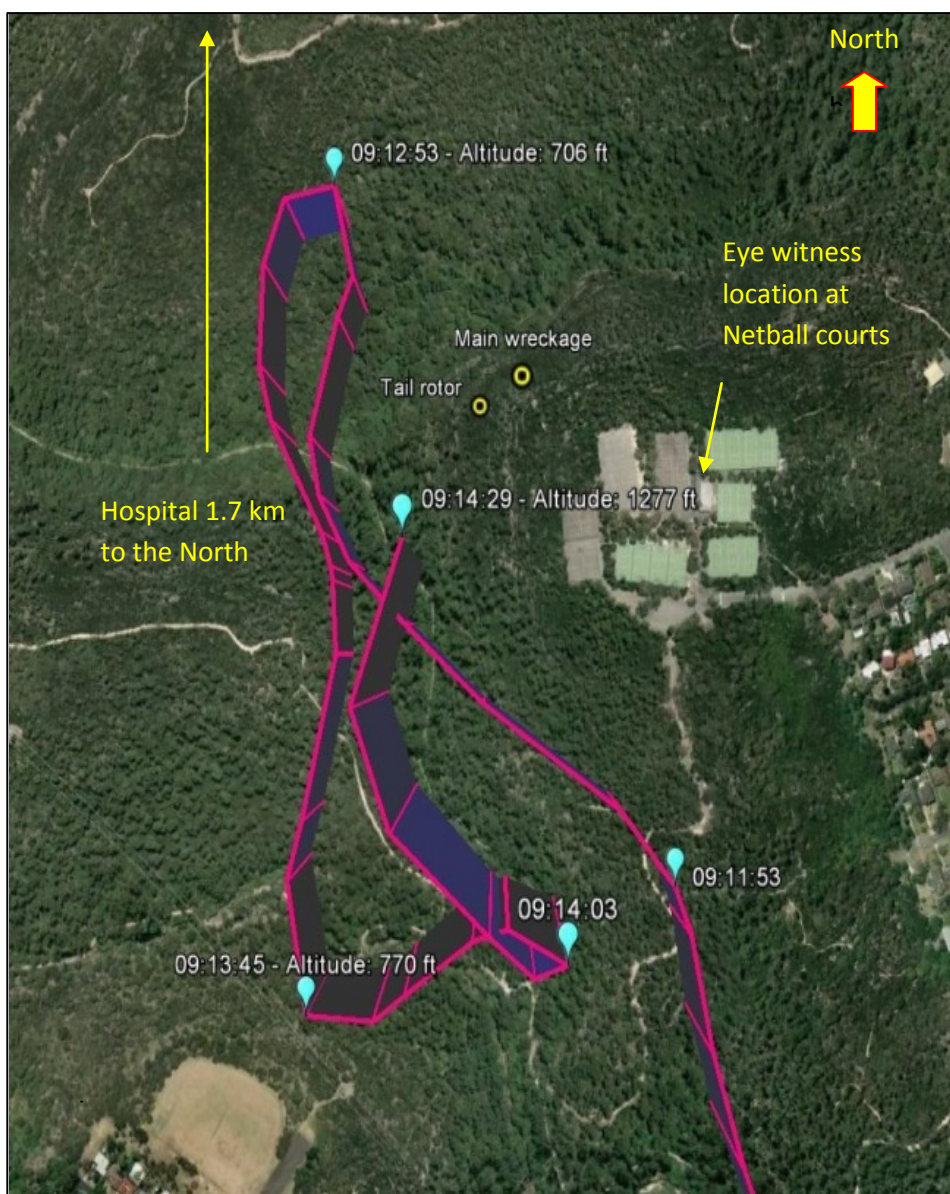
**Figure 1: GPS track showing helicopter manoeuvring prior to the accident**

Data downloaded from a damaged Garmin map 495 GPS, operating on board at the time of the accident, indicated that at about 1.4 km from the destination, the helicopter track reversed for about 1 minute (Figure 1). The data showed the helicopter manoeuvring for about 20 seconds, followed by the commencement of a climb in the general direction of the hospital. Several eye witnesses in the local area observed that while it was manoeuvring, the helicopter was obscured at times by cloud and was observed climbing.

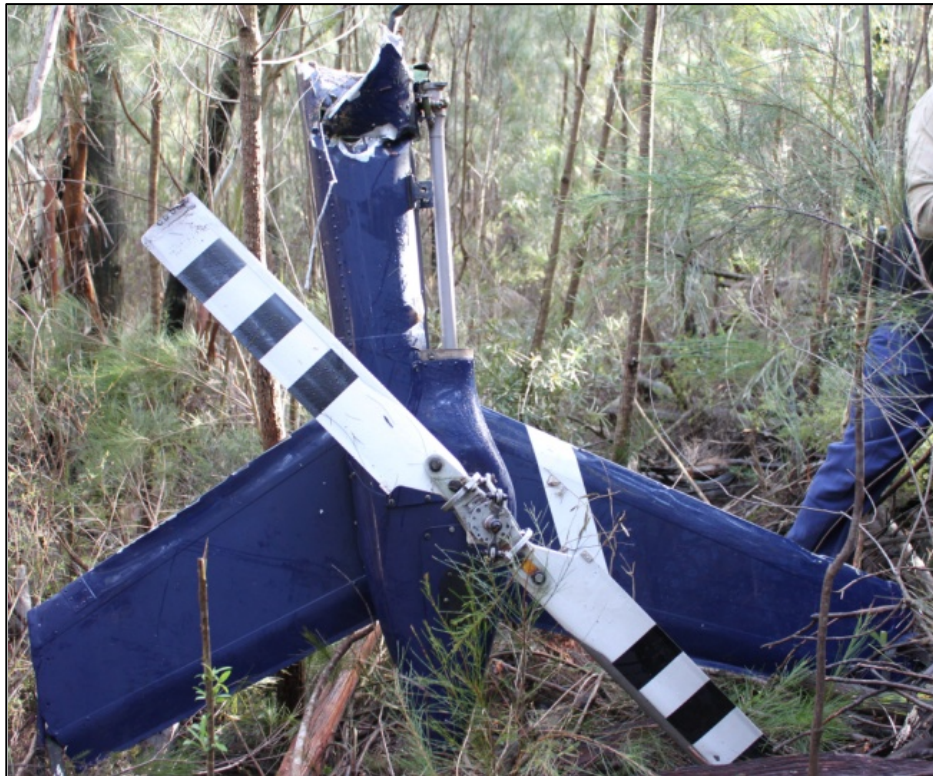
**Figure 2: Separated tail boom section and tail rotor**

Two eye witnesses reported seeing the helicopter appear below the cloud and that parts had separated from around the tail area. The helicopter was observed rolling to the right before being lost from sight behind trees. The helicopter then collided with terrain, fatally injuring both the pilot and passenger.

Evidence found at the accident site confirmed that the main rotor blade/s had struck and severed the helicopter's tail boom. When that occurred, the helicopter lost the tail rotor thrust that normally opposes main rotor torque effect, seriously compromising directional control. In addition, loss of the tail boom removed the stability provided by the vertical and horizontal stabilisers. From that point, control of the helicopter was no longer possible and collision with terrain unavoidable.

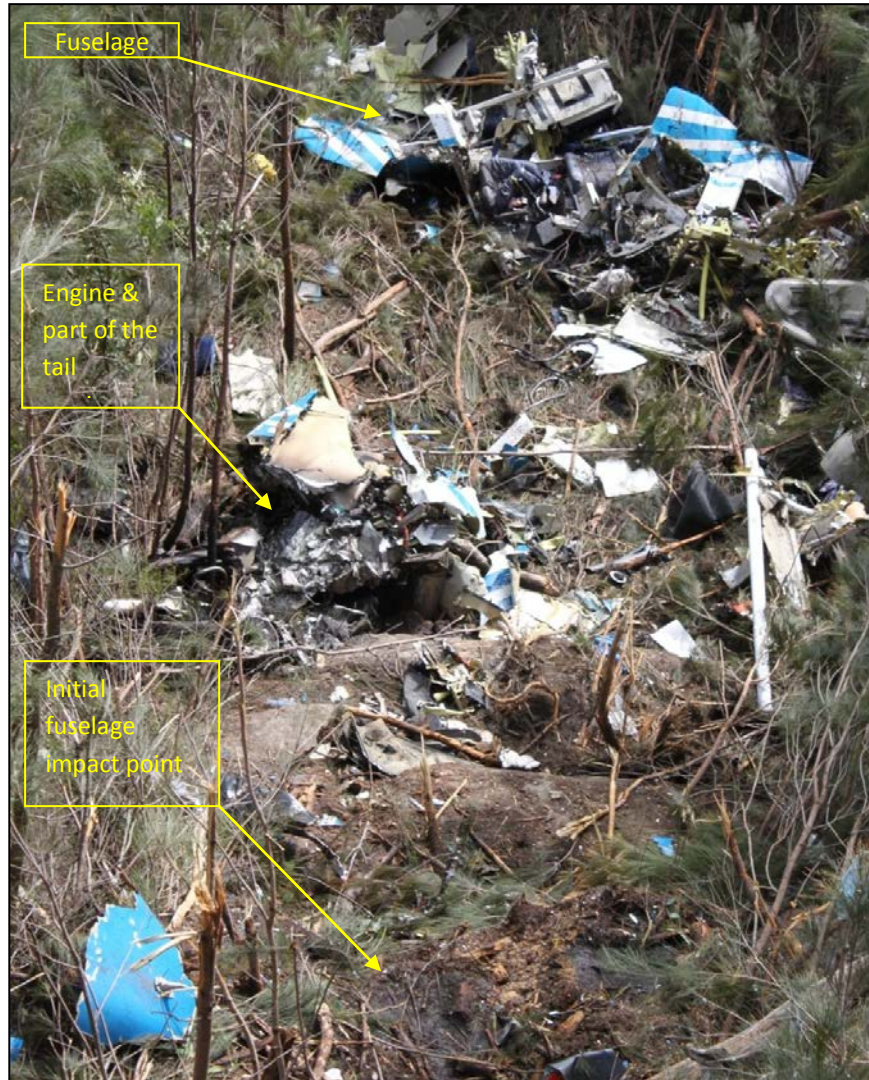
**Figure 4: Wreckage component locations looking down hill**

Fuselage impact marks were first observed several metres up-slope from where the main wreckage had come to rest (Figure 4). The wreckage had been significantly disrupted by impact forces. The cabin area was completely destroyed, the upper deck and transmission had separated from the cabin, the engine and a small section of tail boom had separated from the upper deck and the remaining parts of the main rotor blades had separated around one metre from their inboard ends (Figure 5).

Strike marks and damage found on surrounding trees, rocks and the ground indicated considerable force and unidirectional characteristics consistent with main rotor impacts.

The unidirectional splintering of the wooded terrain at the initial main wreckage impact point was consistent with the helicopter impacting terrain while inverted and in an uncontrolled state.

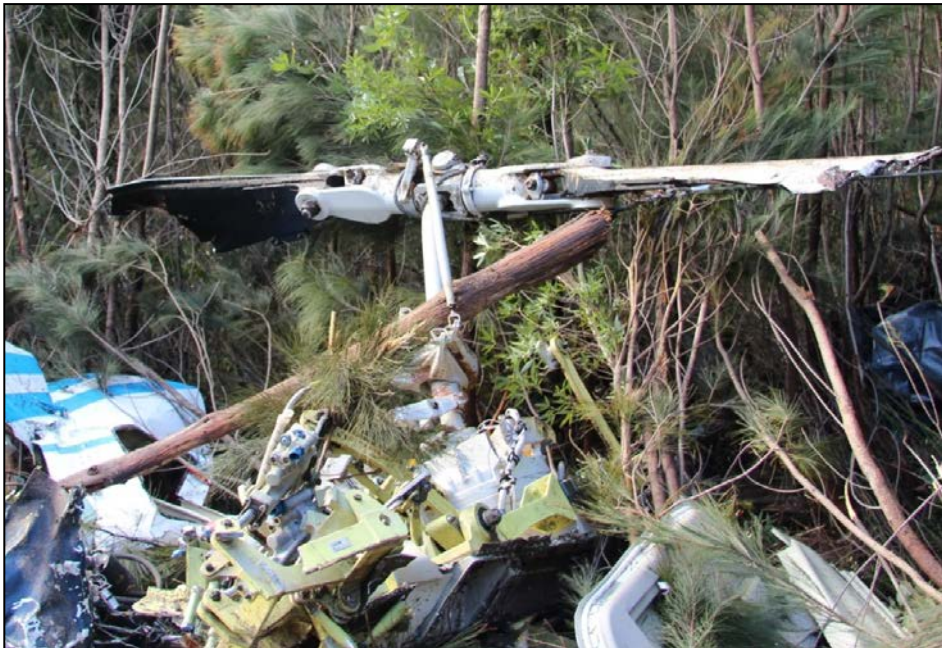
**Figure 5: Upper deck transmission and main rotor**

Both main rotor blades were still securely attached to the rotor hub and displayed extensive fragmentation and chord wise bending in the opposite direction to rotation. All fractures were the result of impact-related overstress and were consistent with the effects of high rotational energy.

Both blades and the rotor head showed free movement in all principal axes. Examination of the main rotor system showed continuity from the input of the main rotor gearbox to the main rotors, with the assembly operating freely when turned by hand.

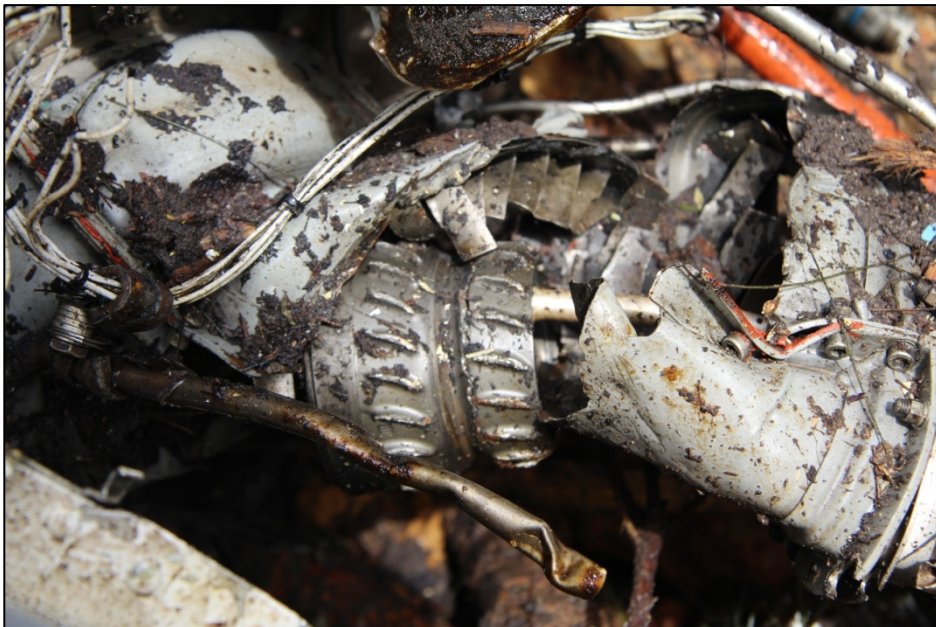
**Figure 6: Sheared axial compressor blades**

Examination of the engine on site found the first two stages of axial compressor blades sheared off at the blade root (Figure 6). The free-wheeling unit coupling bolts had sheared and bolt holes were elongated; consistent with power being delivered to the main rotor. The unit operated as expected when turned by hand.

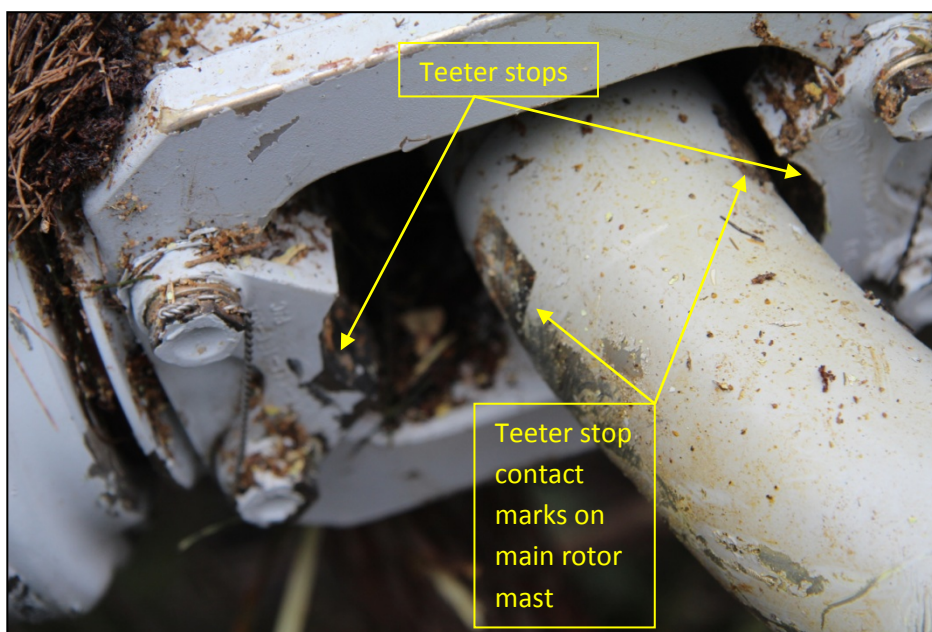
**Figure 7: Evidence of mast to hub contact**

An inspection of the main rotor mast showed heavy contact marks from the teeter stops (Figure 7). The mast itself was bent in two places; at the top, in line with the teeter stops and at the very bottom, where it entered the main rotor gearbox.

For an under-slung teetering-rotor helicopter such as CIV, main rotor contact with the tail boom is a symptom of either a main rotor system defect or flight outside normal operating parameters. In this case, no abnormalities were found in the main rotor blades or control system.

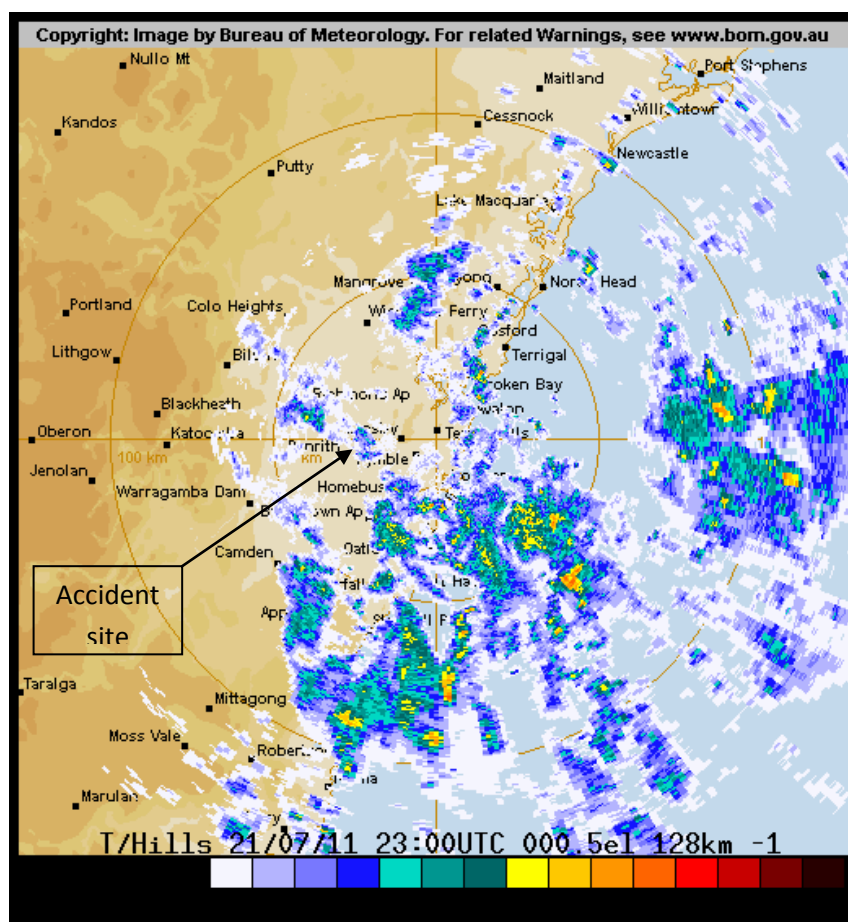
**Figure 8: Radar image of weather at the accident site (arrowed).**

.... Radar images (Figure 8) from Sydney (Terrey Hills) radar show that prior to and at around the time of the incident, scattered precipitation, including heavy falls, affected Sydney Metropolitan area, including the incident location. Surface weather observations and reports from the nearest available meteorological observation sites indicate that all the locations across the area of concern experienced heavy rainfall prior to and at around the time to the incident due to a persistent moist and deep south-easterly air stream across NSW coast.

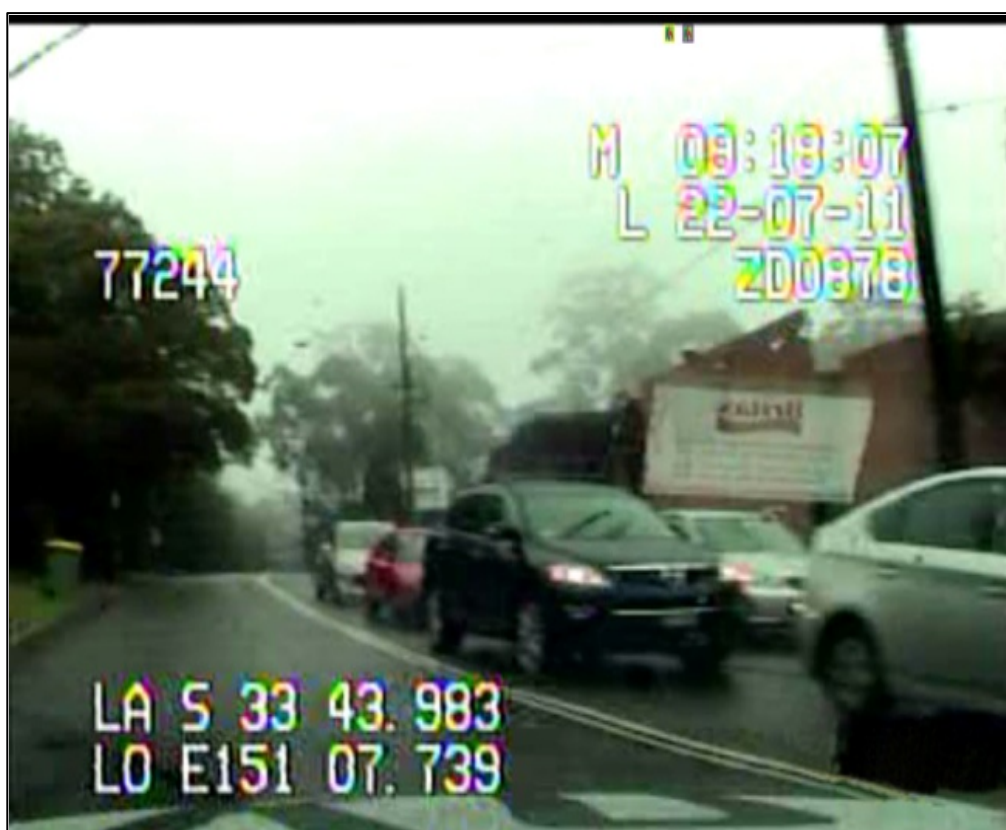
Figure 9: Police in-car video still at 700 ft elevation

In-car video recorded from a police vehicle responding to the accident (at a location 500 to 700 feet AMSL) showed low cloud and rain in the area 3 minutes after the accident (Figure 9).

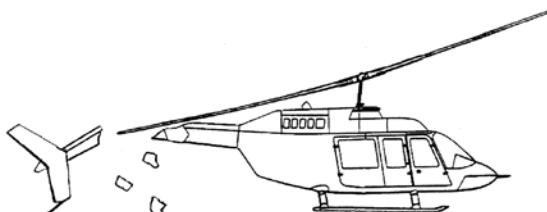
**Figure 10: Typical main rotor contact to tail**

‘In-flight ‘mast bumping’ or hub to mast contact can occur when an under-slung teetering-rotor helicopter enters unapproved flight regimes. It may be possible for in-flight hub to mast contact to occur during low-g maneuvers or aerobatic flight (whether intentional or not). If a VFR helicopter pilot loses visual reference, then it is possible that pilot control inputs may cause the helicopter to depart from normal flight regimes. If the helicopter departs from normal flight regimes and hub to mast contact occurs, it may be possible for the main rotor to contact the tail boom in-flight.’(Figure 10)
