# Collision between the Liberian bulk carrier *Grand Rodosi* and the Australian fishing vessel *Apollo S*

Port Lincoln, South Australia | 8 October 2010

**ATSB Transport Safety Report**  
Marine Occurrence Investigation  
279-MO-2010-008  
Final

MO-2010-008

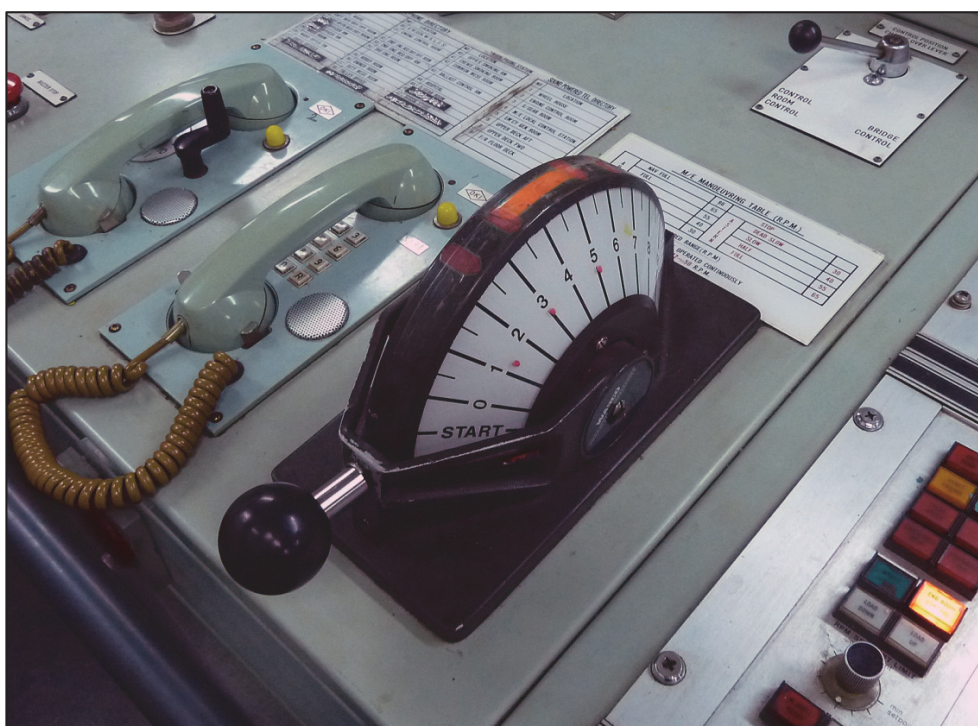
**Figure 3: The start/fuel lever in the stop position**

Following the movement of the ERC telegraph, when the start/fuel lever (Figure 3) was moved from the stop position to the start position, 'starting' air was admitted to the cylinders and the engine turned over on air. The order of air admitted to the combustion chambers depended on the desired direction of rotation for the main engine (ahead or astern). When the start/fuel lever was moved past the start position, the supply of starting air was shut off and fuel was admitted to the cylinders and the engine began to run on fuel. The speed of the engine was controlled by the amount of fuel admitted to each combustion chamber.

If the engine was turning in the opposite direction to that requested by the telegraph, when the start/fuel lever was moved to the start position, the introduced air became 'braking air'. The operator then needed to hold the braking air on until the engine stopped rotating. Once the engine was stopped, the air would then start to turn the engine in the direction ordered and then fuel could be introduced into the engine, as discussed above.

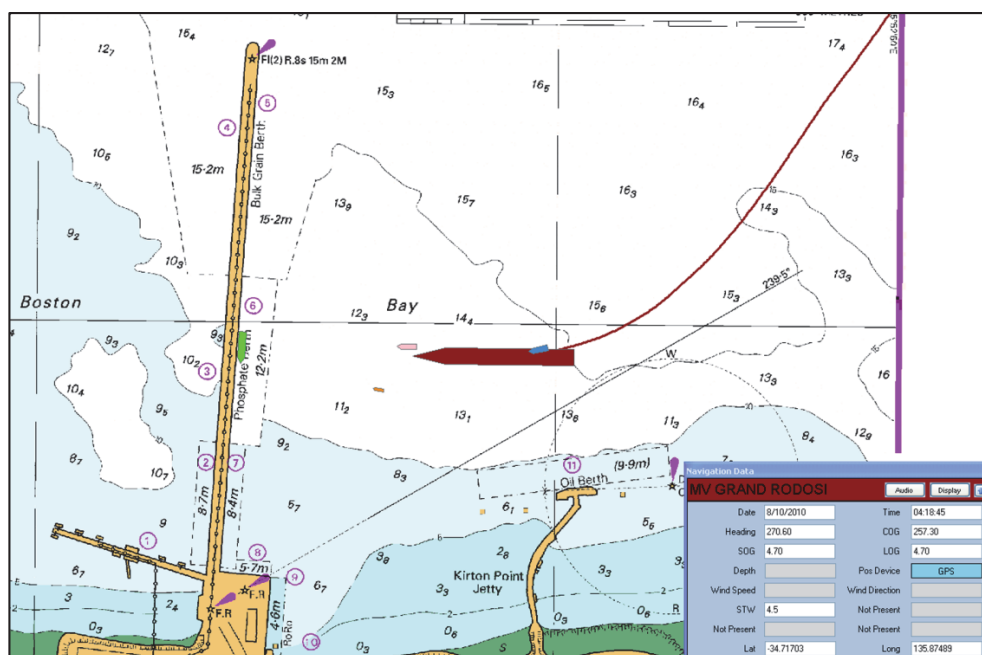
Figure 9: *Grand Rodosi* S-VDR replay at 1448 $\frac{1}{4}$

Concerned that the ship was not slowing down or turning to starboard, at 1448 $\frac{1}{4}$ , the pilot ordered *Wangary* to push at three quarters power. He then immediately ordered full astern. The third mate put the telegraph to full astern and this was acknowledged in the engine room. The pilot then ordered *Kioloa* to standby to 'lift off'. At 1448 $\frac{3}{4}$ , the third mate reported that the ERC telegraph was at full astern. However, *Grand Rodosi*'s speed was still about 4.5 knots. The pilot then ordered *Kioloa* to lift off at half power.

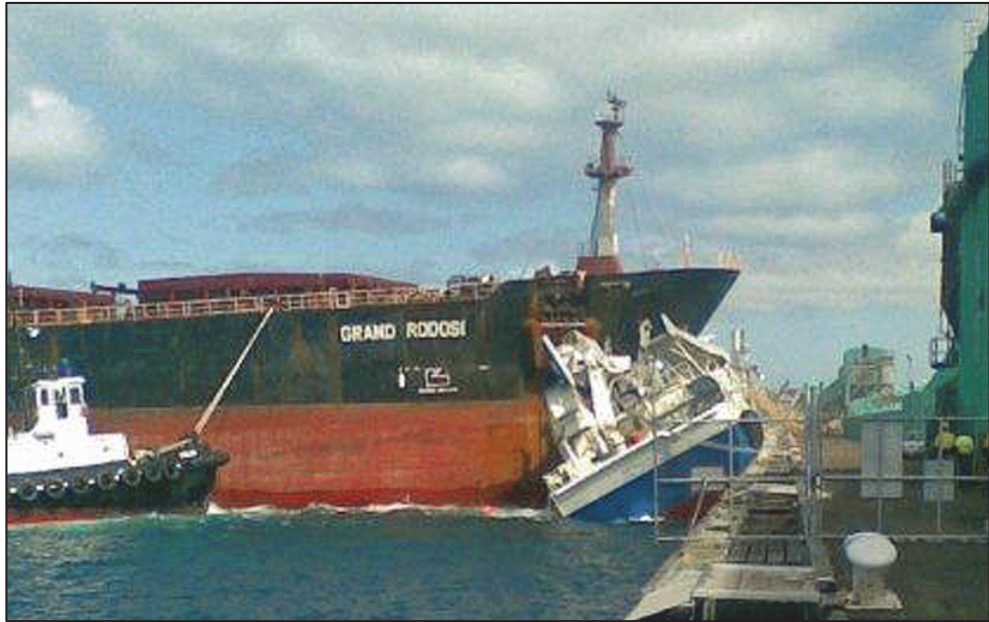
**Figure 10: *Grand Rodosi* crushing *Apollo S* against the wharf**

At about 1450, *Grand Rodosi*, at a speed of 4.9 knots, hit *Apollo S* and crushed the fishing vessel against the wharf (Figure 10).

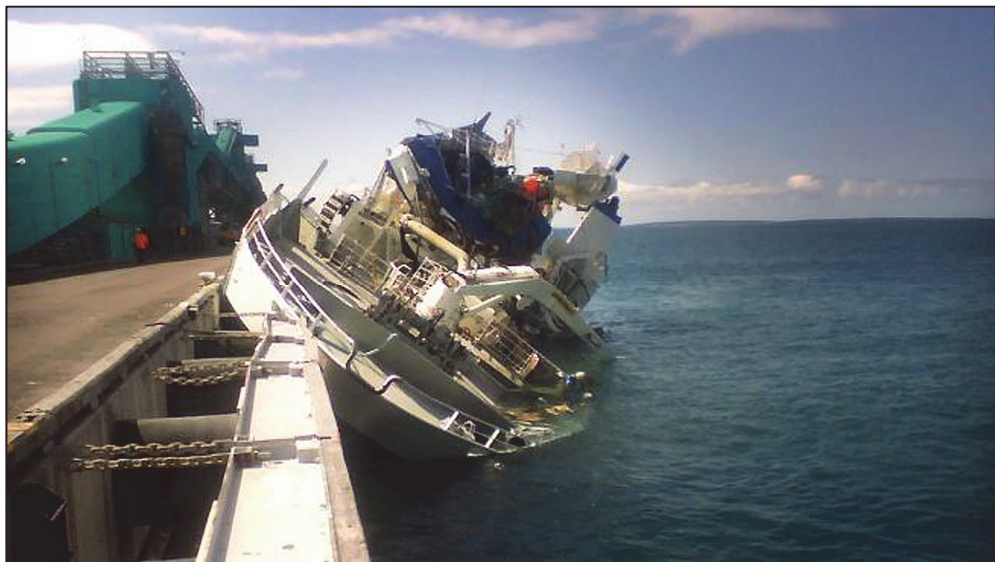
**Figure 11: *Apollo S* immediately after *Grand Rodosi* had pulled clear**

At about 1500, the master started notifying relevant parties, including the Australian Maritime Safety Authority (AMSA), about the collision. While he was doing this, the pilot continued to back *Grand Rodosi* away from *Apollo S*. When the ship finally pulled clear of the fishing vessel, *Apollo S* rolled onto its port side and began to sink (Figure 11).

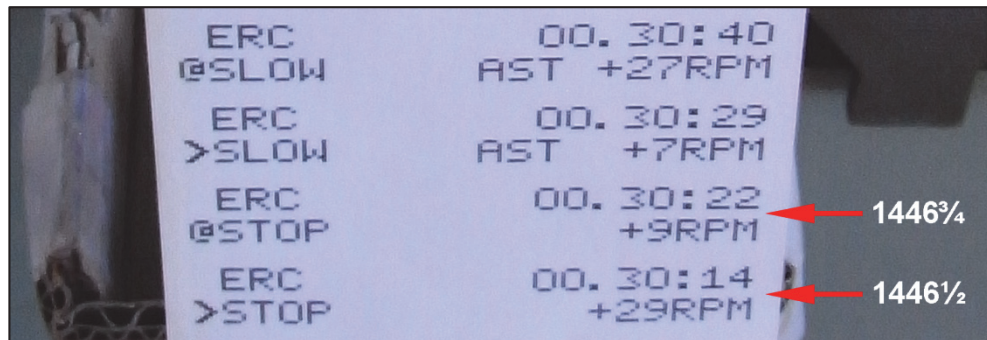
**Figure 12: Data logger printout showing ahead rpm when astern movement requested**

At 1446½, when the stop order was given, the main engine was rotating at 29 rpm in the ahead direction (Figure 12). Then, when the slow astern order was given at 1446¾, the engine was rotating at 9 rpm in the ahead direction because the ship was still moving ahead with the water flow through the propeller causing the main engine to ‘windmill’.

To follow the pilot's telegraph orders, the chief engineer, operating the main engine start/fuel lever, brought the lever to the stop position when the ERC telegraph was put to stop. However, when the ERC telegraph was then quickly put to slow astern, he moved the lever to the start position, and then out of the start position to the run position. Because the main engine was still rotating in the ahead direction, when he moved the start/fuel lever, he did not allow enough time for the braking air to stop the engine rotating ahead and then turn it in the astern direction. As a result, because the engine was still turning ahead, when fuel was admitted to the engine, the engine ran in the ahead direction, despite the astern positioning of the ERC telegraph and the fuel cams.

When asked during interview whether he looked at the main engine analogue tachometer to check on the direction of rotation, the chief engineer said that he was concentrating on the speed of the telegraph orders and was looking at the ERC telegraph, the lever position and the digital rpm counter on the Norcontrol panel on the engine room console, a counter which did not show direction of engine rotation. At no time did he look at either the analogue tachometer, which clearly displayed rpm in the ahead or astern direction or the fuel cam indicators on the main engine indicator panel, which were just below and to the right of the analogue tachometer. Consequently, he was not aware that the engine was rotating in the ahead direction instead of the astern direction.

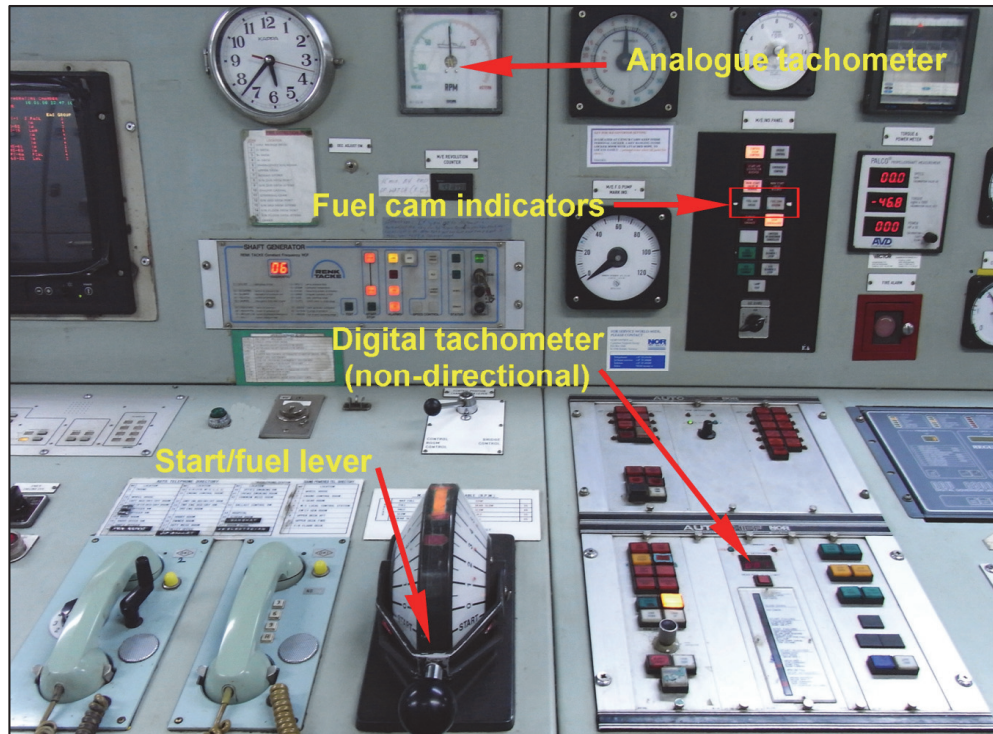
**Figure 13: Main engine tachometer mounted on the engine console**

At no time from when the initial astern movement order was given at 1446<sup>3</sup>/<sub>4</sub> to about 1451, when it was observed that the ship's main engine was still operating ahead, did *Grand Rodosi*'s chief engineer look at the analogue tachometer located directly above the start/fuel lever and directly forward of where he was standing at the console (Figure 13) to see which way the main engine was rotating. As he stated in his interview, his attention was diverted by the quick telegraph orders, and by looking at the ERC telegraph and the digital tachometer.

However, there were two other engineers at the console at the time and neither of them looked at the analogue tachometer at any time. These men, along with the chief engineer, should have been making sure that the engine was turning in the right direction.

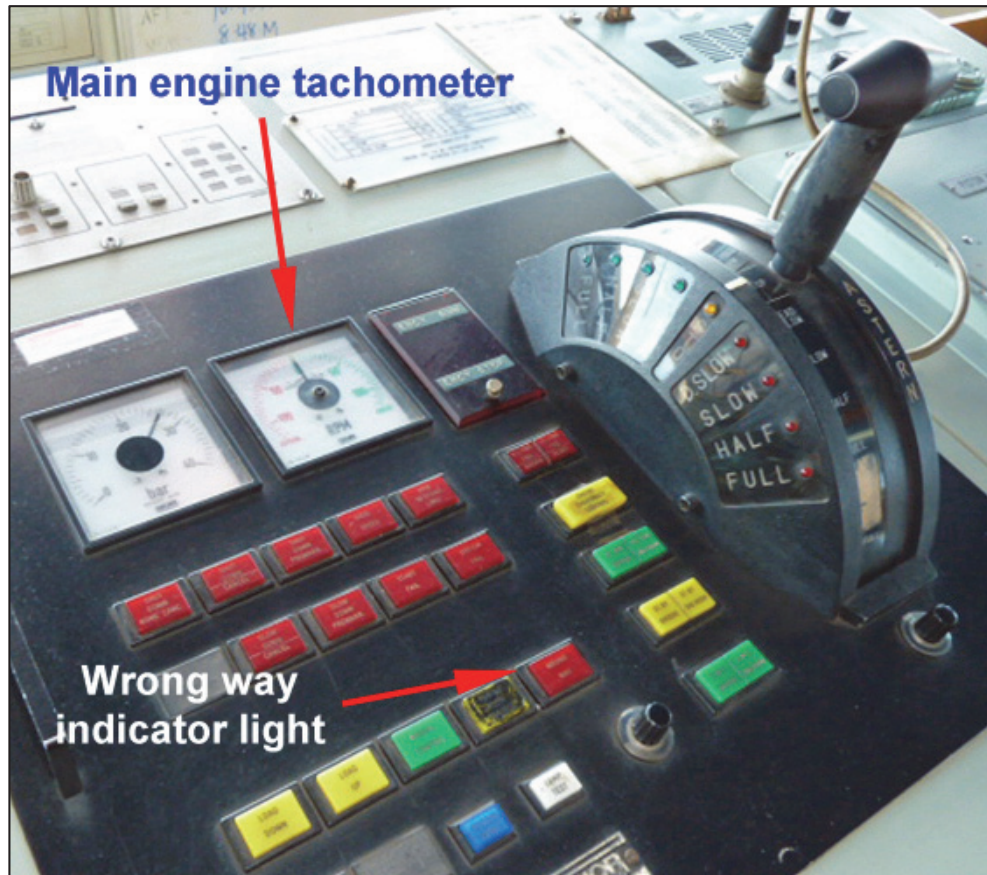
**Figure 14: Main engine tachometer mounted on the engine console**

Regardless of the inaction of the engine room staff, neither the pilot, the ship's master nor the third mate looked at the main engine tachometers located, and clearly visible, on the bridge at any time from when the initial astern order was given, throughout the following sequence of astern orders, until the after tug master advised the pilot that the ship's engine was running ahead.

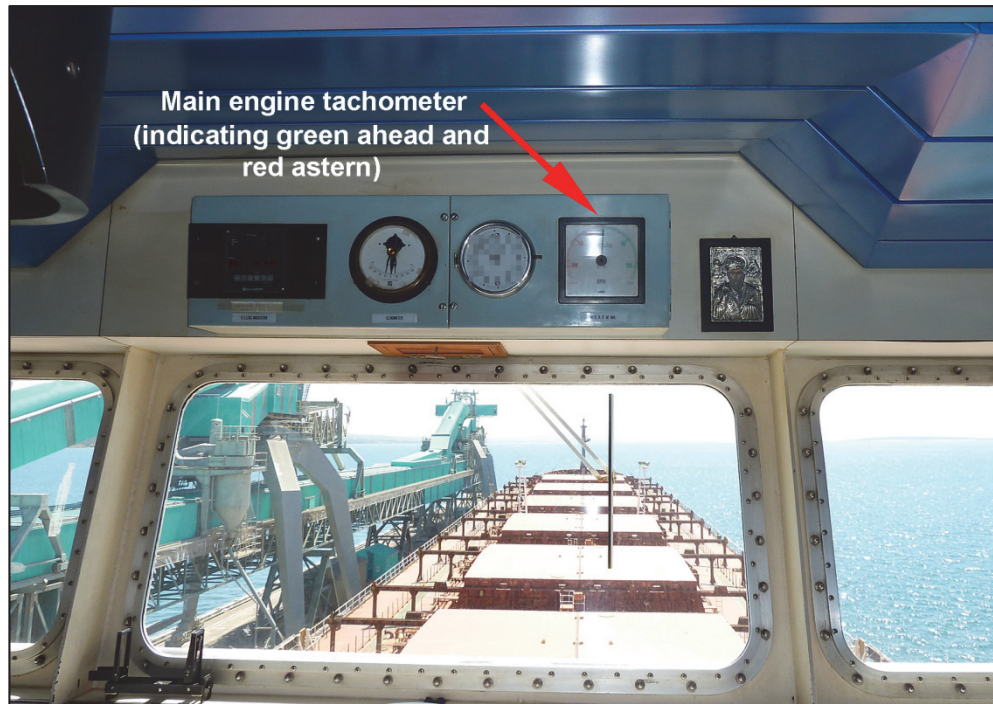
**Figure 15: Main engine tachometer mounted on the bridge front**

After moving the bridge telegraph to any of the astern positions, the third mate should not only have checked that the ERC telegraph matched the bridge telegraph orders, but that the direction of engine rotation also corresponded to the orders. This was a simple task – looking at the engine tachometer located immediately next to the bridge telegraph (Figure 14) or the tachometer mounted on the bridge front (Figure 15), immediately in front of him. In addition, the third mate's level of attention during the pilotage should have been such that the red flashing 'wrong way' light on the bridge telegraph console should have alerted him to the fact that something was not right; and therefore prompted him to take further action to see what the flashing light meant.

Had the third mate done so, he could have alerted the pilot and the master to the fact that the engine was still turning in the ahead direction at about 1447, just after the first astern order and in time for corrective action to be taken to ensure that the engine did turn as desired.

In addition, both the master and pilot should have looked at the tachometer after each engine order. Had they simply glanced once at the tachometer, it would have been apparent to them that things were not as they should have been at 1447, and corrective action could have been taken. As it was, they remained standing on the port side of the bridge front, expecting that the orders for increased astern power, and the requested assistance of the tugs, would stop the ship's unrelenting progress towards the fishing vessel at the berth ahead.
