Partial power loss and collision with terrain – De Havilland Aircraft Pty Ltd DH-82A, VH-GVA

Maryborough Airport, Victoria | 27 January 2012

ATSB Transport Safety Report
Aviation Occurrence Investigation
AO-2012-017
Final

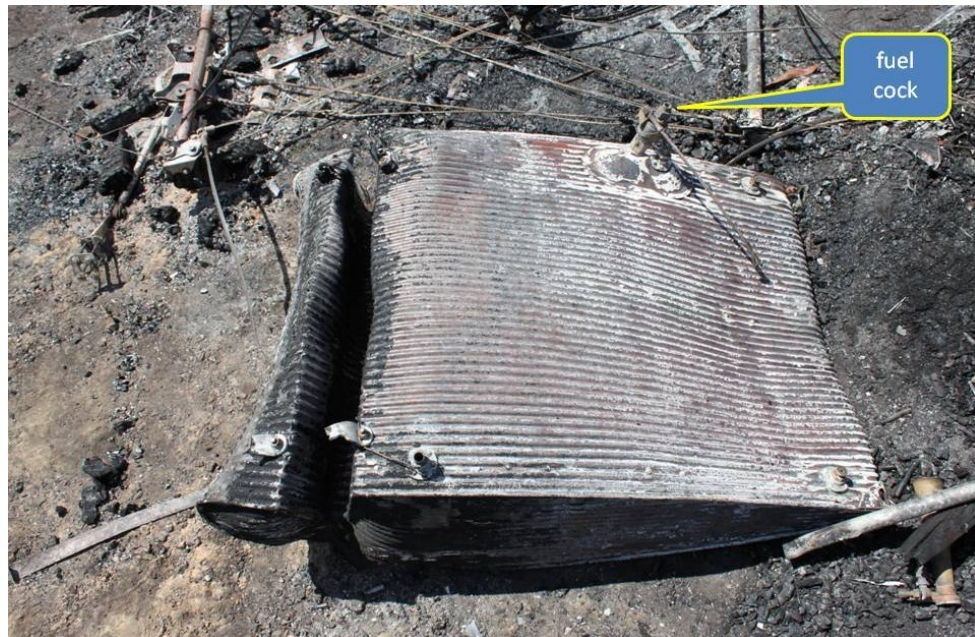
Figure 1: Main fuel tank (inverted) and fuel cock

The aircraft was equipped with a fuel tank mounted between the upper wings with a capacity of 86 L and an auxiliary fuel tank in front of the passenger seat with a capacity of 46 L. Fuel was gravity fed to the engine from the main tank, and a fuel cock was mounted at the tank outlet (Figure 1). Fuel was fed to a carburettor that contained a varnish-coated cork float for controlling fuel flow.

The aircraft was consumed by a post-impact fire. The extent of the fire damage was consistent with the fuel tanks being full or nearly full at the time of the collision. A fire-damaged piece of organic material was found in the main tank fuel cock and, on examination, was identified as being similar to that used in the fuel filler cap cork gasket.

The lodgement of an obstruction in the fuel cock, such as fuel filler cap gasket material, would have reduced the fuel supply to the engine. This would explain the partial power loss as reported by witnesses. However, the separation of the fuel tank from the wing during the impact sequence, which left the fuel cock open to the environment and post-impact fire, prevented a definitive conclusion as to the origin of the gasket material, or whether it lodged in the fuel cock prior to the accident.

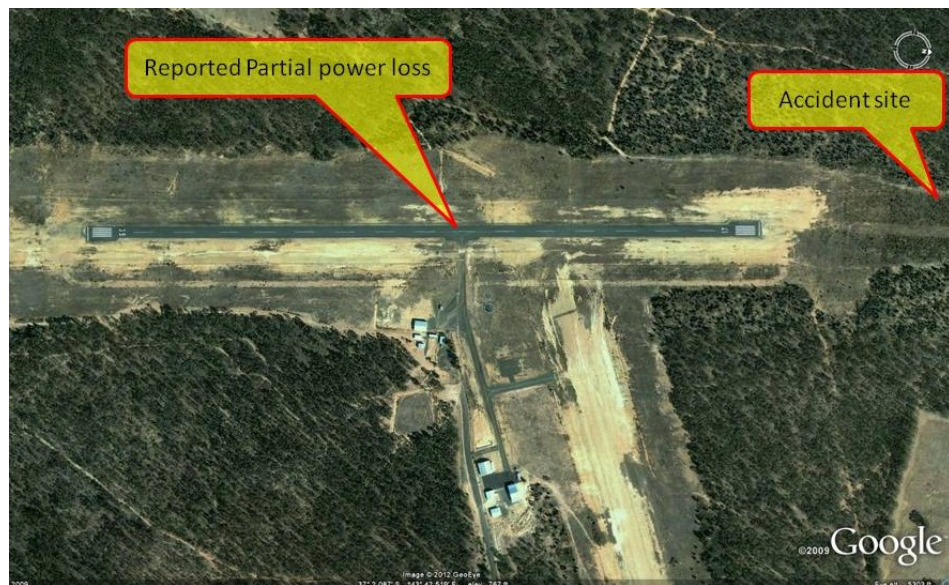
Figure 2: Accident location

The wreckage was located in low bushland about 220 m beyond the departure end of runway 35 and 85 m to the left of the extended runway centreline (Figure 2).

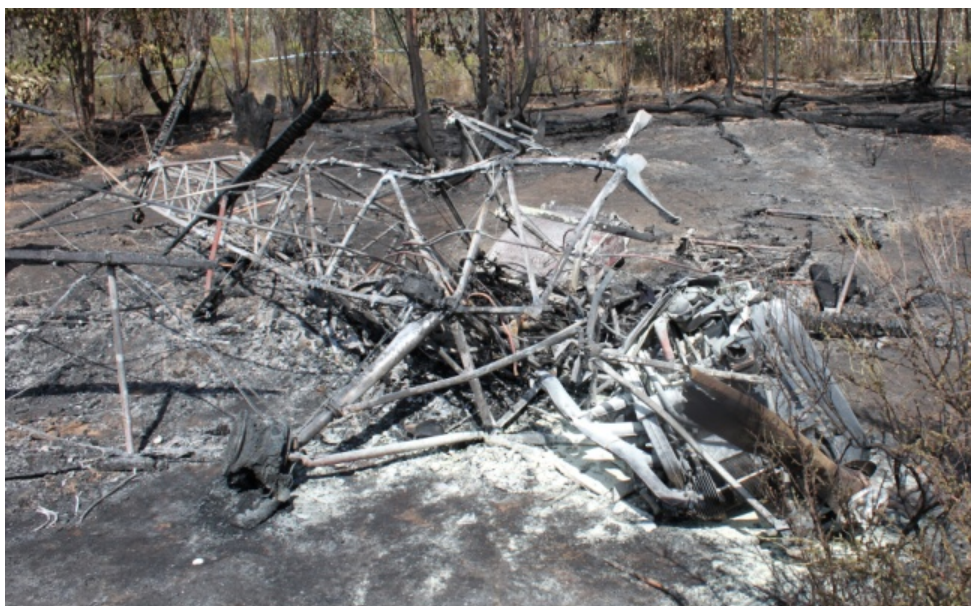
Figure 3: Aircraft accident site

On-site examination of the wreckage found no anomalies with the aircraft's flight control systems. The aircraft impacted the ground in a nose-low attitude in a left bank, with a low forward speed (Figure 3). There was no evidence of any piece of the aircraft separating in flight.

The main fuel tank had separated from the upper wing during the impact sequence. Damage to the propeller indicated the engine was producing little or no power when the aircraft collided with the ground.
