Air Safety Investigation Branch

## ACCIDENT INVESTIGATION REPORT

**Piper PA-23-250 Aztec Aircraft VH-SPM**  
**near Mount Scratchley, Papua,**  
**on 26th September, 1970**

**SOUTH PACIFIC AERO CLUB'S  
PIPER PA-23-250 AZTEC AIRCRAFT VH-SPM  
NEAR MOUNT SCRATCHLEY, PAPUA,  
ON 26th SEPTEMBER 1970**

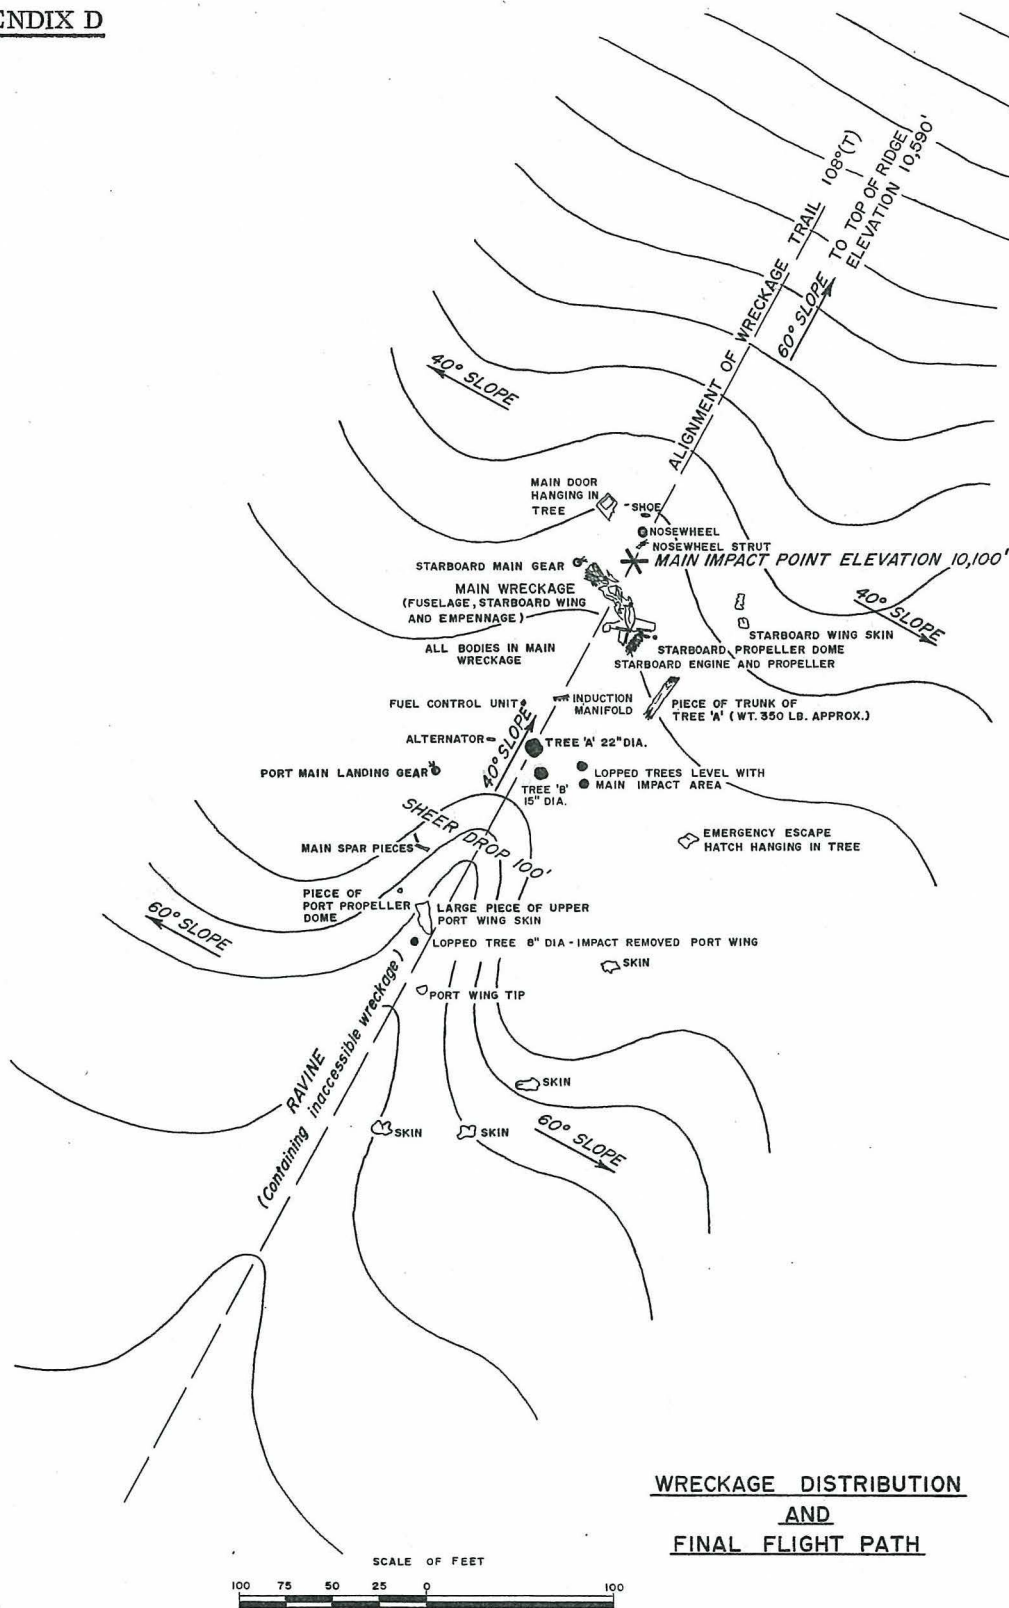
# APPENDIX D

The wreckage trail (refer to Appendix D) extended for a distance of about 300 feet back along the flight path from the main impact point. It is apparent that the aircraft initially struck the tops of trees whilst climbing at an angle of about 6 degrees. It commenced to break-up immediately and pieces of skin and structure were found in the trees and on the ground on both sides of the ravine along the length of the wreckage trail. After passing through the tops of small trees for a distance of about 100 feet the aircraft struck and sev-

ered the top of a larger tree and this impact removed the port wing at the wing root. The remainder of the aircraft continued for a further 100 feet where it struck the trunks of two large trees growing close together. The trunks of these trees, which were 15 inches and 22 inches in diameter, were broken off. The violence of this impact showered the sides of the ravine with broken pieces of the aircraft structure and the remainder of the aircraft continued on for a further 100 feet until it struck the face of the ridge and came to rest.

The final flight path, from the first contact with trees until the aircraft came to rest, can be represented by a straight line some 300 feet in length on a heading of 108 degrees (T). The aircraft, whilst traversing the first 100 feet of the wreckage trail until it struck the tree which dislodged the port wing, was laterally level and climbing at an angle of about 6 degrees. This climbing flight path continued for another 100 feet until the aircraft struck and severed the trunks of two large trees. Notwithstanding the severity of this impact, however, the aircraft continued on a level flight path over the final 100 feet until it struck the face of the ridge. It would seem, in order to achieve this flight path and absorb the impact forces which occurred, that the aircraft must have been travelling, initially, at something in excess of the normal climb speed. However, the flight path evidence is not compatible with a dive or a steep climb such as in a high speed recovery from a dive. It seems most likely therefore that, immediately prior to the first contact with trees, the aircraft was operating at about the normal cruise speed.

WRECKAGE DISTRIBUTION  
AND  
FINAL FLIGHT PATH

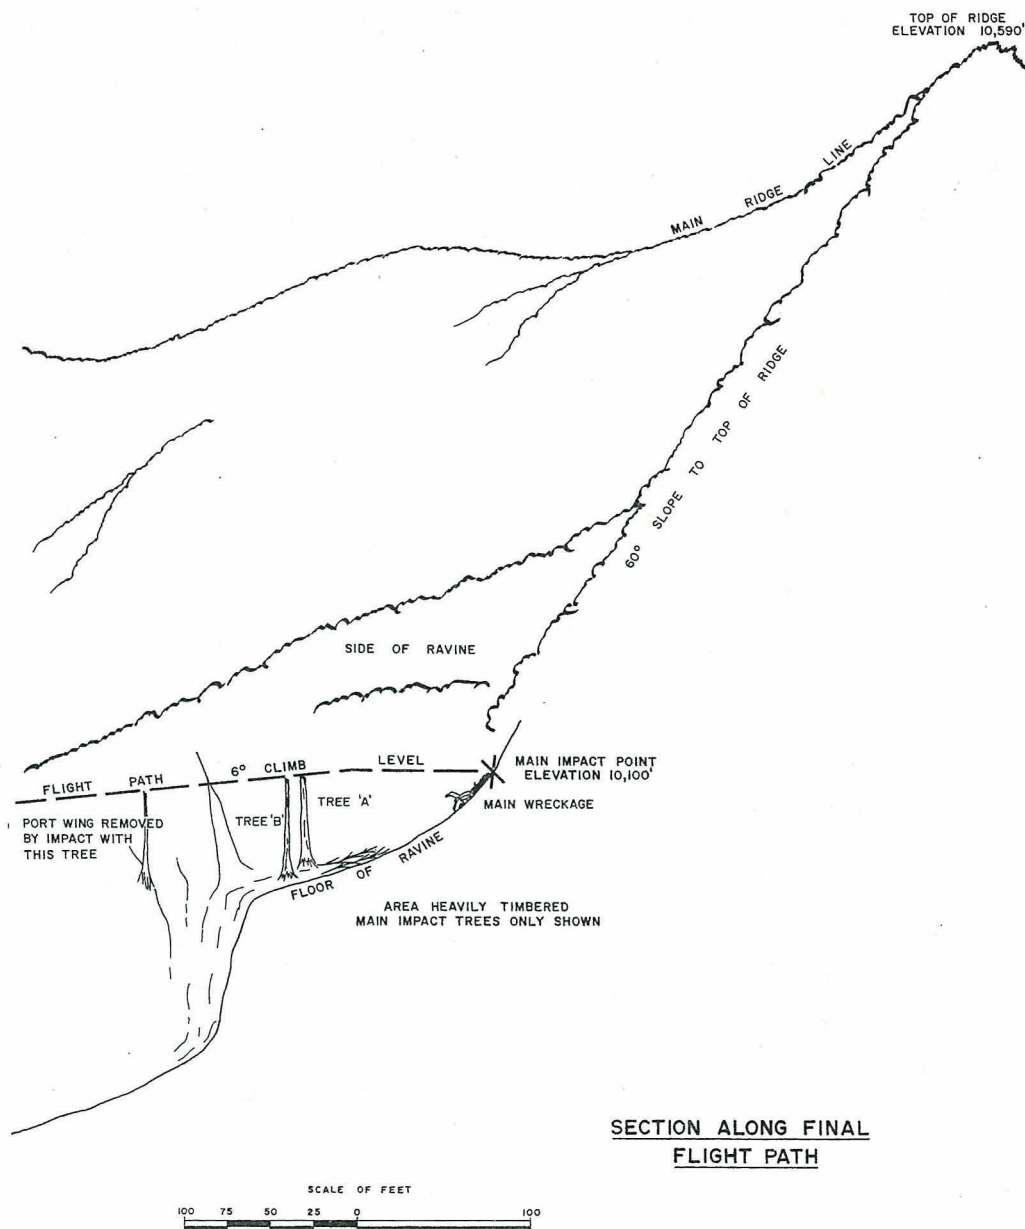
## APPENDIX E

The wreckage was located 10,100 feet above mean sea level on the north-western side of a ridge which runs in a north-easterly direction from the Owen Stanley Range. The top of the ridge immediately above the impact point is 10,590 feet above mean sea level. The main impact occurred at the end of a blind, steep-sided ravine and against a 60 degree slope which extends upwards to the top of the ridge (refer to Appendix E). The area in which the accident occurred is uninhabited, and covered by thick jungle growth. Access to the main wreckage was extremely difficult and was made from the ridge above the accident site. The descent of the last 100 feet was achieved only with the aid of ropes.

The main wreckage, consisting of some 60 per cent of the total structure and including the fuselage, the inner section of the starboard wing and the empennage, was found lying against the face of the ridge ten feet below the principal impact point and resting on a slope which was some 40 degrees from the horizontal. The fuselage wreckage consisted of a compact mass of broken and twisted metal 15 feet long and 10 feet wide. The only relatively intact part of the structure was the empennage and beneath it was the starboard engine with its propeller attached, but with the propeller dome shattered. The damage to the propeller blades indicated that they were rotating at high speed when the engine was dislodged during the main impact.

SECTION ALONG FINAL  
FLIGHT PATH
