# Collision with terrain- VH-HOU, Robinson R44

93 km south of Alice Springs Aerodrome, Northern Territory, 10 June 2012

AO-2012-078

Final

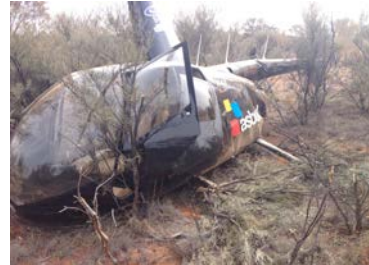
VH-HOU

On 10 June 2012 at about 1245 Central Standard Time<sup>1</sup>, a Robinson Helicopter Company R44 Raven 1, registered VH-HOU, was seriously damaged, following a reported loss of power and collision with terrain near Maryvale, Northern Territory. The helicopter was providing support and aerial filming of a competitor participating in the annual Finke Desert race.

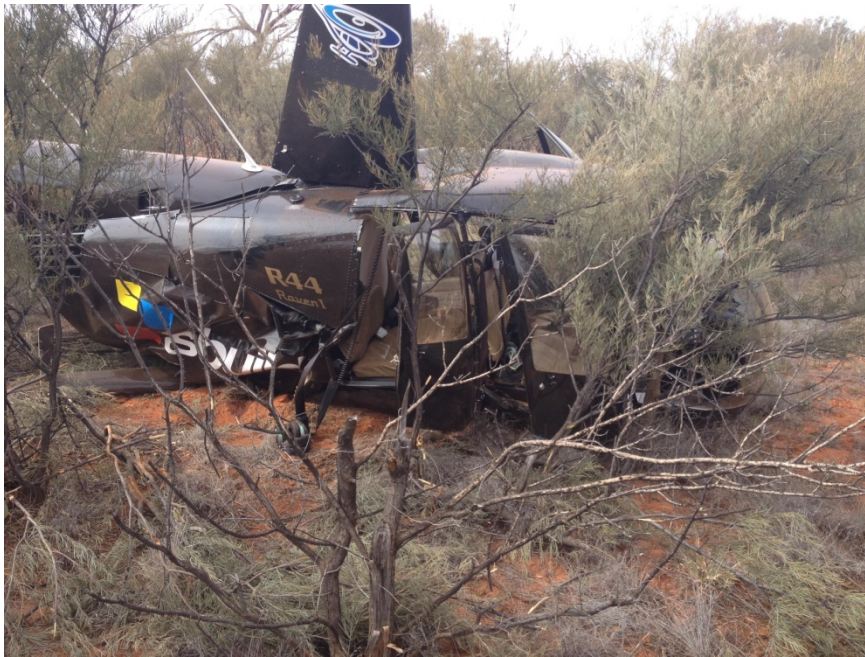
**Figure 1: VH-HOU**

The helicopter impacted the terrain in a level attitude collapsing the skids on impact. The helicopter came to rest on its belly in an upright position (Figure 1). The pilot and front seat passenger exited the helicopter without assistance. The front seat passenger and the pilot were able to assist the two rear seat passengers to exit the aircraft. The passenger seated behind the pilot sustained serious injuries. The other passengers and the pilot sustained minor injuries.

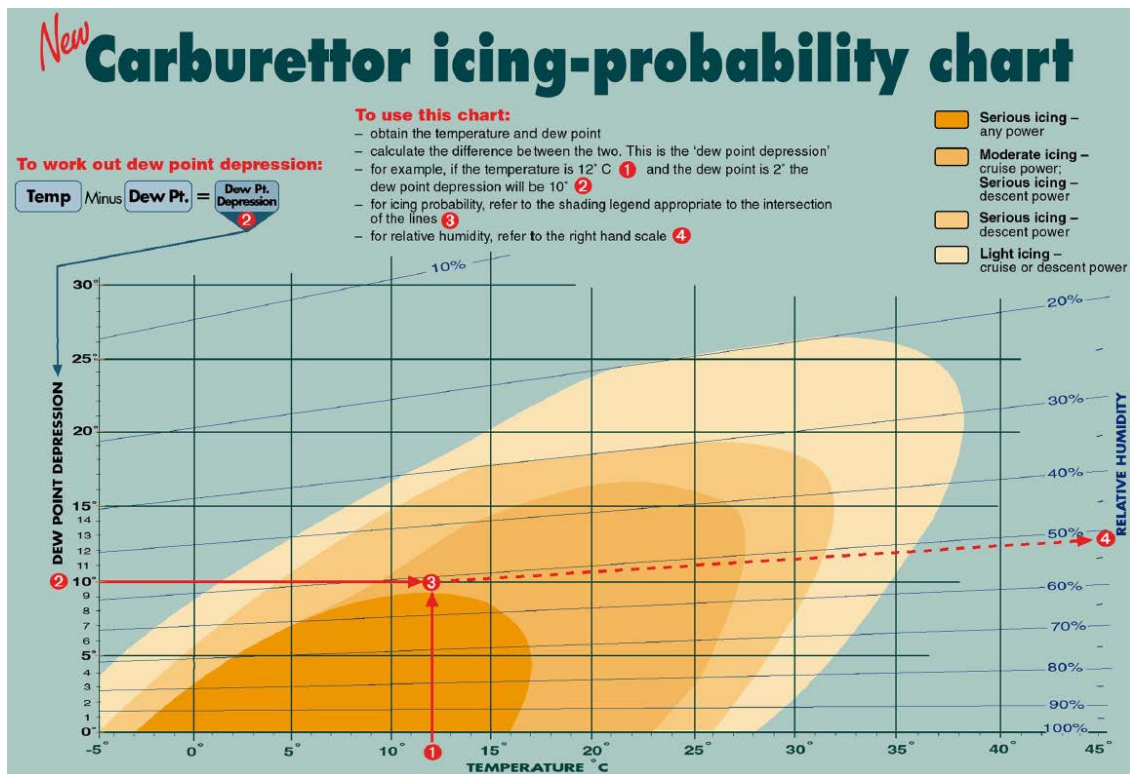
Figure 2: Carburettor icing probability chart

A definitive reason for the reported loss of engine power could not be determined. However, a review of the carburettor icing probability chart reveals that the temperature/dew point spread, put the accident flight in the 'serious icing – descent power' operating realm (Figure 2).

Robinson Safety Notice SN-31 contains a reminder to pilots that if carburettor heat assist is used in conjunction with the throttle governor, it will reduce carburettor heat where the aircraft is lifting off to a hover and that the control may require adjustment in flight. This safety notice also contains a reminder to apply full carburettor heat when the manifold pressure is below 18 inches.
