Aircraft proximity event – two Cessna 172S, VH-EWE and VH-EOP

Moorabbin Airport, Victoria – 19 July 2012

ATSB Transport Safety Report
Aviation Occurrence Investigation
AO-2012-099
Final

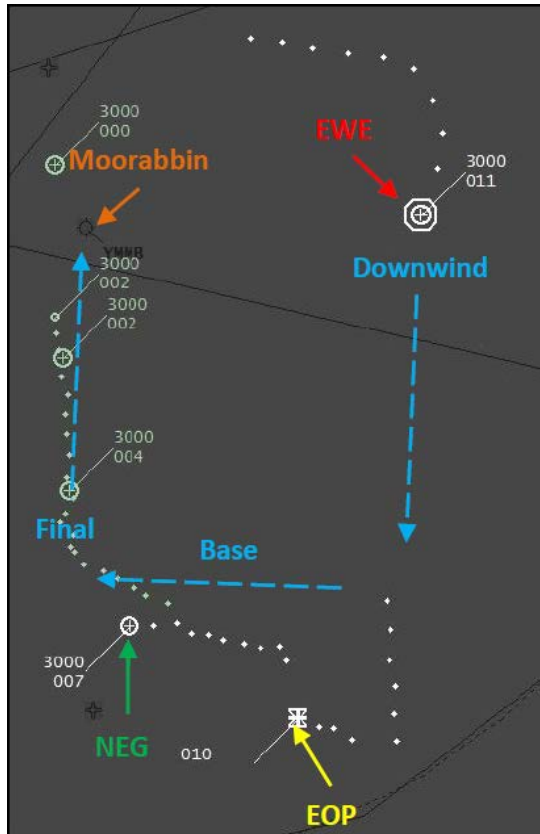
Figure 1: Aircraft positions at 1627

On 19 July 2012, at about 1622 Eastern Standard Time¹, the pilot of a Cessna 172S aircraft, registered VH-EOP (EOP), broadcast on the Moorabbin Airport, Victoria, Tower frequency advising he was inbound from the 'Academy' visual flight rules approach point, following a Cessna 182T aircraft, registered VH-NEG (NEG). The pilot of EOP was instructed by Moorabbin air traffic control (ATC) to join the downwind leg of the circuit for runway 35 Right (R)². At the same time, the flight instructor and student pilot of another Cessna 172S aircraft, registered VH-EWE (EWE), were on downwind, conducting circuit training.

At about 1627, EWE was turned onto downwind, during which time the student made a broadcast on the Moorabbin Tower frequency advising they were turning downwind for a touch-and-go. Moorabbin ATC then instructed EWE to '...follow the Cessna turning, correction, on mid-base' (EOP). Both the instructor and student sighted a Cessna (NEG) in their 2 o'clock⁵ position on late base, and believed this to be the aircraft referred to by ATC (Figure 1). Given the distance between EWE and NEG, the instructor of EWE believed there was sufficient separation between the two aircraft. The pilot of EOP reported hearing EWE broadcast their downwind call.

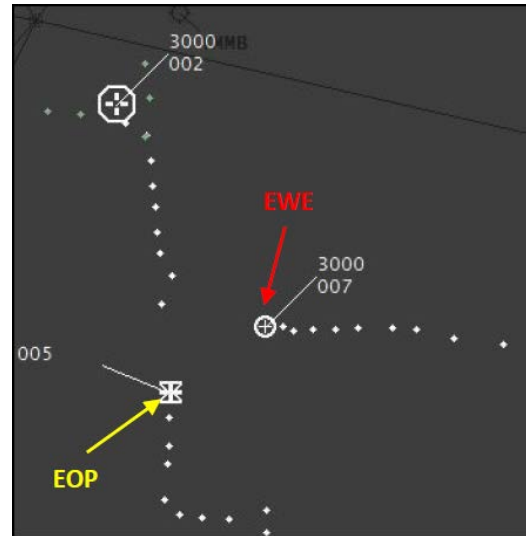
Figure 2: Aircraft positions at 1629

A subsequent review of Airservices Australia surveillance data showed that, at about 1629, EOP and EWE were on converging tracks (Figure 2). Shortly after, the instructor and student of EWE again looked for traffic. With no traffic sighted, they commenced the turn onto final. The turn was conducted lower and later than normal. At about the same time, EOP received an ATC clearance to land.

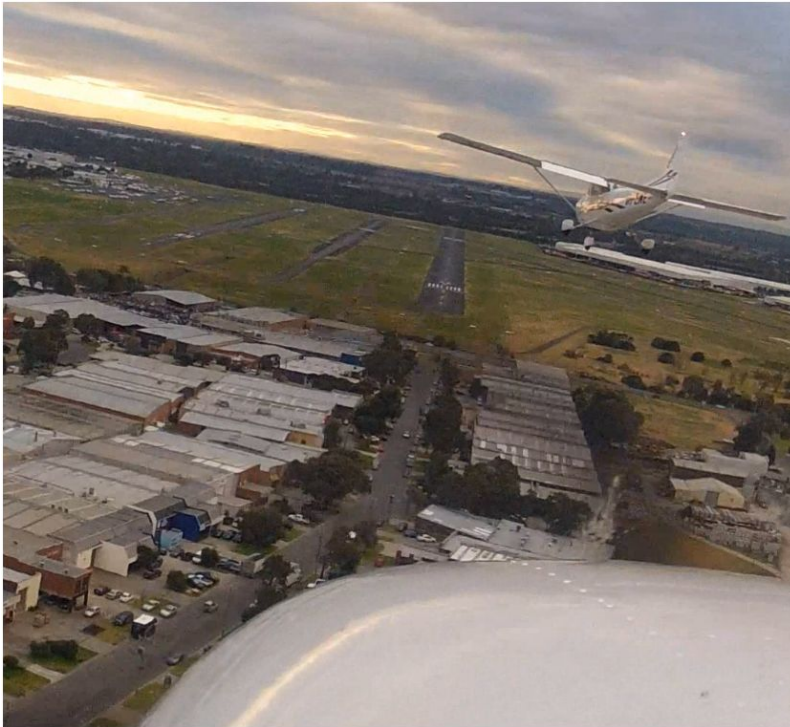
Figure 3: The incident

The pilot of EOP reported that several seconds later he observed EWE pass overhead from his right, about 10-20 metres in front of his aircraft (Figure 3). In response, he reduced engine power and raised the nose of the aircraft slightly to slow the aircraft and increase separation. The pilot then advised ATC that EWE had 'cut in front' of his aircraft. Air traffic control immediately instructed EWE to conduct a go-around. The student of EWE commenced a go-around and EOP landed without further incident.

- **Radio broadcasts:** The instructor stated that he could not recall hearing any broadcasts made relating to EOP. The student had recently commenced circuit training and the instructor had spent a reasonable amount of time throughout the lesson conversing and demonstrating. It was possible that any broadcasts made could have been missed. As a result of this incident, the instructor now limits his conversation. If a detailed explanation is required, he assumes control of the aircraft and demonstrates, rather than talking the student through the procedure.

- **Traffic scanning area:** The instructor reported that EOP may have been outside his normal scan area when looking for traffic due to the wide circuit pattern conducted by EOP.

- **Lookout vigilance:** The instructor was of the understanding that they were following NEG in the circuit. Consequently, when he observed NEG landing, he reported that his lookout vigilance may have reduced as he believed there was no other traffic to follow.

- **Wind:** The distance between EWE and EOP reduced as a result of a tailwind on downwind and a headwind on base and final.

The practice of see-and-avoid has long been recognised as the primary method for minimising the risk of collision when flying in visual meteorological conditions; it is considered a crucial element of a pilot's situation awareness. An ATSB research report titled '*Limitations of the See-and-Avoid Principle*' showed that, when searching for traffic, alerted see-and-avoid (when a radio is used in combination with a visual lookout) is eight times more effective than unalerted see-and-avoid (when no radio is used). However, pilots should be mindful that the absence of a traffic broadcast does not necessarily mean the absence of traffic. Pilots should remain vigilant and employ both unalerted and alerted see-and-avoid principles to ensure the greatest level of traffic awareness is achieved.
