# Wirestrike – Robinson R44, VH-HIE

21 km E of Maryborough aerodrome, Victoria, 12 June 2012

**ATSB Transport Safety Report**  
Aviation Occurrence Investigation  
AO-2012-079  
Final

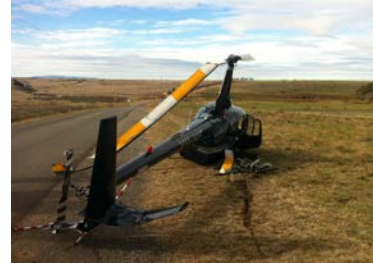
## Accident site

Following the wirestrike, the helicopter swung upwards on the wire and the pilot remembered seeing the sky before the wire broke, releasing the helicopter. The pilot had limited control and was able to change the attitude to remain relatively straight and level until the helicopter landed heavily on the right skid.

The pilot was not injured, however the helicopter sustained serious damage.

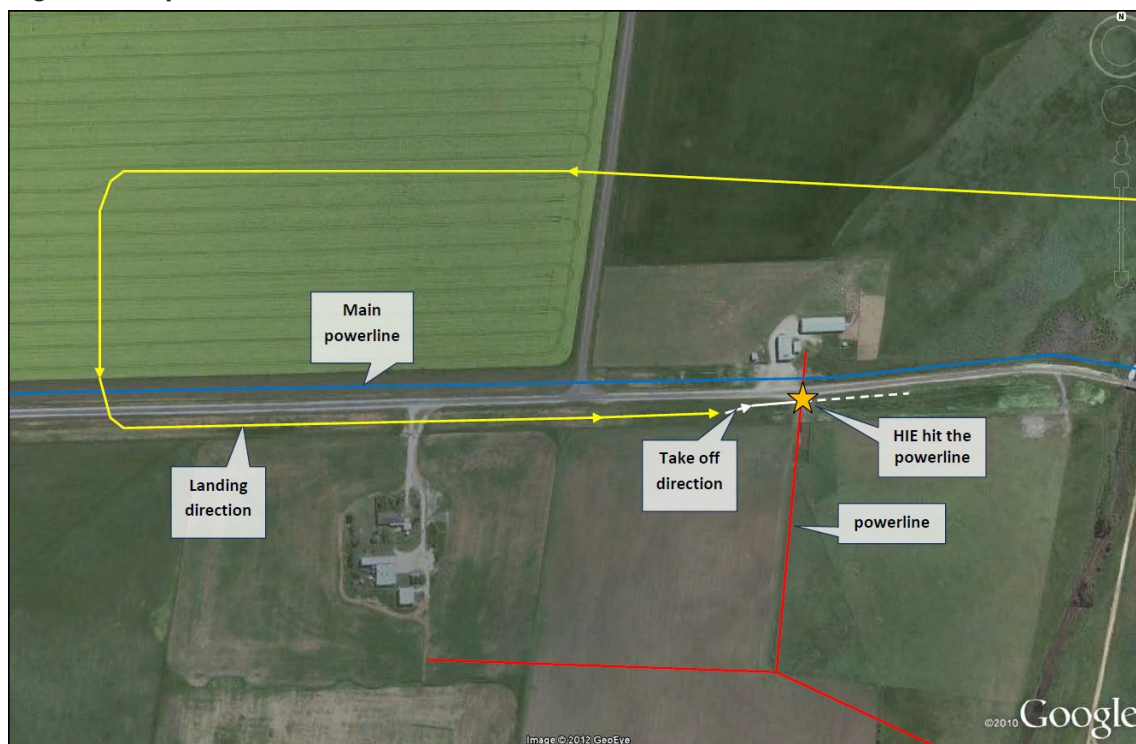
**Figure 1: Map of accident site**

As there was no wind, the pilot flew HIE past the bore site in a westerly direction, parallel with the road and the main powerline, before conducting a left turn and landing south of the road in an easterly direction (Figure 1). This approach path enabled him to scan the area for obstacles.

The main powerline ran in an east-west direction north of the road (marked in blue in Figure 1) and formed a major part in the pilot's choice of approach and departure paths.

The pilot had known of the second powerline prior to the incident flight, but only remembered it as it came into sight, as he transitioned from hover to forward flight, about 40 m from where he had landed. The second powerline was a single multi-strand wire of about 6 to 8 mm diameter. One pole for the wire was about 8 m to the south of the accident site; the other was beside a house on the northern side of the road. The pole near the house appeared to the pilot to be a part of the main powerline system that ran parallel to the road.

The main powerline running along the road in the vicinity of the landing site and the location of the poles supporting both the main and second powerlines, in the pilot's opinion, most likely provided a considerable distraction and contributed to his inability to identify the second powerline during the evaluation of his departure path.
