Fuel contamination – Cessna 182P, VH-WTS

near Cunnamulla Aerodrome, Queensland, 19 June 2012

ATSB Transport Safety Report
Aviation Occurrence Investigation
AO-2012-083
Final

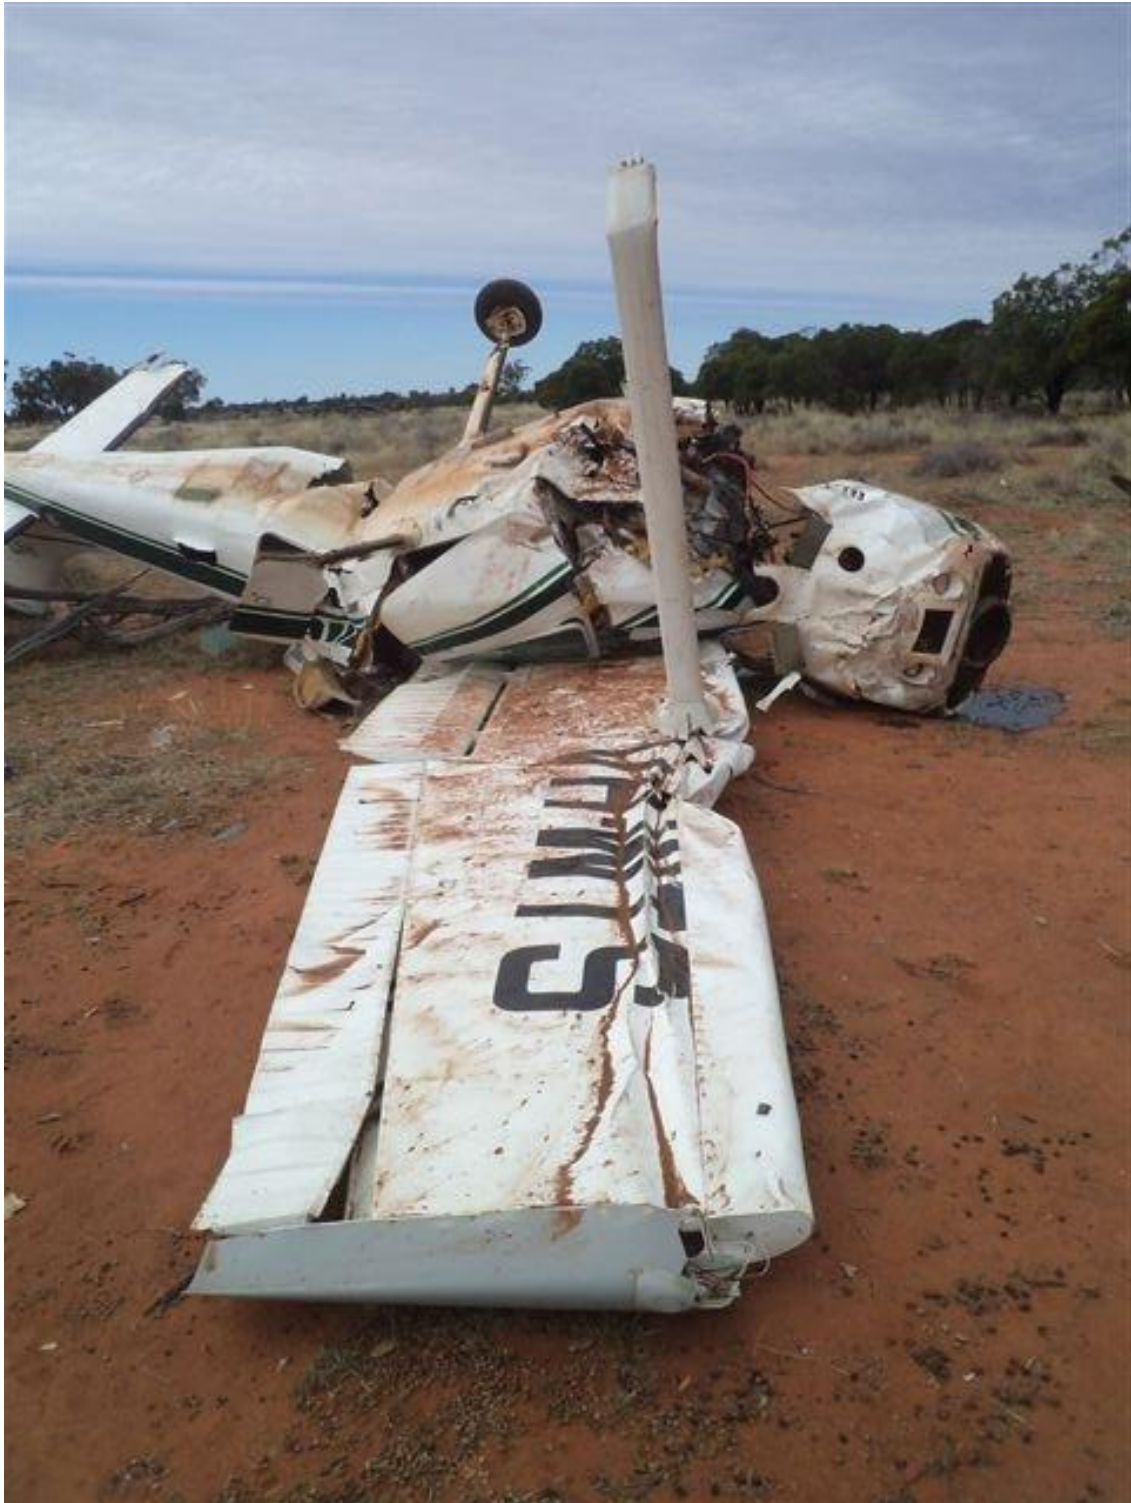
Figure 1: VH-WTS

On 19 June 2012, at about 0815 Eastern Standard Time¹, the pilot of a Cessna Aircraft Company 182P aircraft, registered VH-WTS (WTS), departed Mayvale Station, about 53 km east-north-east of Cunnamulla, Queensland, for an aerial inspection of the property. Shortly after becoming airborne, at about 80 to 100 ft, the pilot recalled the aircraft losing airspeed and then clipping a tree during the subsequent forced landing. The pilot's next recollection was being on the ground, out of the aircraft and unable to stand. The aircraft had collided with the ground and came to rest inverted (Figure 1).

Following the accident, a considerable amount of water was found in fuel samples taken from a number of locations in the aircraft's fuel system. Water was also found in a sample taken from the drum.
