Aviation Short Investigation Bulletin

Issue 14

ATSB Transport Safety Report
Aviation Short Investigations
AB-2012-157
Final

Report No. AB-2012-157

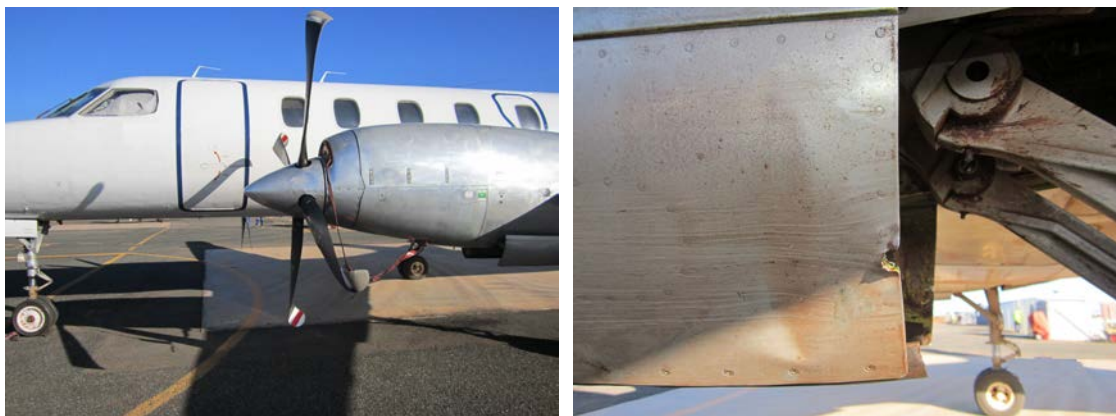
Figure 1: Propeller and landing gear door damage

After shutdown, the crew inspected the aircraft and determined that the left propeller had contacted the ground. The aircraft sustained damage to the left propeller blades and spinner, and the left landing gear doors (Figure 1).

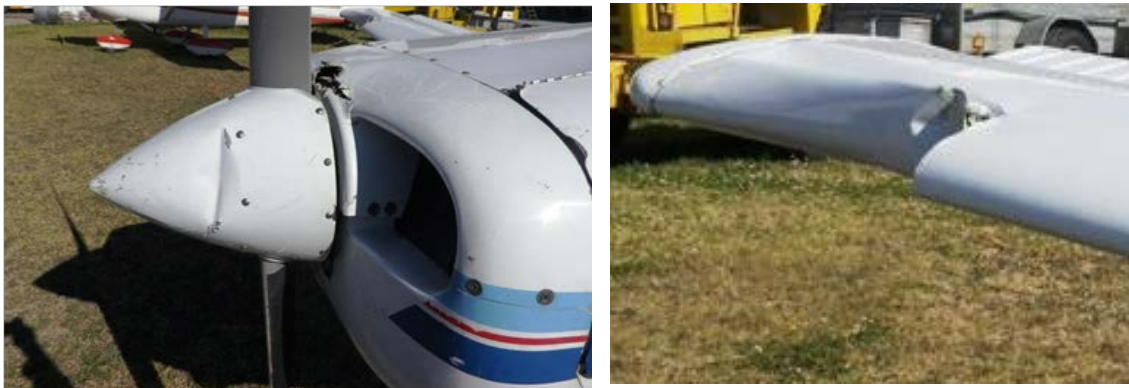
Figure 1: Aircraft damage

After landing, when the pilot applied full power for take-off, SFK veered suddenly to the left onto the grass. The pilot reduced the throttle setting to the idle position and applied the brakes, however the aircraft collided with the airport perimeter fence. The pilot shut down the aircraft and exited. The aircraft sustained substantial damage (Figure 1) and the pilot sustained minor injuries.

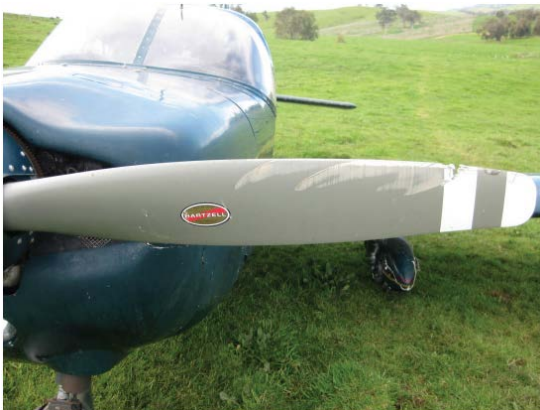
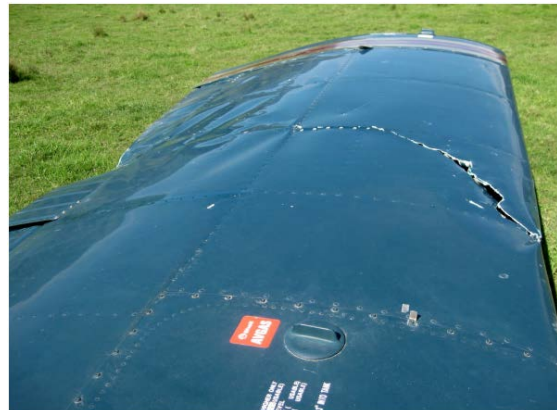
Figure 1: Aircraft damage

The pilot moved the throttle to the idle position and prepared for the landing. During the landing, the pilot noted that engine power had been restored. The aircraft subsequently impacted two fences and sustained substantial damage. Both occupants were uninjured.

An insurance representative attended the site and noted that there was a significant quantity of fuel in all the tanks, apart from the left tip tank, which had been damaged in the accident. There was evidence that fuel had leaked from that tank onto the ground. The insurance representative also found evidence of insects, likely wasps, lodged inside the left and right tip tank vent pipes.
