Engine failure involving Piper PA-32, VH-FAJ

4 km E of Yea, Victoria, 22 September 2012

ATSB Transport Safety Report
Aviation Occurrence Investigation
AO-2012-125
Final

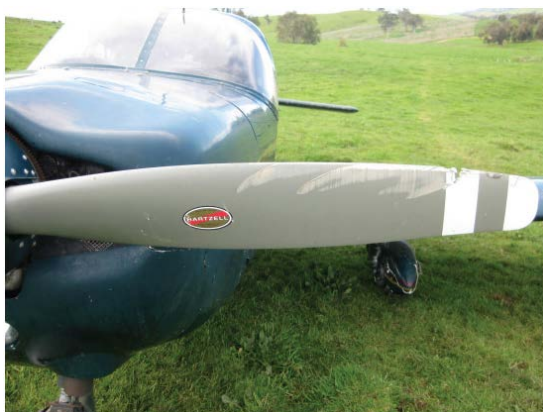
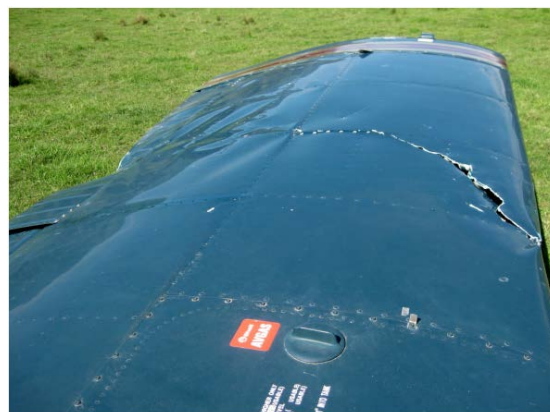
Figure 1: Aircraft damage

The pilot moved the throttle to the idle position and prepared for the landing. During the landing, the pilot noted that engine power had been restored. The aircraft subsequently impacted two fences and sustained substantial damage. Both occupants were uninjured.
