Man overboard fatality from the container ship *MSC Siena*

off Fremantle, Western Australia | 17 November 2011

ATSB Transport Safety Report
Marine Occurrence Investigation
290-MO-2011-010
Final – 5 February 2013

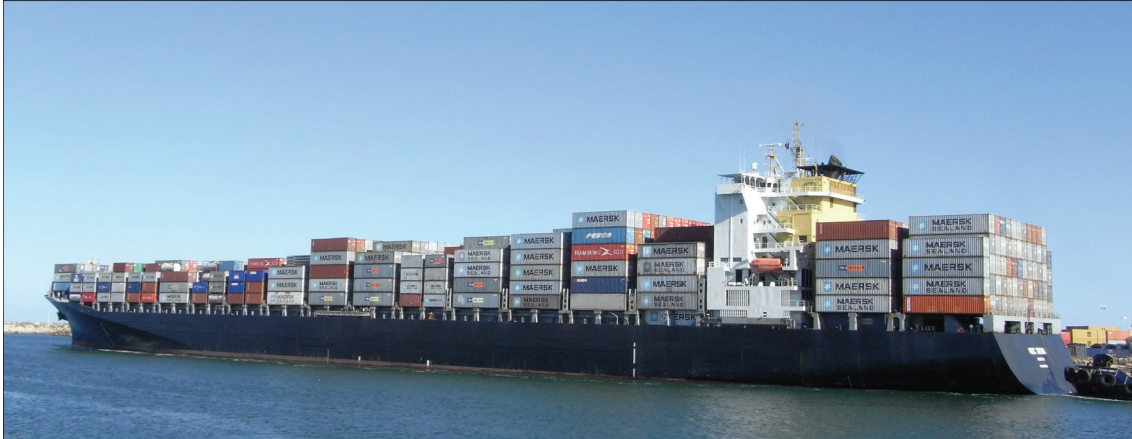
Figure 1: *MSC Siena* in Fremantle harbour

In the early hours of 17 November 2011, the 4,542 TEU¹ capacity container ship *MSC Siena* (Figure 1) was in the final stages of its passage from Melbourne to Fremantle. The ship was expected to arrive at the Fremantle pilot boarding ground at about midday.

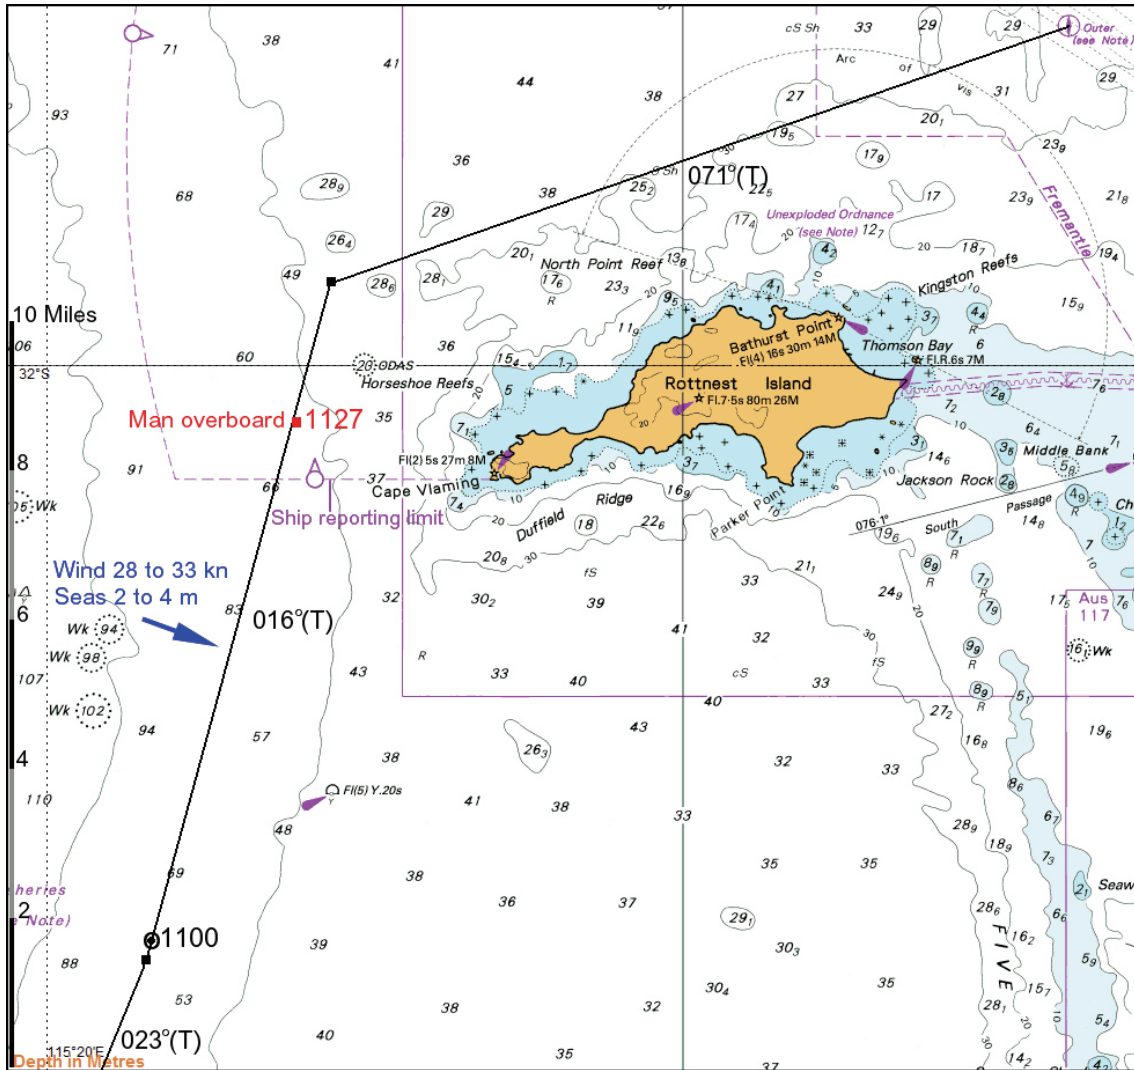
Figure 2: Section of navigational chart Aus 754 showing the ship's location

At 1100, *MSC Siena* was south-southwest of Rottnest Island and on a course of 016° (T) at a speed of 15 knots (Figure 2). The now force 7 (28 to 33 knots) westerly wind was on the port beam and the ship was rolling easily in the rough seas and swell. The next course alteration to 071° (T), towards the pilot boarding ground, was due at about 1135.

By this time, *MSC Siena* had arrived near the ship reporting limit west of Rottneest Island (Figure 2). At 1122, the third mate reported the ship's position to the 'Port of Fremantle' and was advised that the pilot would board at 1230, as scheduled.

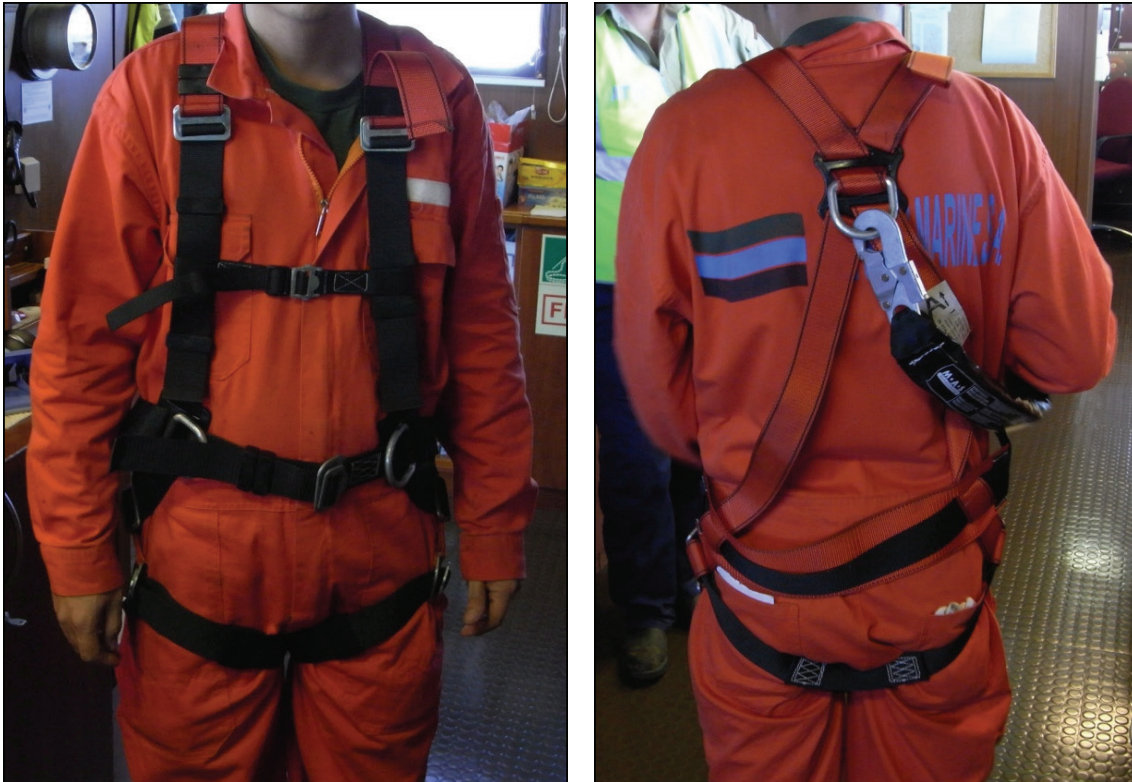
Figure 3: The same type of safety harness as used on 17 November (front and back)

By 1624, *MSC Siena* had been secured alongside its berth in the port of Fremantle. Police officers boarded the ship and retained the harness that the OS had been wearing. The harness had been found with the right leg and chest buckles (that is, two of its four buckles) undone.

It is not known exactly how the OS came out of the harness. None of its buckles or straps failed nor did the lanyard. However, the two buckles found undone would have made it easier to come out of the harness.

The only explanation for the undone buckles is that either they had not been done up or the OS undid them to avoid being pounded against the ship's side (the latter is unlikely because it is difficult to undo a buckle with weight on it). The OS was seen hanging limp and his upper back, shoulder and one arm appeared deformed, indicating that he was injured and probably unconscious. In such a condition, loss of muscle tone would have made slipping out of the harness more likely, particularly as the OS's body was lifted and tossed about by the waves.

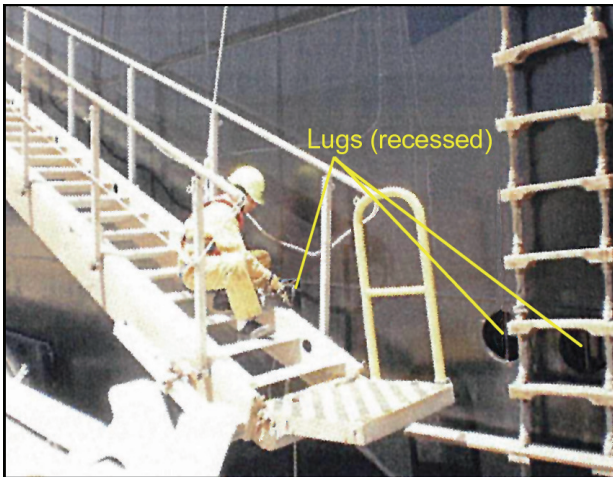
Figure 4: MSC Siena's combination pilot ladder

Shortly after 1100, the bosun, two ordinary seamen and the deck cadet went to rig the combination pilot ladder⁵ (Figure 6) on the ship's port side. After they had swung out the accommodation ladder, one of the ordinary seamen (OS), with some assistance from the other seaman, donned a full body safety harness (Figure 3). He connected the harness lanyard to a rope that was pre-attached to a railing on deck and stepped onto the ladder's top platform. The OS secured the top platform stanchions and handrails and then, with help from the other men, lifted and secured the ladder's side handrails and bottom platform stanchion.

At about 1115, the accommodation ladder was lowered until the bottom platform was about 7 m below the main deck, the usual level for rigging a combination ladder. The OS connected his harness lanyard to a longer rope, also pre-attached to a railing on deck, and descended the accommodation ladder. Using a rope, he lashed the lower part of the accommodation ladder to a set of lugs recessed in the ship's side (Figure 4). Meanwhile, the crew on deck lowered the pilot ladder so that its lowest step would be about 2.5 m above the waterline (in a calm sea).

At about 1123, as the bosun watched the OS, he saw a 'large wave suddenly rise up' and strike the underside of the bottom platform of the accommodation ladder with force (the rope lashing the

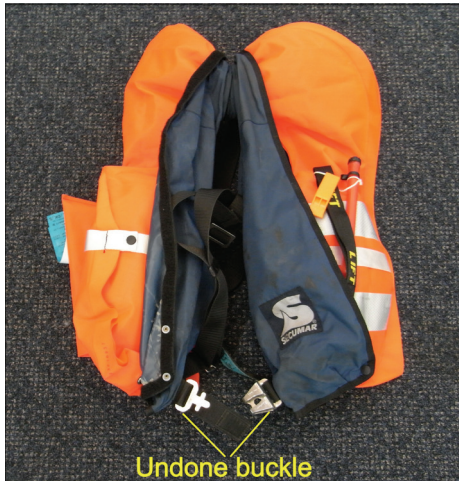
Figure 5: Inflated lifejacket

A nearby charter fishing vessel was the first to respond to the emergency call. At 1136, its crew located two lifebuoys and an inflated automatic type lifejacket with its buckle undone (Figure 5). Another small vessel soon joined the search.

An inflated lifejacket, with its buckle undone, was found during the search for the missing OS. However, the evidence suggests that he may not have been wearing the lifejacket when he was knocked off the accommodation ladder.

It is possible but unlikely that the OS was wearing the lifejacket with its buckle undone, or that he managed to undo it while he was being pounded against the ship's side. It is more likely that he was not wearing a lifejacket and that it was thrown overboard at the same time as the lifebuoys.

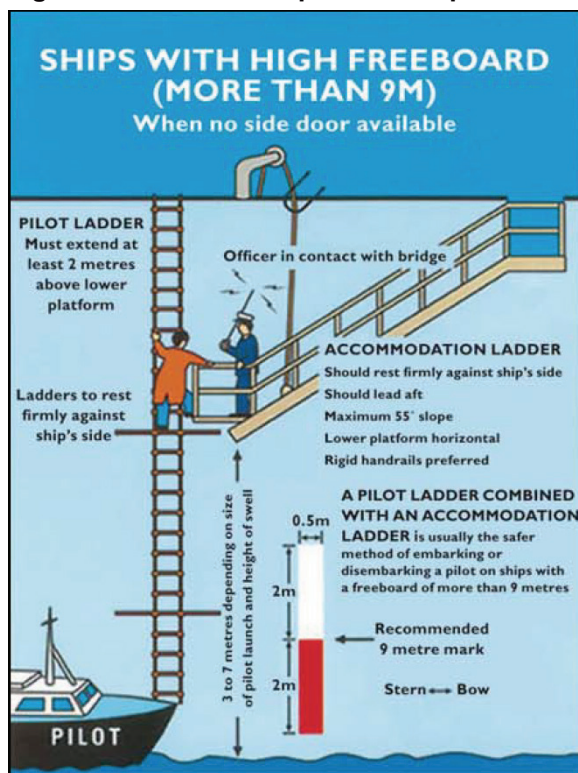
Figure 6: Combination pilot ladder poster

If a ship's freeboard⁸ is more than 9 m, a combination pilot ladder (Figure 6) is required. Even with freeboards less than 9 m, combination ladders are often used because they are considered safer.⁹ However, since rigging a combination ladder involves working over the side, there is a higher risk of a crew member falling overboard while rigging it.

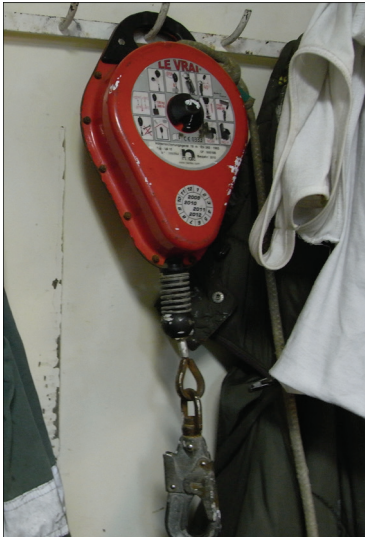
Figure 7: Fall arrestor

The bosun indicated that the fall arrestor stored in the crew's change room (Figure 7) was used when working at heights (for example, on a mast) but not when rigging a combination pilot ladder. This suggests that *MSC Siena's* crew did not consider rigging a combination ladder as working at a height. For rigging a ladder, they hooked the harness lanyard to the eye of a tethering rope, the other eye of which was secured to a handrail adjacent to the accommodation ladder (Figure 8).
