# Aircraft proximity event between Beech 1900, VH-EMK and Airparts FU-24, VH-HVP

Jabiru, Northern Territory, 5 October 2012

**ATSB Transport Safety Report**  
Aviation Occurrence Investigation  
AO-2012-134  
Final – 27 February 2013

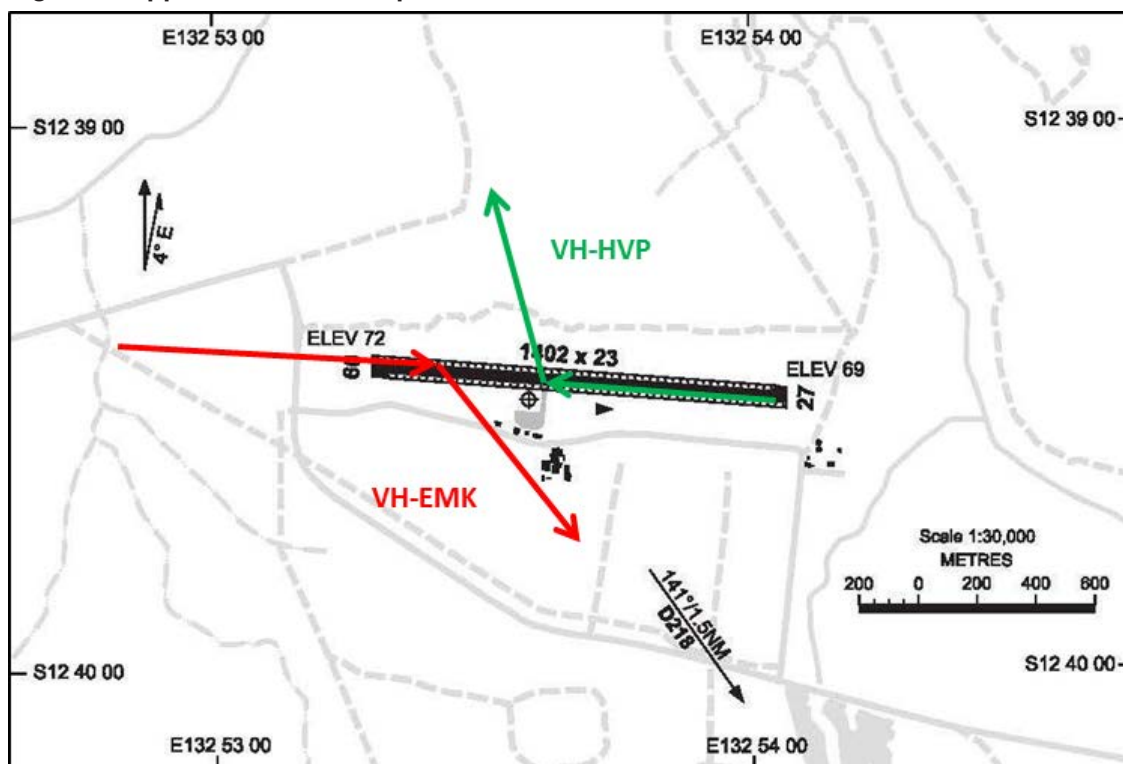
Figure 1: Approximate aircraft positions

When at about 1 NM inbound, the crew of EMK observed HVP taking-off on runway 27, directly opposite to their approach path. The Captain immediately called for a go-around, which the FO initiated. The FO took avoiding action by manoeuvring the aircraft to the right.

The crew of EMK and HVP reported different assessments as to the minimum separation of the two aircraft. It appears that separation reduced to about 300 ft vertically and 200-250 m laterally.
