# Loss of separation between VH-TFK and VH-PDP

6 km N of Cairns, Queensland | 23 November 2011

**ATSB Transport Safety Report**  
Aviation Occurrence Investigation  
AO-2011-147  
Final

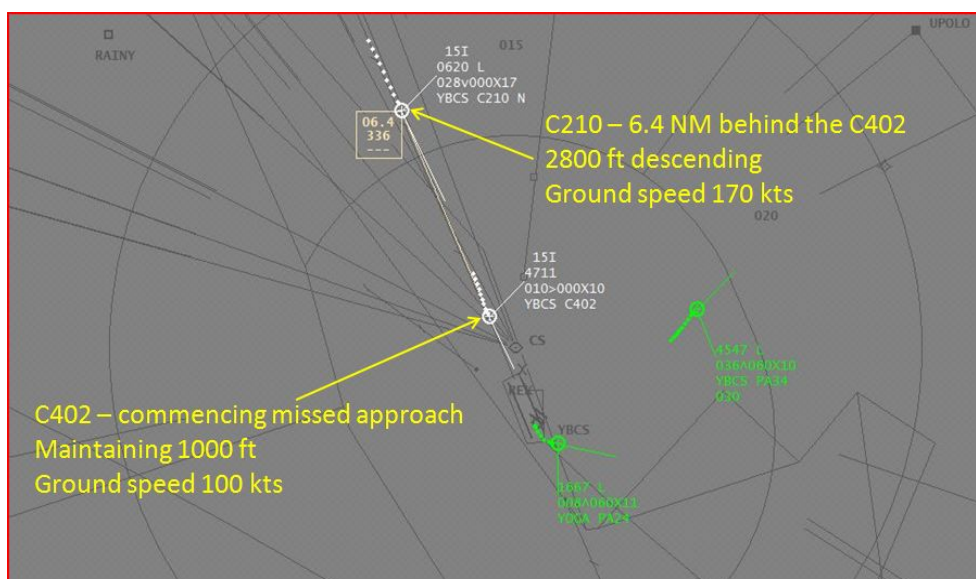
**Figure 1: C402 commencing the missed approach at 1006:01**

At 1006:01, the pilot of the C402 advised the tower controller that the aircraft was going around.<sup>7</sup> At that time the C402 was established on the localiser, but positioned above the glideslope. The aircraft was about 2 NM (3.7 km) from touchdown, maintaining 1,000 ft with a ground speed of 100 kts. The C210 was now 6.4 NM (11.9 km) behind the C402 and descending through 2,800 ft with a ground speed of 170 kts, which was 70 kts faster than the C402 (Figure 1).

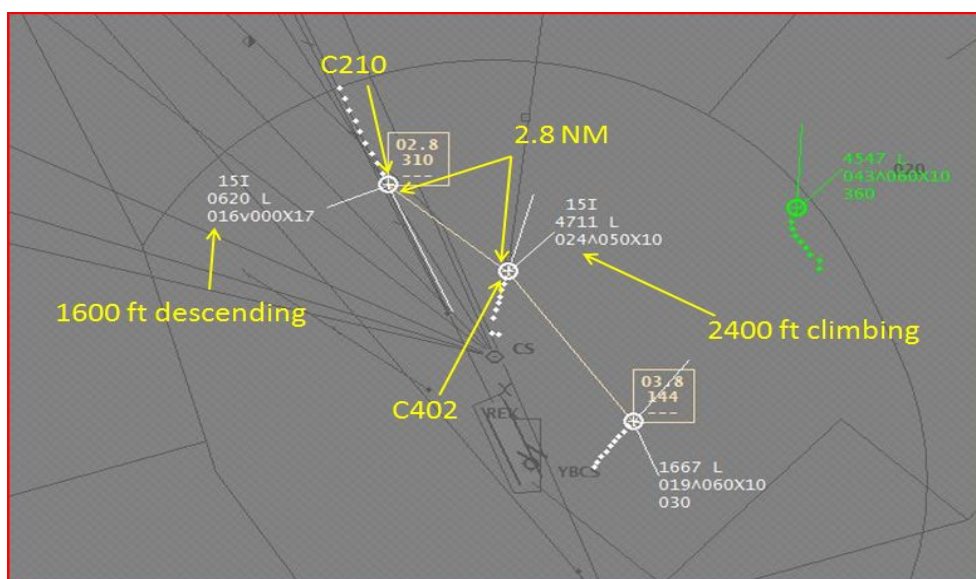
**Figure 2: Loss of separation at 1007:16**

A LOS occurred at 1007:16 when the radar distance between the C402 and the C210 reduced to 2.8 NM (5.2 km) (Figure 2). Vertical separation at the time was 800 ft and visual separation was not applicable as both aircraft were operating in instrument meteorological conditions (IMC).<sup>10</sup> The vertical separation standard of 1,000 ft was re-established at 1007:29 without further controller instructions or inputs.

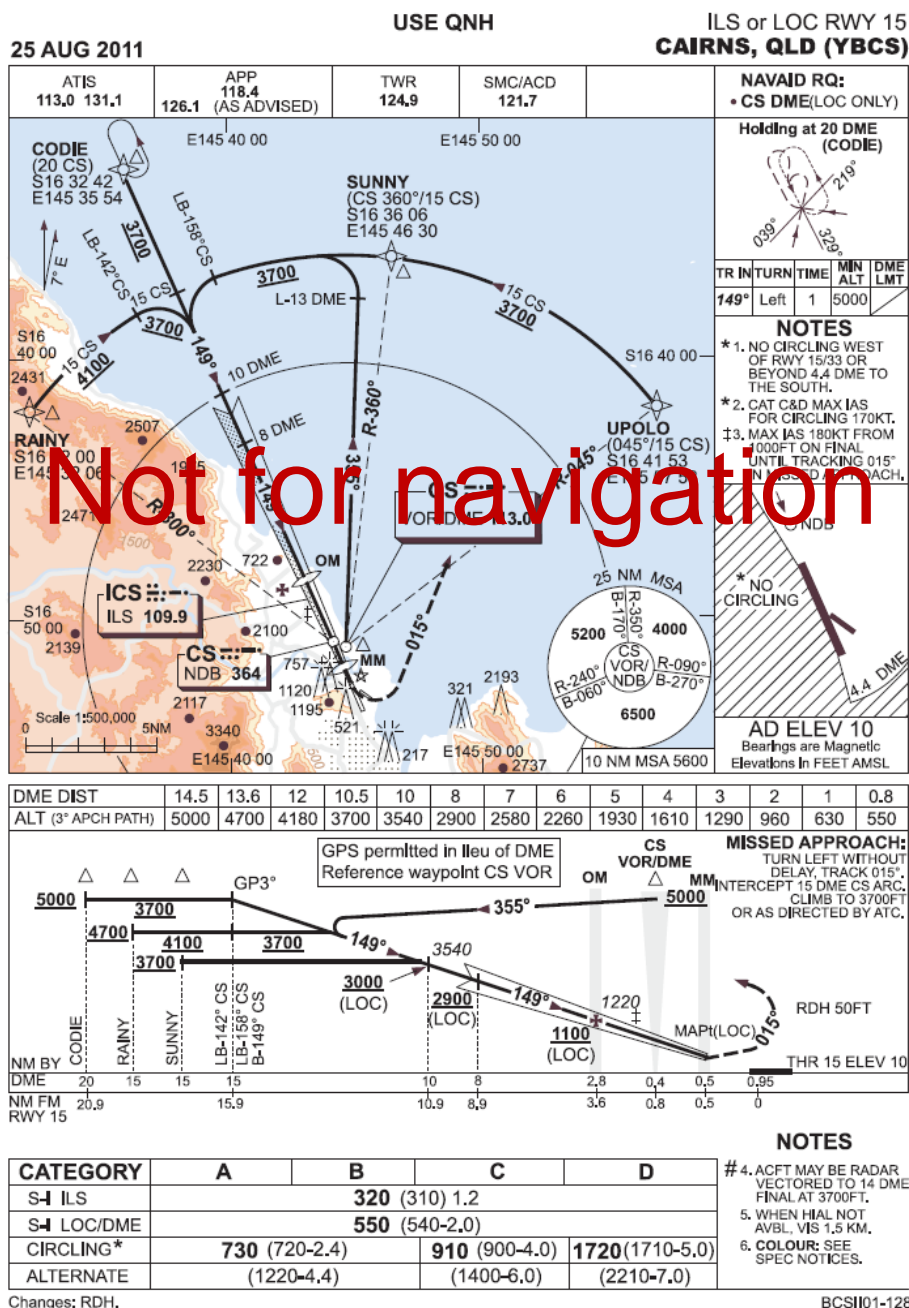
# APPENDIX A: ILS or LOC RWY 15, CAIRNS (25 Aug 11)

For the Cairns runway 15 ILS approach, aircraft were radar vectored on to the approach path at 14 DME and 3,700 ft. This position was also included as operational note No. 4 on the ILS/LOC instrument approach chart (Appendix A).

In contrast with the requirements of operational note No. 4 to the Cairns ILS/LOC instrument approach chart, the radar vector that was issued to the pilot of the C402 positioned the aircraft on the ILS approach path at 10.4 DME. The pilot reported that from this distance, the aircraft remained above the glideslope throughout the ILS approach by a half full-scale deflection,<sup>15</sup> increasing to a full-scale deflection just prior to the outer marker. It was at that point that the pilot commenced initiated the missed approach.

A national request for change has been raised to create ILS or LOC Y and Z approaches to runway 15. The 'TURN LEFT WITHOUT DELAY' note is being removed from these procedures. The planned implementation date for this change is 7 March 2013 to coincide with the AIRAC cycle.
