Landing on a closed airstrip involving a Piper PA-28R, VH-HKZ

Geelong (Grovedale), Victoria, 17 November 2012

ATSB Transport Safety Report
Aviation Occurrence Investigation
AO-2012-155
Final – 27 February 2013

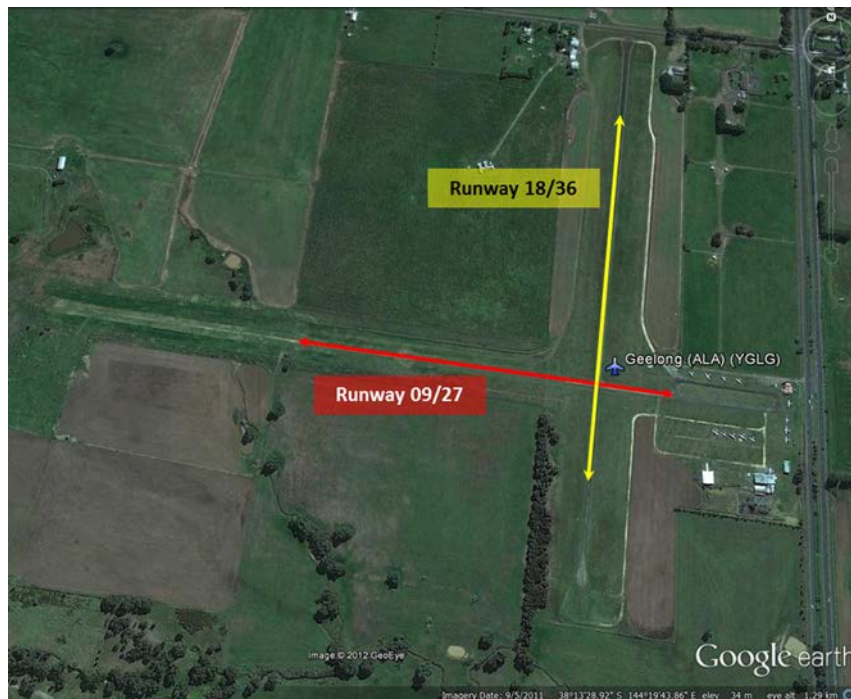
Figure 1: Geelong (Grovedale) airstrip

On arrival at the airstrip (Figure 1), the pilot observed flags adjacent to the powerlines on the approach to runway 27. At the time, he believed that the flags may have been installed for increased awareness due to a wirestrike accident that occurred in 2010. Subsequently, the aircraft joined the downwind leg of the circuit for runway 18.

After landing, the pilot noticed that the office buildings were unoccupied and a fence had been placed across runway 09/27. The pilot and passenger exited the aircraft and were subsequently advised by people on the ground that the airstrip had been closed and was being redeveloped. The pilot then contacted Airservices Australia via telephone to cancel his SARTIME¹; in acknowledging the cancellation, the Airservices employee made reference to Barwon Heads as the planned destination.

The pilot reported that neither he nor the passenger observed any markings on the runway to indicate the airstrip was closed. The pilot did, however, observe a marking at the northern end of runway 18/36. Prior to departing Geelong, the pilot visually inspected the runway and noted that the marking was a large square or rectangle covering the width of the runway, and was of a powder-like substance. The pilot could not recall sighting the windsock.
