Speed control during landing Bombardier DHC-8-102, VH-QQA

Cairns Airport, Queensland | 30 December 2011

Aviation Occurrence Investigation
AO-2012-005
Final

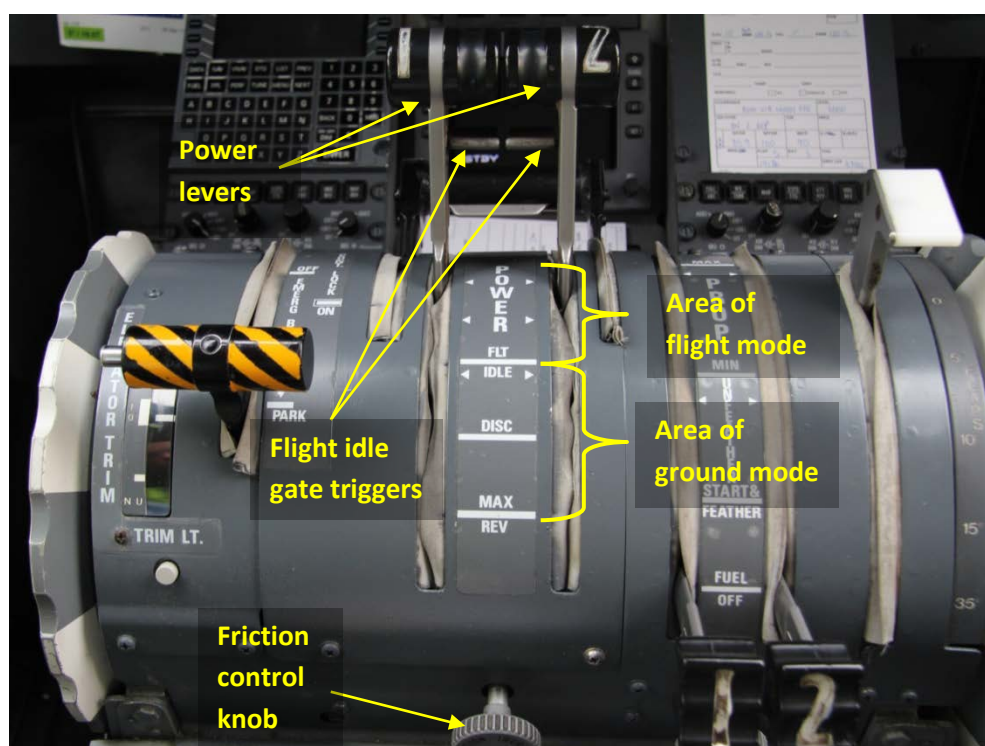
Figure 1: Exemplar picture of the DHC-8 power lever controls

The aircraft is fitted with two power levers, one for each engine. The levers have two modes of operation: flight mode and ground (or beta) mode. In flight mode the power levers control engine speed between flight idle and take-off power. In ground mode the power levers control engine speed and propeller RPM in a range from below flight idle to maximum reverse (Figure 1).

The power lever quadrant includes a mechanical stop, called the flight idle gate, to assist with preventing movement of the power levers below flight idle in flight. Each power lever grip incorporates a flight idle gate release trigger that has to be lifted in order for the power levers to bypass the flight idle gate and enter the ground mode. In normal operation the pilot raises the flight idle gate release triggers after landing to bypass the flight idle gate and use ground mode as required.

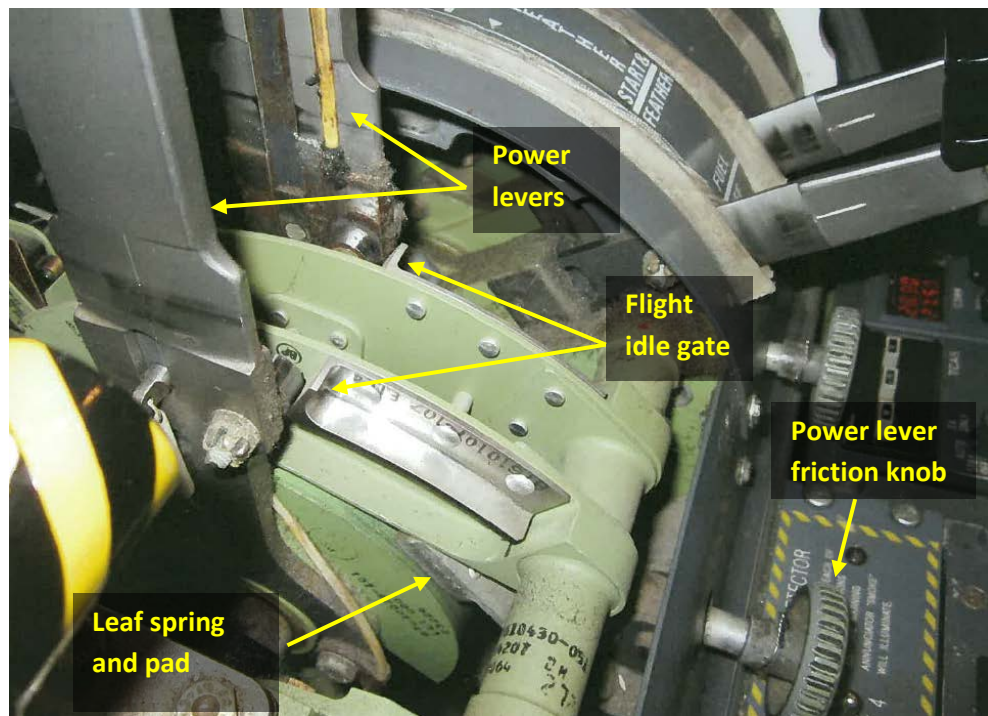
Figure 2: Power lever controls with the dust cover removed

Figure 2 shows the aircraft's power levers, flight idle gate and power lever friction adjustment mechanism with the dust cover removed. The power levers are in the flight idle position.

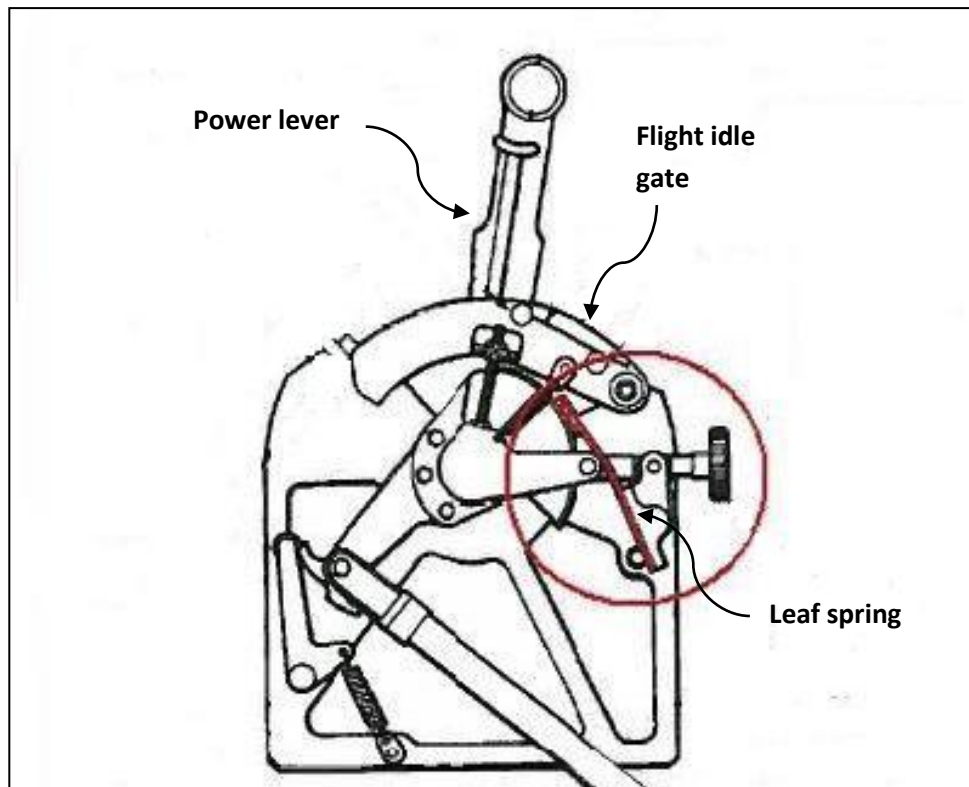
Figure 3: Power lever and friction adjustment mechanism

Figure 3 shows the power lever, flight idle gate and power lever friction mechanism with the friction leaf spring highlighted in red.

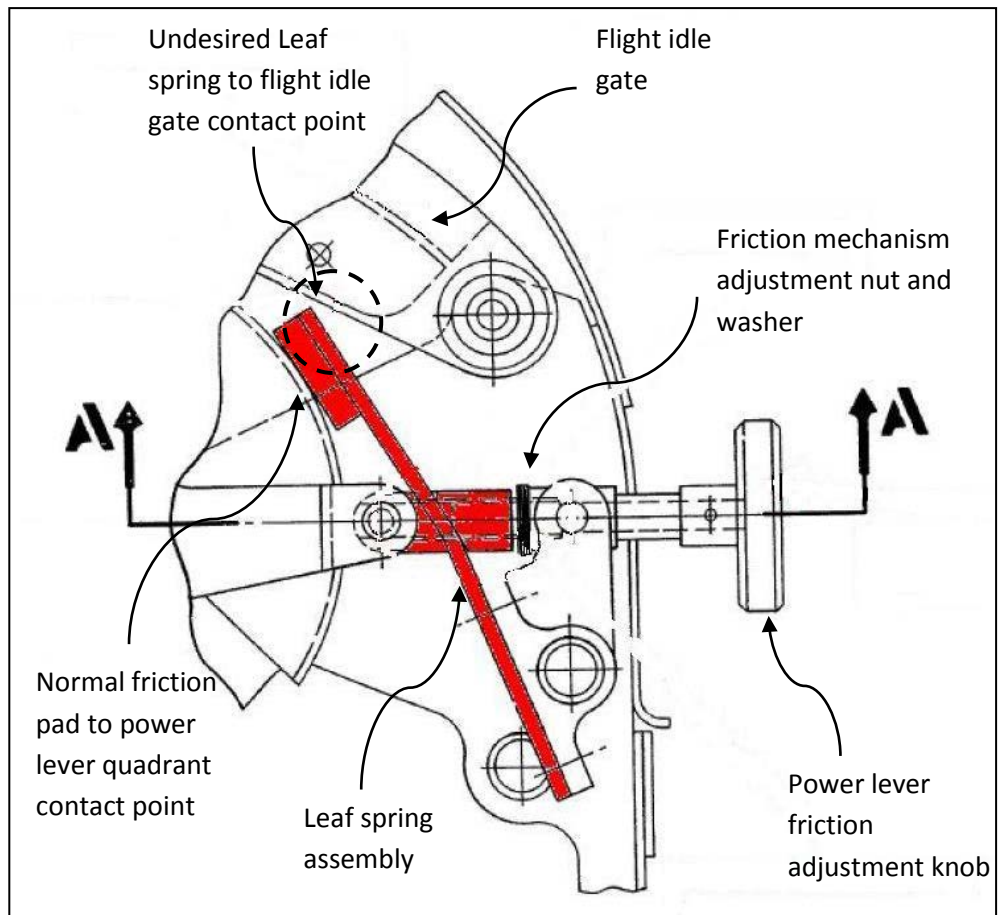
Figure 4: Friction adjustment mechanism

The second and more serious issue was an underlying design problem within the power lever control system. It was discovered that if the engine power lever friction adjustment knob was wound completely out (friction off) then the forward upper edge of the leaf spring would come in contact with the lower part of the flight idle gate (Figure 4). The flight idle gate could be raised by the leaf spring a sufficient amount so that the power levers could bypass the flight idle gate without the flight idle gate release triggers being lifted. In effect the flight idle gate could be rendered ineffective at protecting the propeller system against inadvertent activation of propeller ground beta range in flight.

If the power levers were moved into the ground beta range inflight, the propeller speed would no longer be controlled by the propeller systems, leaving the propellers susceptible to an overspeed condition that could rapidly lead to engine damage and, in the worst case, engine failure.

In response to this design problem, Bombardier Inc. issued an alert Service Bulletin A8-76-32 on 24 January 2012, which recommended the modification of the friction lever spring on all aircraft between serial number 001 thru 039 in order to prevent contact between the friction lever spring and the flight idle gate.

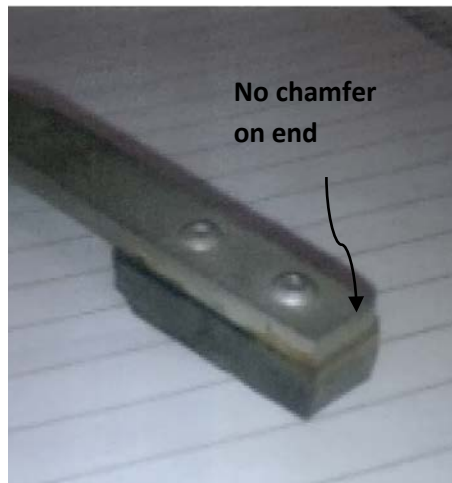
Figure 5: Initial leaf spring

Even though all aircraft after serial number 039 were fitted with the new leaf spring, the service bulletin did not mention the modification or replacement of the leaf spring to incorporate the chamfered end. As a result, aircraft with serial numbers 001 to 039 did not have a leaf spring with a chamfered end fitted. The manufacturer confirmed that the leaf spring fitted to VH-QQA was the pre-modification part that did not include a chamfered end.

The aircraft operator confirmed that SB 8-76-2 had been incorporated into VH-QQA and that it was ineffective at preventing contact between the friction leaf spring and the flight idle gate without the leaf spring chamfer modification. That meant that the service bulletin was ineffective at preventing leaf spring to flight idle gate contact in all aircraft that did not have a post-modification leaf spring with a chamfered end.

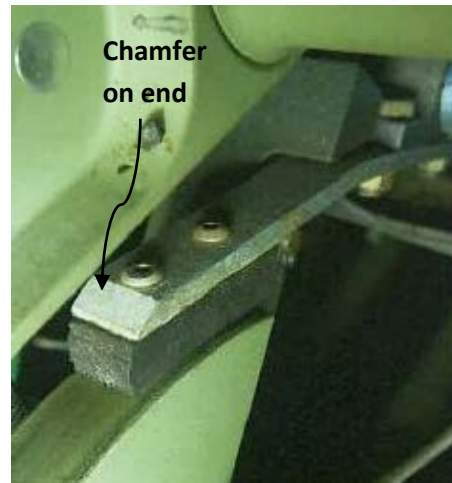
Figure 6: Modified leaf spring

The service bulletin was also incorporated into all aircraft that were manufactured after serial number 039. The newer aircraft were also fitted with a modified type of leaf spring, which replaced the initial design with a chamfer at the end of the leaf spring so that the spring would not make contact with the flight idle gate (Figures 5 and 6). The modified leaf spring had an identical part number to the unmodified version.
